**FULL RESERVE STUDY**

***TWISTED CREEK TOWNHOMES  
HOLLY SPRINGS, NC***

***JULY 25, 2018***

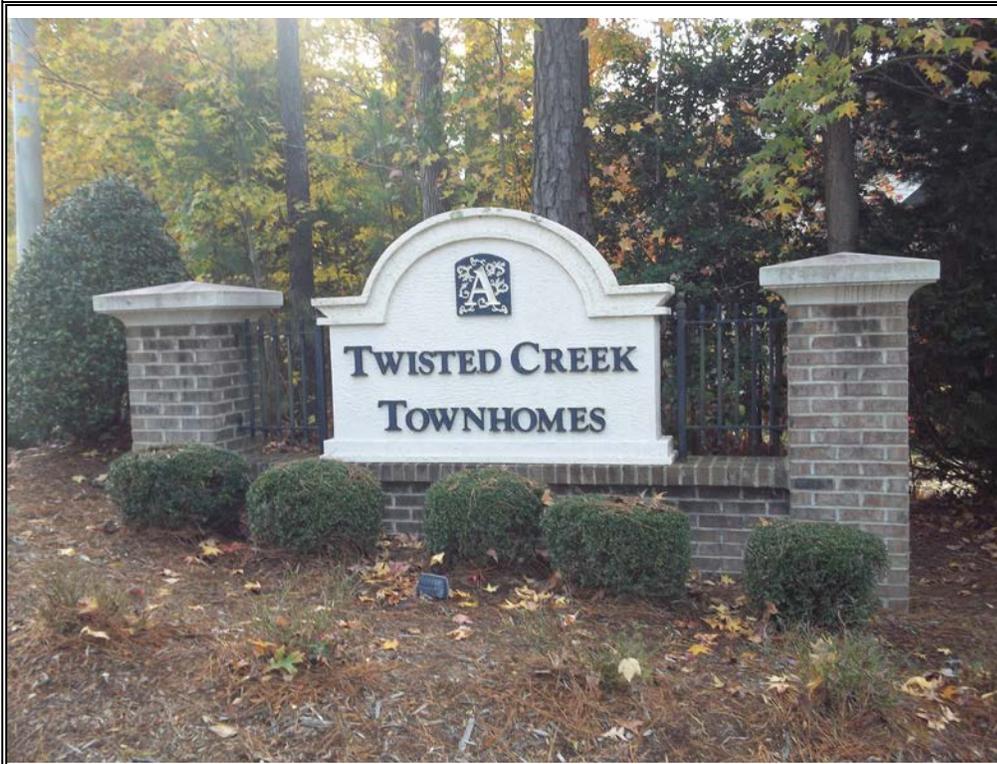
**Photo Number**  
**1**

A brick veneer monument is located at the main entrance to the community and includes a metal signage with stucco finish and metal lettering. The entrance signage includes landscape irrigation systems and low-voltage landscape lighting systems. The monument structure and signage appeared to be in good condition. We have allocated funds to refurbish the entrance monument and associated landscaping fixtures on a 15-year cycle beginning in 2026.

**Description:**  
View at entrance  
monument to  
community at  
Florians Drive

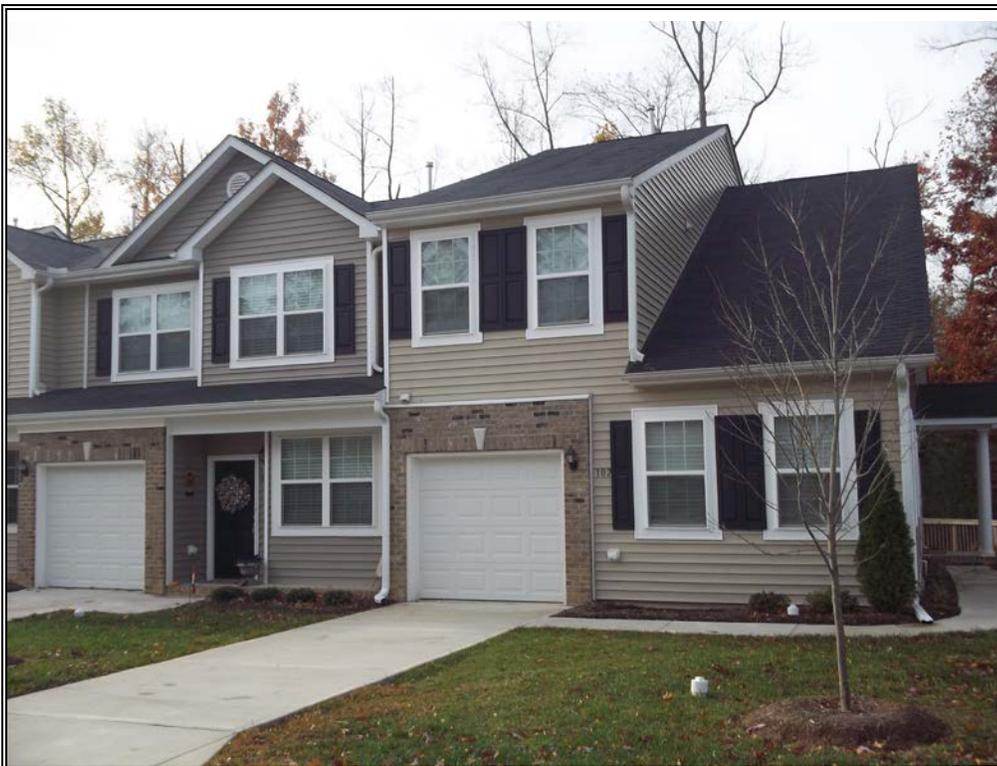
**Photo Number**  
**2**

**Description:**  
Typical view of  
townhome units  
within community

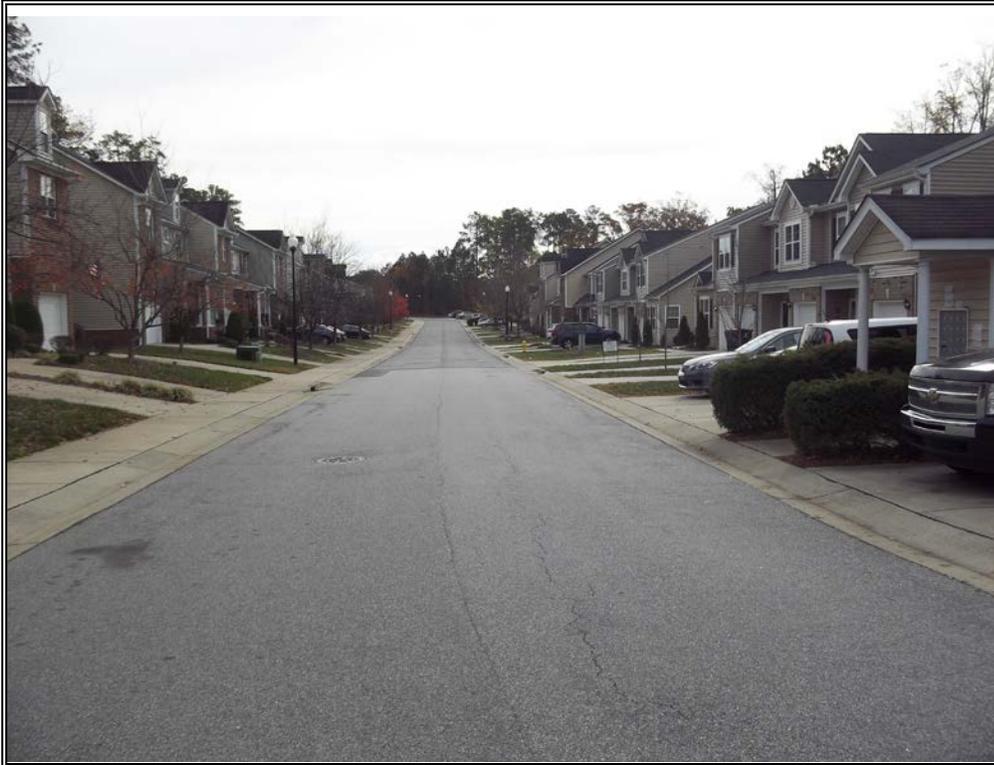
**Photo Number**  
**3**

The streets and parking sections in the community are asphalt paved and maintained by the association. The paving generally appeared to be in fair to good condition. Some areas of fatigue cracking, rutting and depressions were noted within the asphalt pavements.

**Description:**  
View of asphalt  
pavement along  
Florians Drive

Typically, we recommend the application of an oil resistant sealant to all asphalt paved surfaces on an approximately 5 to 7-year cycle. At this same time, all cracks should be properly filled, patched, and sealed. We have allocated funds for crack repairs and to seal the pavement on a 5-year cycle beginning in 2020.

Assuming sealing and crack repairs occur in the interim, we anticipate the asphalt paving in the community to have an estimated useful life of approximately twenty years prior to full resurfacing. We have allocated funds to resurface all of the asphalt paving in two phases, beginning in 2028. Asphalt resurfacing would include full depth repairs of sections of paving with structural failure, milling around curbs and driveways to maintain an adequate drainage profile, surface preparations and the installation of an approximately 1.5" thick new layer of asphalt paving over all of the paved sections.

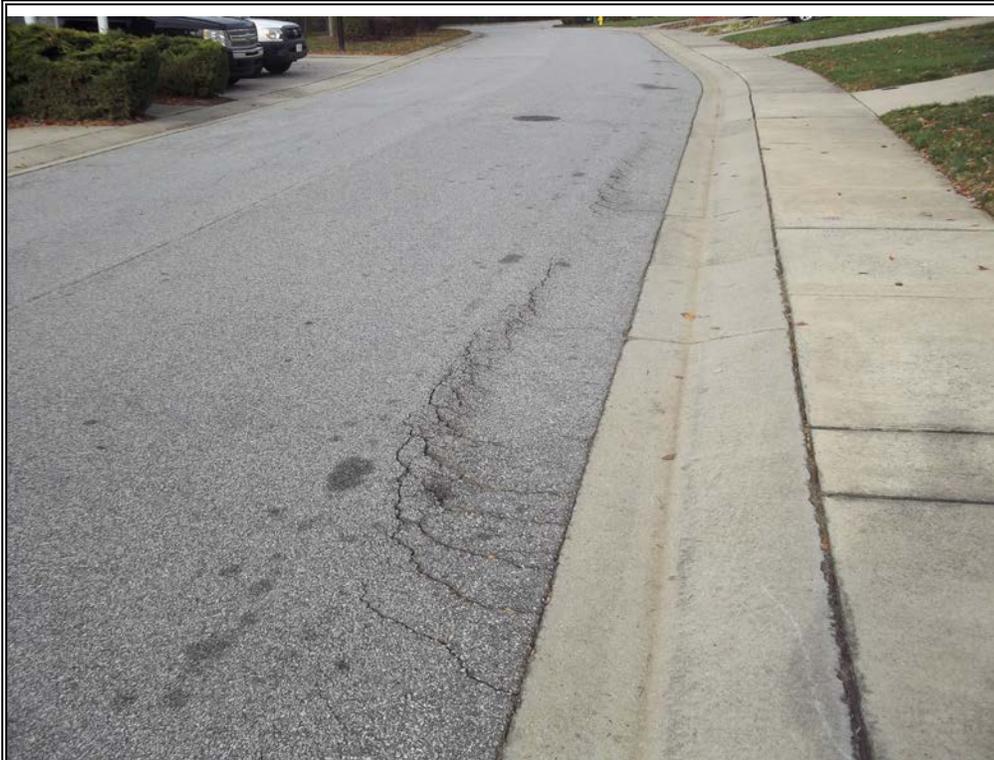
**Photo Number**  
**4**

The areas of fatigue cracking and depressions are typically symptoms of base course/sub-grade failure in the paving. This type of failure would require full depth repairs which would include saw-cutting and removing damaged areas of paving, repairing the sub-grade/base course as needed and installing a new 2" to 4" thick asphalt patch. We have allocated funds for full depth repairs of sections of the asphalt paving on a 5-year cycle in conjunction with seal coating and re-stripping noted above.

**Description:**  
Area of fatigue  
cracking,  
rutting/raveling in  
asphalt pavement

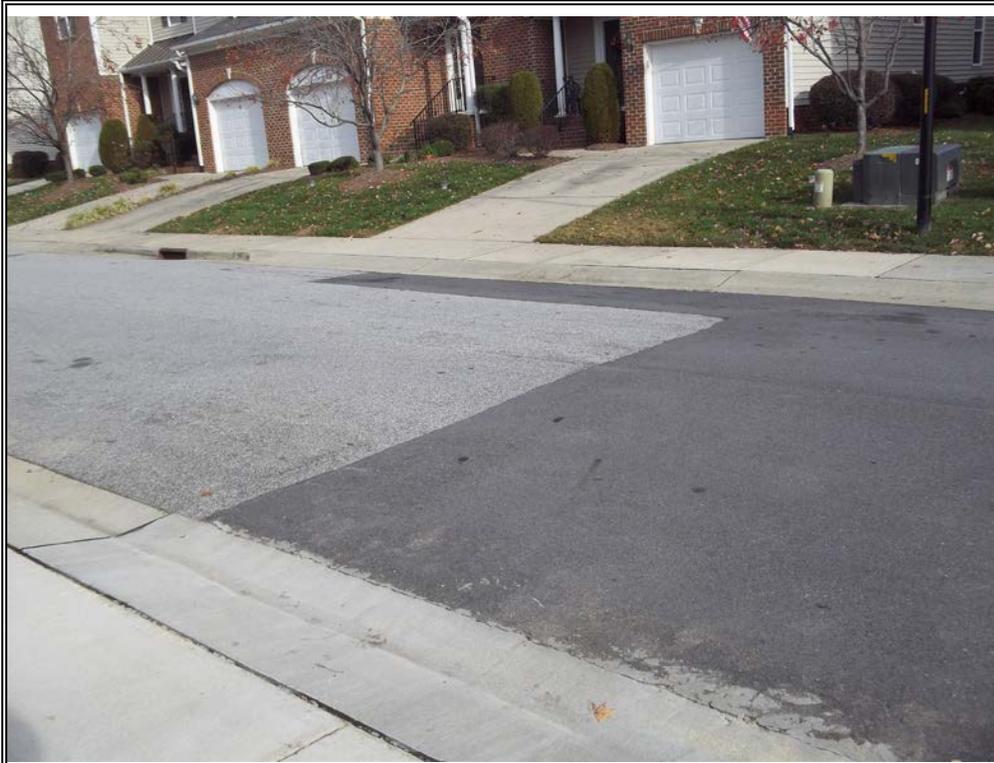
**5**

Portion of asphalt pavement has been resurfaced in the recent term

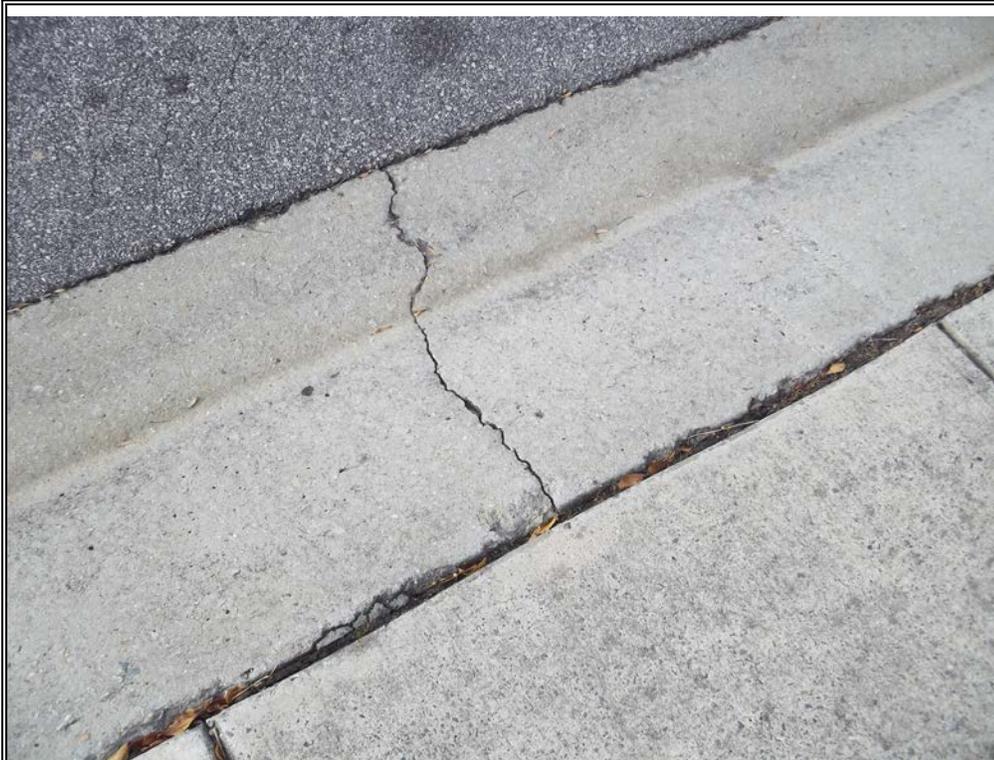
**6**

Concrete curb and gutter line the asphalt paved areas throughout the community. We observed sections of concrete curbing with minor cracking developing. It is likely that due to differential settlement, sections of the curbing will require periodic repairs. Repairs typically include saw-cutting and removing damaged areas, repairing base course and pouring and finishing new concrete curbing. We have allocated funds

Some areas of cracking have developed in concrete curbing.

for periodic repairs of concrete curbing and assumed that approximately 5% of the curbing will require repair every 8 years beginning in 2023.

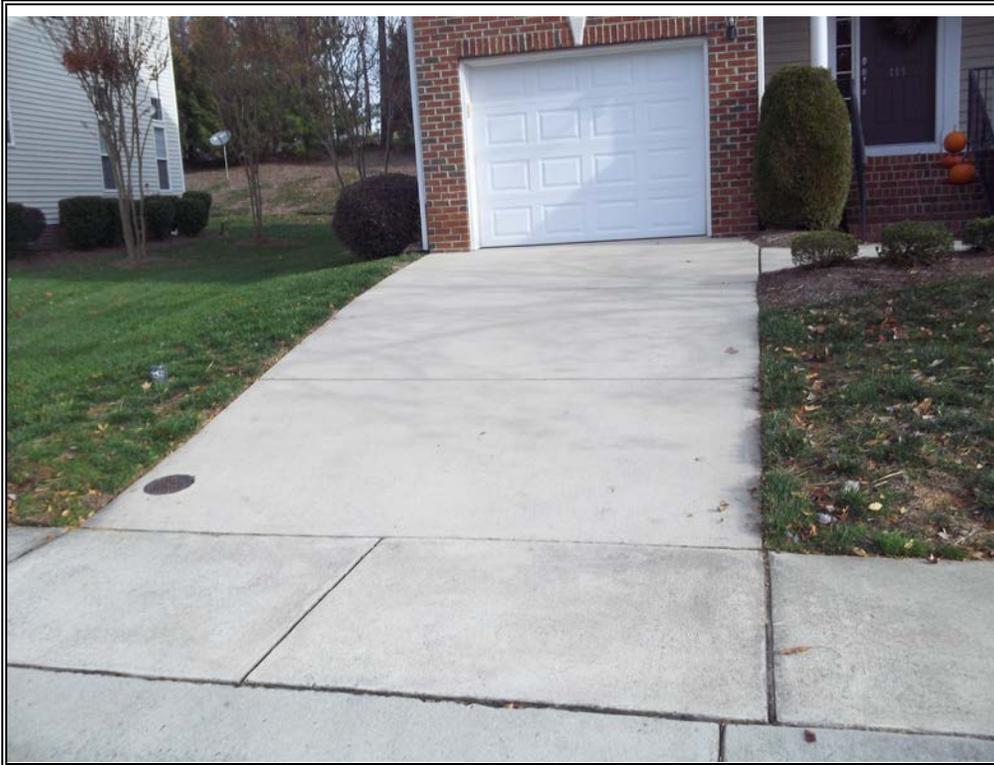
**7**

The association is responsible for maintaining the concrete sidewalks along the streets and common areas, the concrete drive slabs and the rear concrete patios. The concrete sidewalks and drive slabs generally appeared to be in good condition, with minor cracking developing in some areas. We also noted limited areas of spalling in concrete sidewalk sections. We have allocated funds for periodic repairs and/or replacement of the concrete sidewalks and stone/brick pavers as required and have assumed that approximately 5% of the surfaces will require maintenance every 8 years beginning in 2023.

Flatwork maintained by the HOA includes concrete drive slabs.

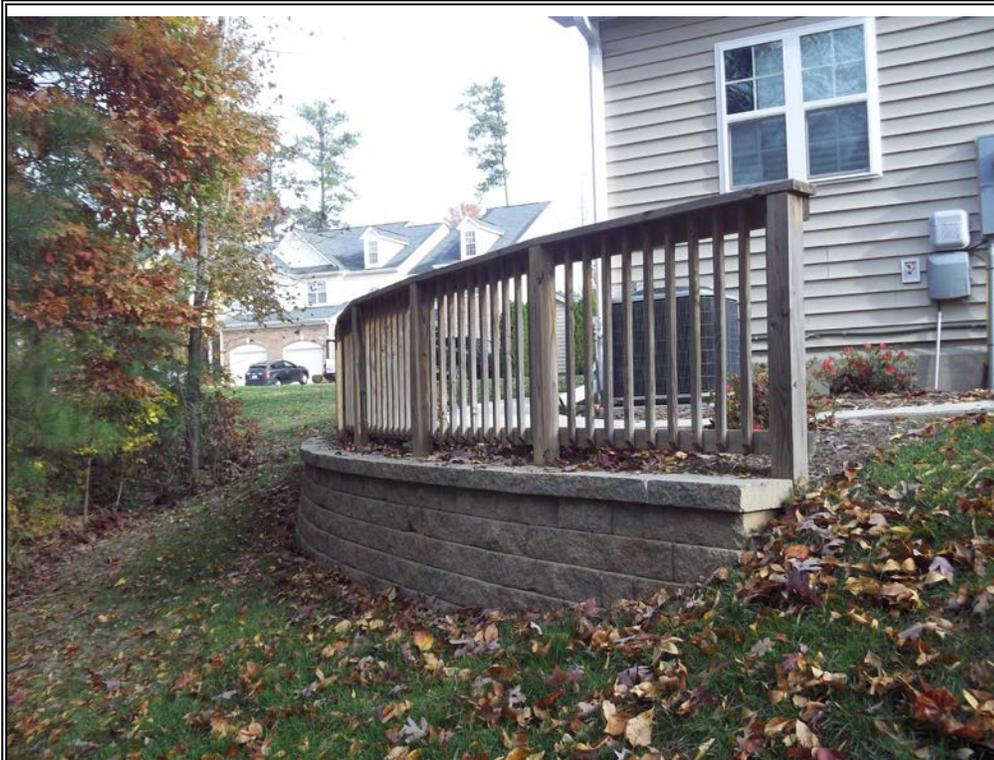
A limited area of wood rail fencing and segmental block retaining wall exists behind at the rear corner of Unit 102. These features appear to have been installed during site construction and are likely not the individual responsibility of the unit owner. The fencing and retaining wall appeared to be in good condition (building was constructed circa 2015). We assume

Limited area of site retaining wall with wood rail fencing.

repairs to the limited wood rail fencing would be funded from the annual maintenance budget. We have allocated funds for retaining wall repairs on a 20-year cycle beginning in 2037.

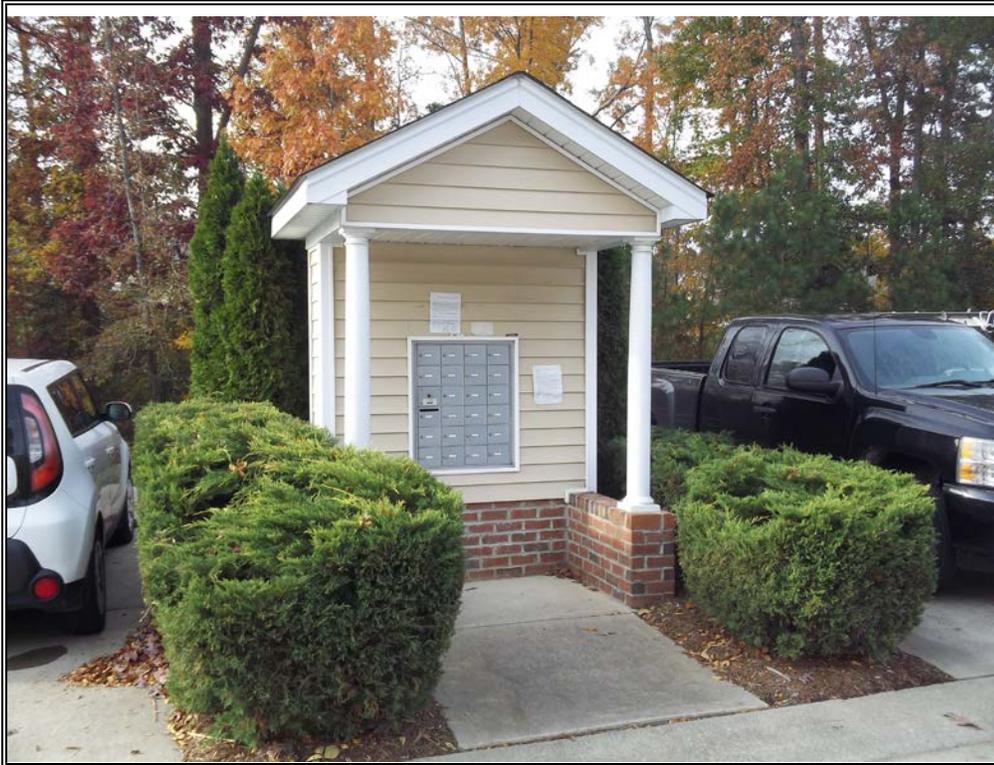
**Photo Number**  
**9**

Mailbox inserts are installed in small mail structures in the community. The mail box inserts generally appeared to be in good condition and have an expected useful life of approximately 20 years. We have allocated funds to replace the mailboxes in 2028.

**Description:**  
Typical mailbox  
kiosk, centrally  
located within  
community

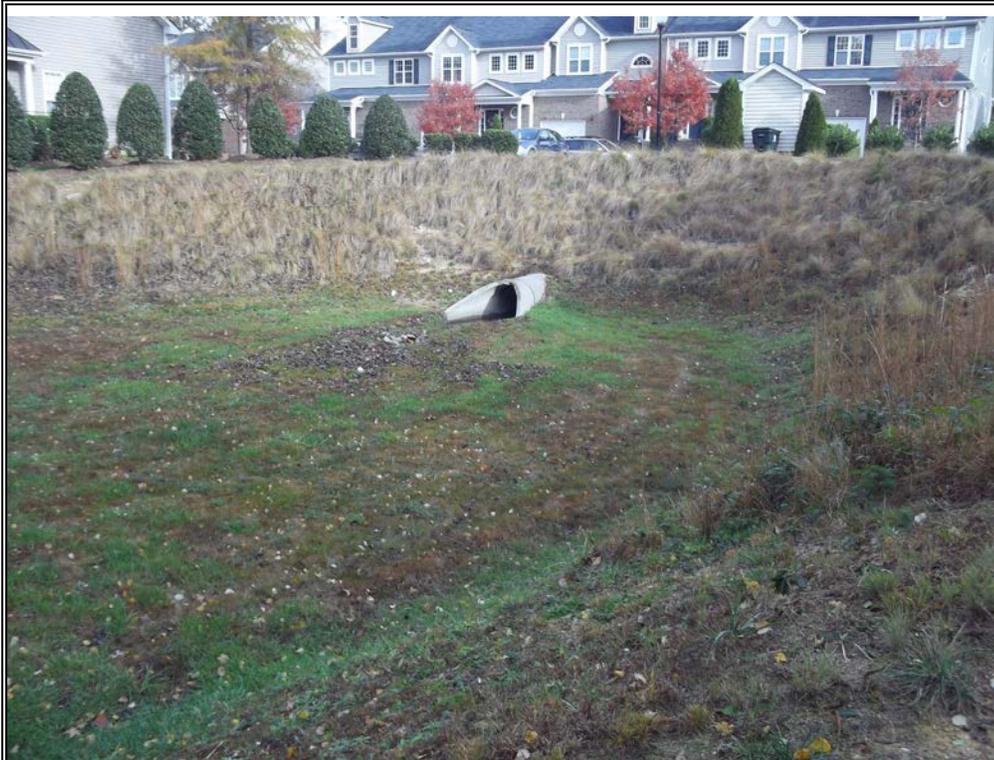
**Photo Number**  
**10**

**Description:**  
View overlooking  
BMP dry pond

We recommend the association contract with a pond maintenance professional to perform routine inspections and maintenance of the ponds in the community. This would include nuisance pest removal, maintaining vegetation and general inspections and repairs as needed. The association should maintain the ponds in accordance with any applicable requirements for such devices. In addition to routine maintenance and periodic drainage improvements noted above, it is likely that the pond will require significant repairs and possibly dredging of accumulated sediment/debris over the long term. We have allocated funds for repairs/dredging of the pond on a 20-year cycle beginning in 2037.

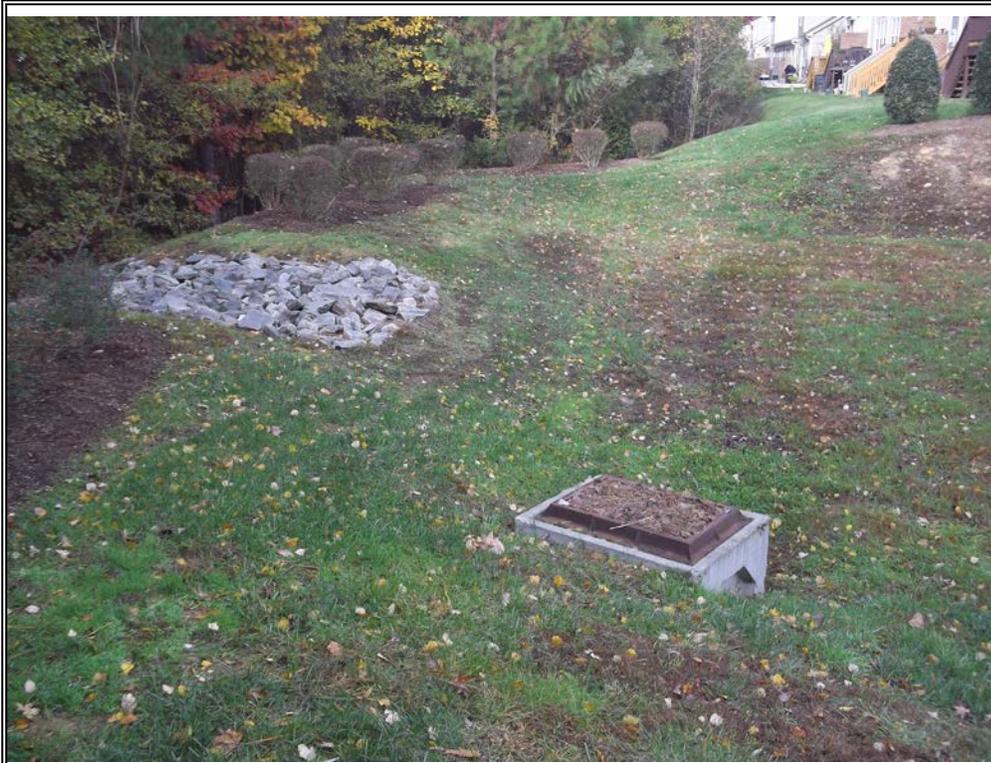
**11**

The dry pond includes one reinforced concrete pipe inlet, a concrete riser structure leading to a reinforced concrete pipe outlet discharging through the earthen dam, and a riprap-armored emergency spillway. We noted moderate vegetation growth in the pond, including planted shrubbery on the earthen dam. Earthen dams should be maintained free of woody vegetation.

Dry pond includes concrete riser structure, and earthen dam with riprap-armored emergency spillway. Some shrubbery is planted on earthen dam.

We have allocated funds for common area drainage improvements on an 8-year cycle beginning in 2023. Repairs would include those concerns noted above in the near term. Long term repairs would likely include re-trenching and re-armoring landscaped swales, repairing/hydro-jetting buried storm water piping and other drainage system improvements. As the infrastructure ages, the association may consider video borescope inspections and mapping of the buried storm water piping to proactively maintain and repair the piping as needed. Repairs to piping may include hydro-jetting to remove debris, vacuuming out debris from inlet basins and excavating and replacing sections of the piping.

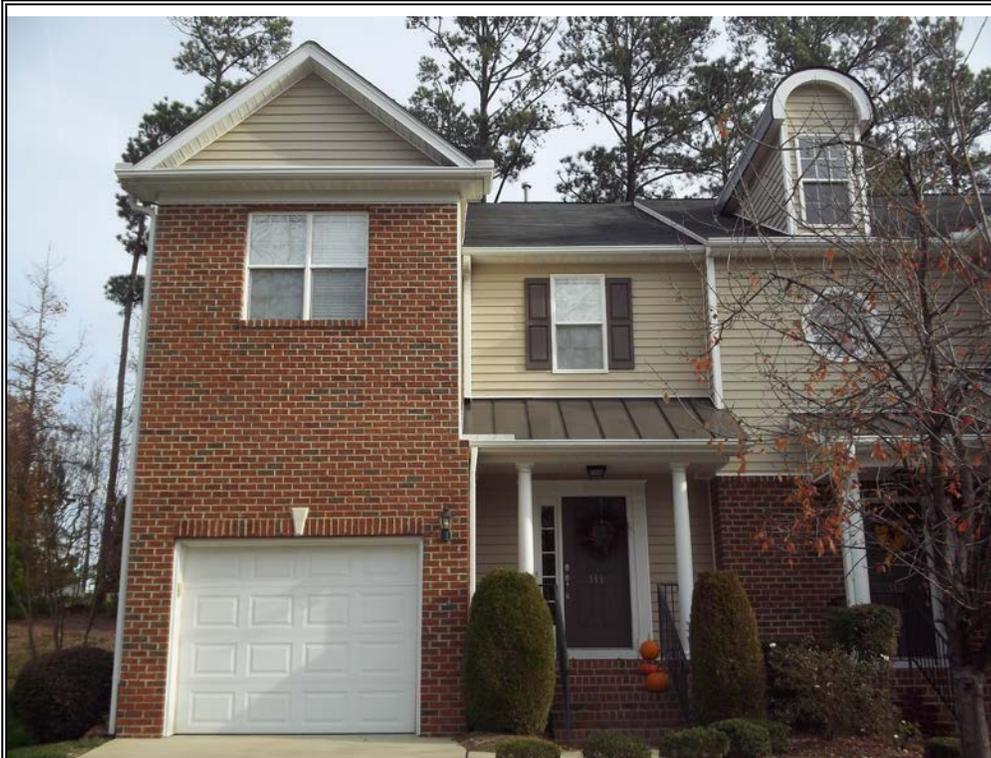
The buildings in the community are of wood framed construction and are primarily clad in vinyl siding with vinyl and aluminum trim components. Limited sections of the buildings are clad in brick veneer. We do not anticipate significant brick veneer repairs over the term other than minor repointing of mortar (if required) and have not allocated any reserve funds for major brick veneer repair/replacement. The exterior vinyl siding appeared to be in good condition and has an expected useful life well beyond the term of this study. Painted components on the exterior of the building include columns, doors, railings and limited trim components. We have allocated funds to paint the trim components and make minor repairs on a 8-year cycle beginning in 2023. Exterior painting projects should include repair/replacement of damaged trim components, replacing deteriorated caulking, surface preparation and cleaning and the application of two coats of a high-quality exterior paint.

Typical view of townhome facades, which include areas of brick veneer and vinyl lap siding. Note limited areas of standing seam metal roofing over front entrances.

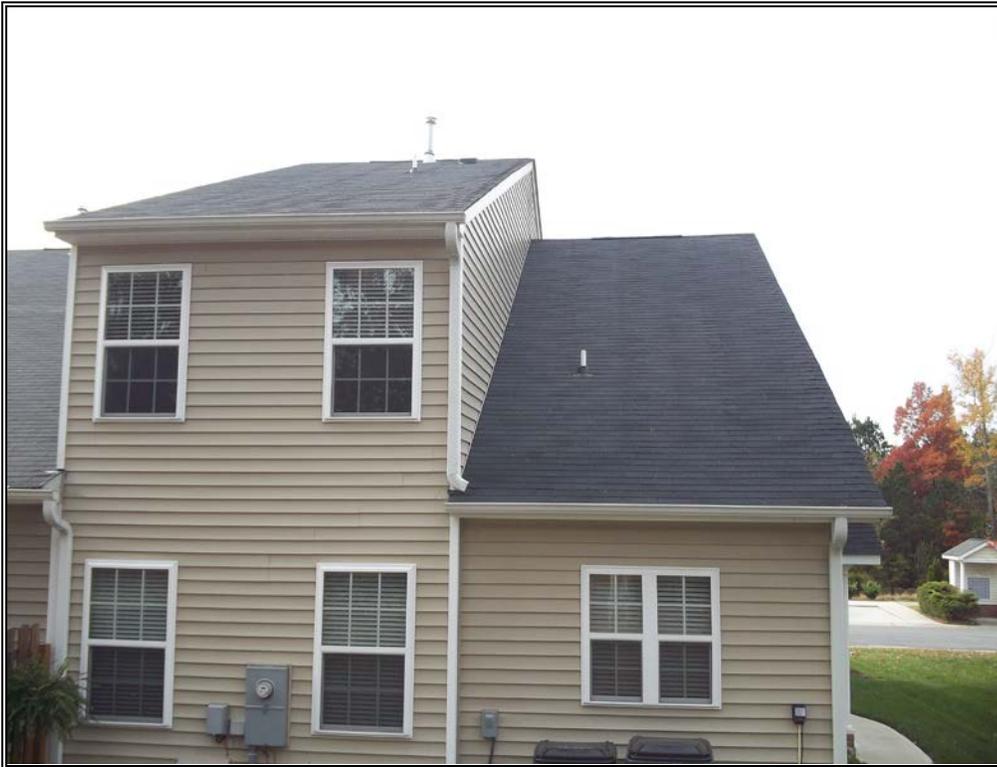
The predominant pitched roof surfaces over the buildings are covered in asphaltic fiberglass three-tab roof shingles. Roof surfacing is applied over roof sheathing, and appears to be in relatively good condition. Typically, this type of roofing surface will last approximately twenty years. We strongly recommend that any re-roofing project closely follow procedures outlined by the National Roofing Contractors Association's *Roofing and Waterproofing Manual*. A re-roofing sequence should include removal of the existing roofing material, replacement of any inadequate roof

Roofing surfaces  
are covered in  
asphaltic fiberglass  
three-tab shingles

We have allocated funds to replace the building roofs on a 20-year cycle. We have included funds for roof replacement in two phases based on dates of original construction: in 2028 (for buildings constructed between 2006-2008), and in 2037 (for buildings constructed between 2014-2015). Gutters and downspouts appeared to be in relatively good condition and sectional replacement of these components will likely be required at the time of roof replacement.
