**CELEBRATION SQUARE
HOMEOWNERS ASSOCIATION
RALEIGH, NC**

APRIL 3, 2023

**FULL RESERVE STUDY
with Site Inspection**

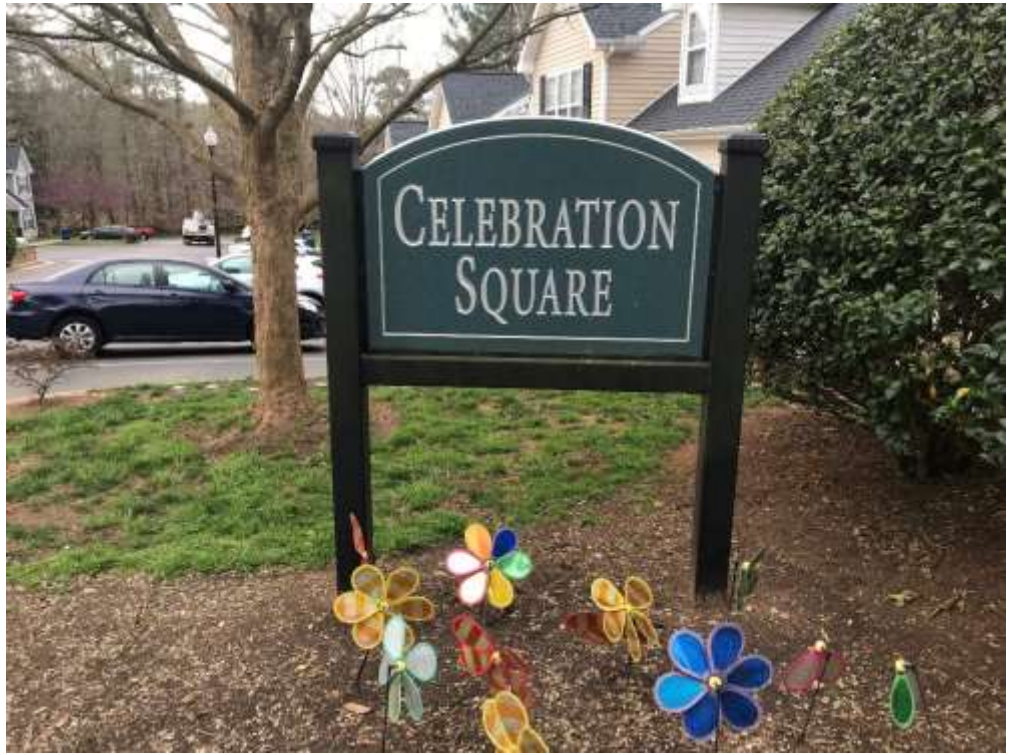
Photo No.
1

View of entrance
signage

An entrance sign is located at the north end of the community that includes painted, engraved community lettering on metal posts. The sign appeared to be in generally good condition. We have provided an allocation of funds to replace the entrance sign on an approximately 15-year cycle beginning in 2034.

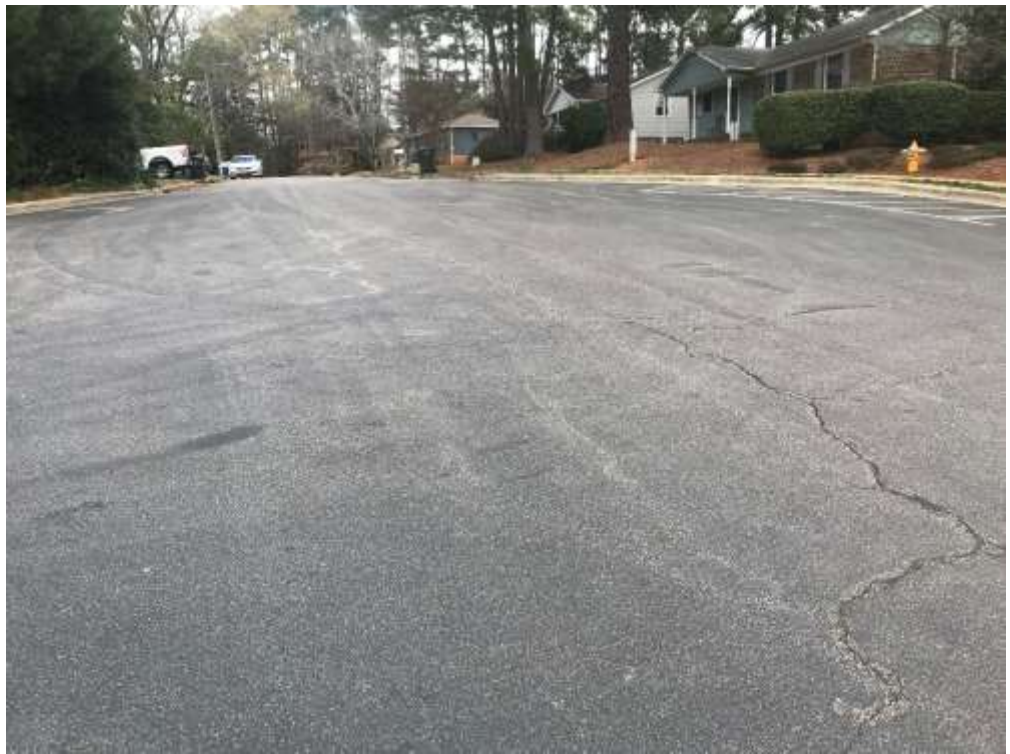
Photo No.
2

We understand that the maintenance of the private asphalt paved streets and parking areas is the responsibility of the association. The pavement appeared to be in generally good to fair condition given the age of the community, with only minor longitudinal and fatigue cracking in isolated areas. Typically, we recommend the application of an oil resistant sealant to asphalt paved surfaces on an approximately 7-year cycle. At this same time, all cracks should be properly filled, patched, and sealed, and all of the markings should be repainted. Per the Board President, Rothshire Court is scheduled to be crack filled and sealed in 2023. Therefore, we have adjusted the allocation in Appendix B in the 'Annual Expense Projection' sheets to only account for crack filling and seal coating Bonnie Ridge Court in 2024. After 2024, we have allocated funds to reseal all of the pavement at the same time on a 7-year cycle in 2031. We assume isolated areas of potholes and fatigue will be repaired using funds from an annual maintenance budget, as needed.

Typical asphalt
pavement with areas of
longitudinal cracking

Assuming sealing and crack repairs occur in the interim, asphalt paving should last approximately 20-30 years prior to resurfacing. We have allocated funds to resurface the current asphalt paving in 2038. The pavement could likely be resurfaced sooner, though we have delayed the project due to funding constraints. Resurfacing will include a 1"-1.5" overlay over the paved surfaces, with limited milling in select areas to maintain an adequate drainage profile and a consistent surface. Sectional full depth repairs or reclamation may be required in areas depending on the level of fatigue at the time of resurfacing, which may increase costs.

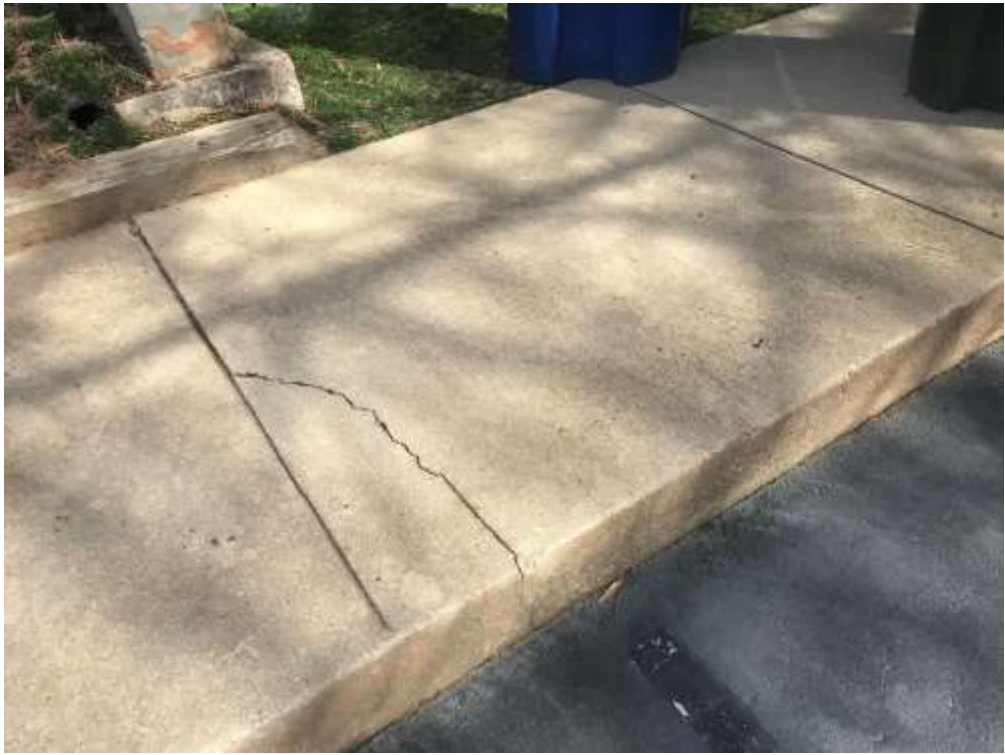
Photo No.
3

The association is responsible for maintaining the concrete walkways along the streets and in front of the buildings. Per the provided maintenance responsibility chart, the individual homeowners are responsible for the rear patios. The concrete walkways were in generally good condition. A heaved section of sidewalk was observed at the front-left of Unit 801 Rothshire Court, likely from root growth from a nearby mature tree. We have allocated funds for periodic repairs and/or replacement of the concrete sidewalks as required and have assumed that 2.5% of the surfaces will require maintenance every 8 years beginning in 2031. Repairs may include grinding to reduce unevenness at cracking or saw-cutting, removing, and replacing sections of the concrete. We assume isolated areas of trip hazards, such as the heave mentioned above, will be repaired/replaced, as needed, using funds from an annual operating budget.

Typical concrete cracking

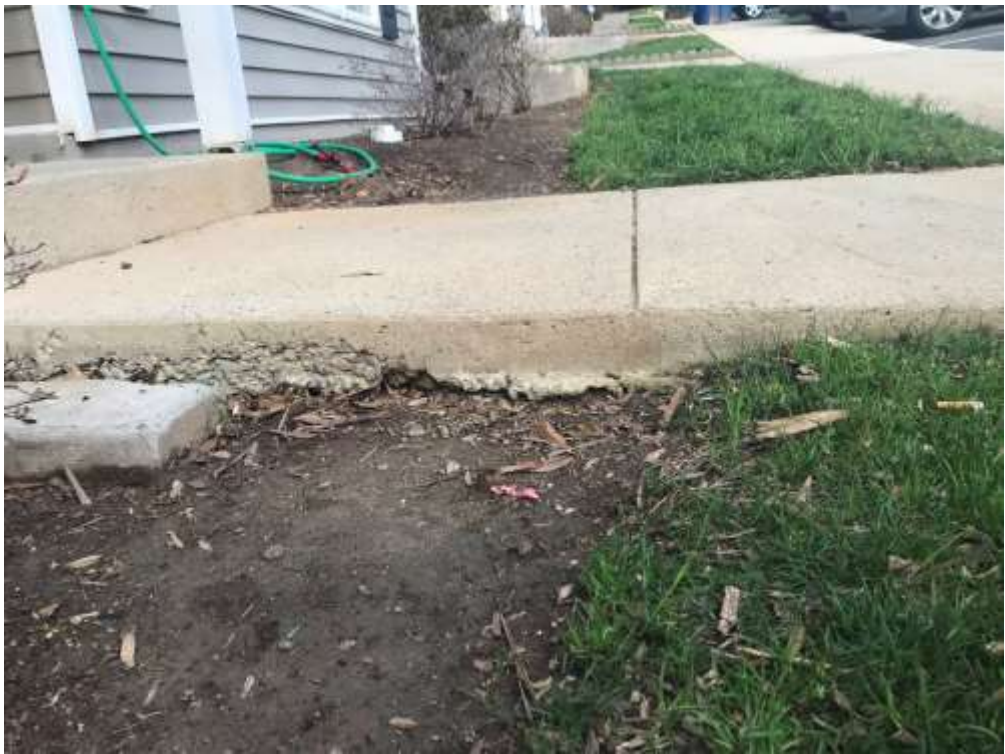
Photo No.
4

Undermined entry sidewalk at Unit 7323

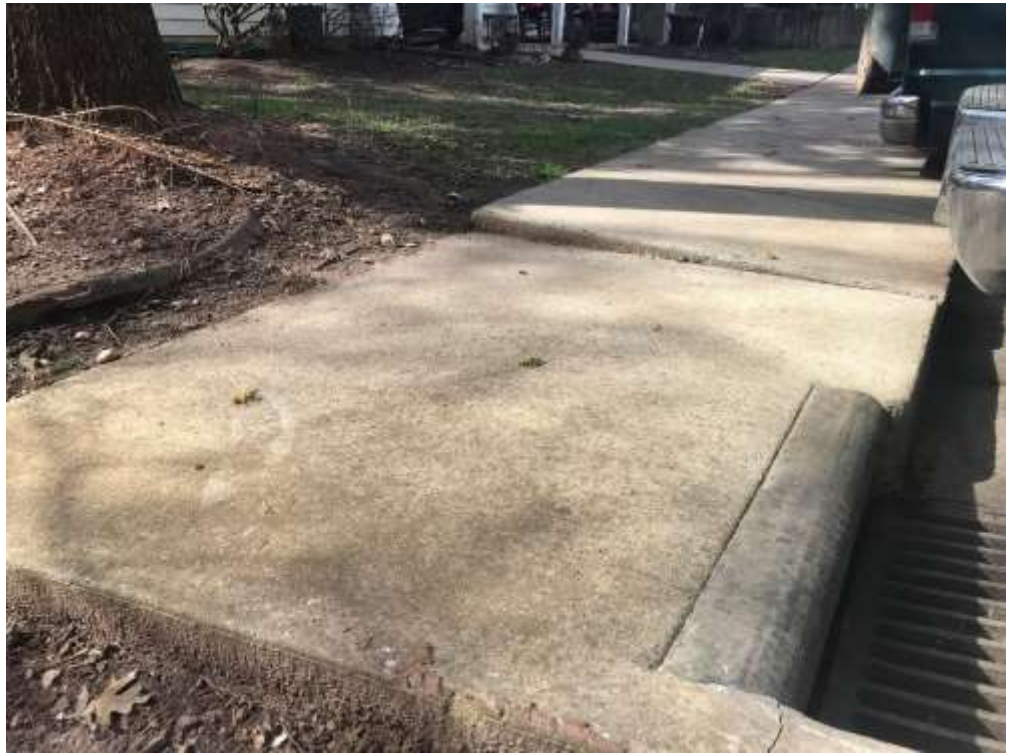
Photo No.
5

Heaved section of sidewalk in front of Unit 801

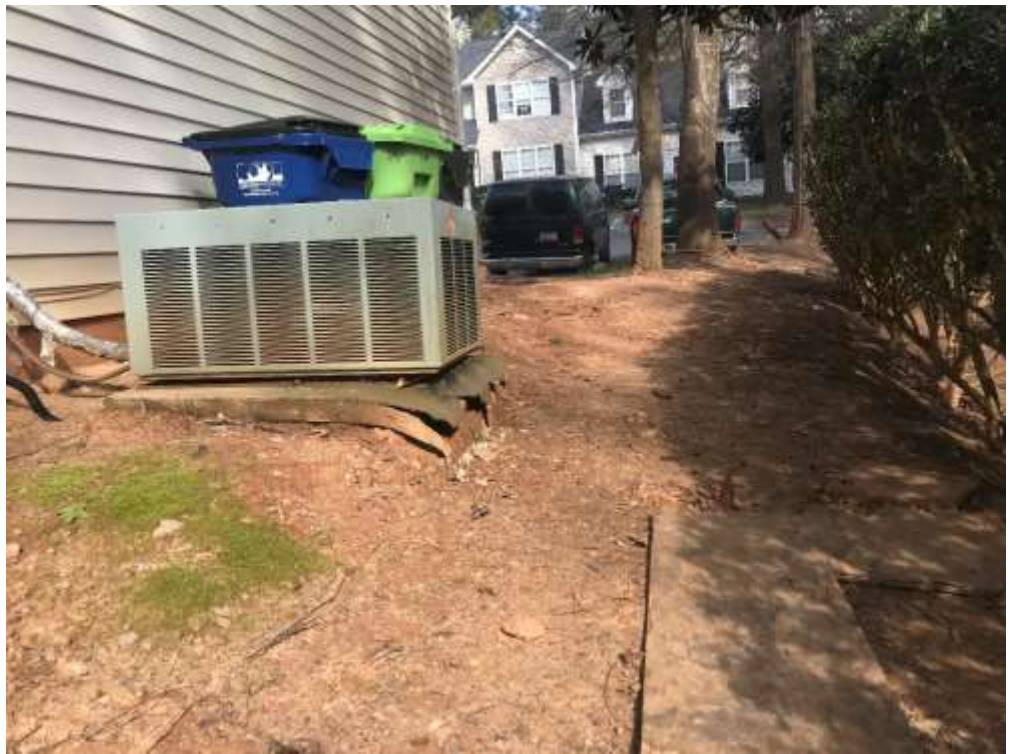
Photo No.
6

Other areas of concern throughout the community include erosion along the embankment at the eastern end of Rothshire Court and along the rears of the buildings west of Bonnie Ridge Court. Erosion was also observed at the rears of Units 804 and 806 Rothshire Court. Significant erosion was observed at the left and rear-left of Unit 801 Rothshire Court, which has led to undermining of the rear-left corner foundation. The front walkway of Unit 7323 Bonnie Ridge Court and the rear patio of 7329 Bonnie Ridge Court were also observed to be undermined. Fill appears to have been added at the rear of Units 7305 and 7307 Bonnie Ridge Court. Minimal grass vegetation was present, as most of the community is shaded from mature tree canopies, which will inhibit grass growth. Where vegetation cannot be maintained, alternative options include a mulch groundcover or stone. Mulch will wash away in areas of concentrated flows. Fill could be added in areas of erosion periodically to bring the slope up to a more level grade and mitigate further erosion that steepens embankments. A suitable flowable fill should be installed in any areas of undermined foundations.

Bare soils and erosion left of Unit 801

We recommend repairing areas of erosion, and installing soil stabilizing ground cover in areas of bare soil throughout the community. Note that the inlet basins may require periodic cleaning out as well. We also recommend having a portion of the private drainage infrastructure in the streets inspected with a video camera system, flushed, and repaired as necessary. We have allocated funds to repair the drainage systems on a 5-year cycle beginning in 2024. In addition to noted areas above, drainage repairs will likely include retrenching of swales to improve flow, adding rip rap or vegetation to stabilize exposed or steep areas, extending gutter downspouts to underground systems, repairing erosion concerns, installing french drains, or other types of drainage systems. Note, we have included a moderate budget to help cover these costs, and costs can vary significantly depending on the scope of work.

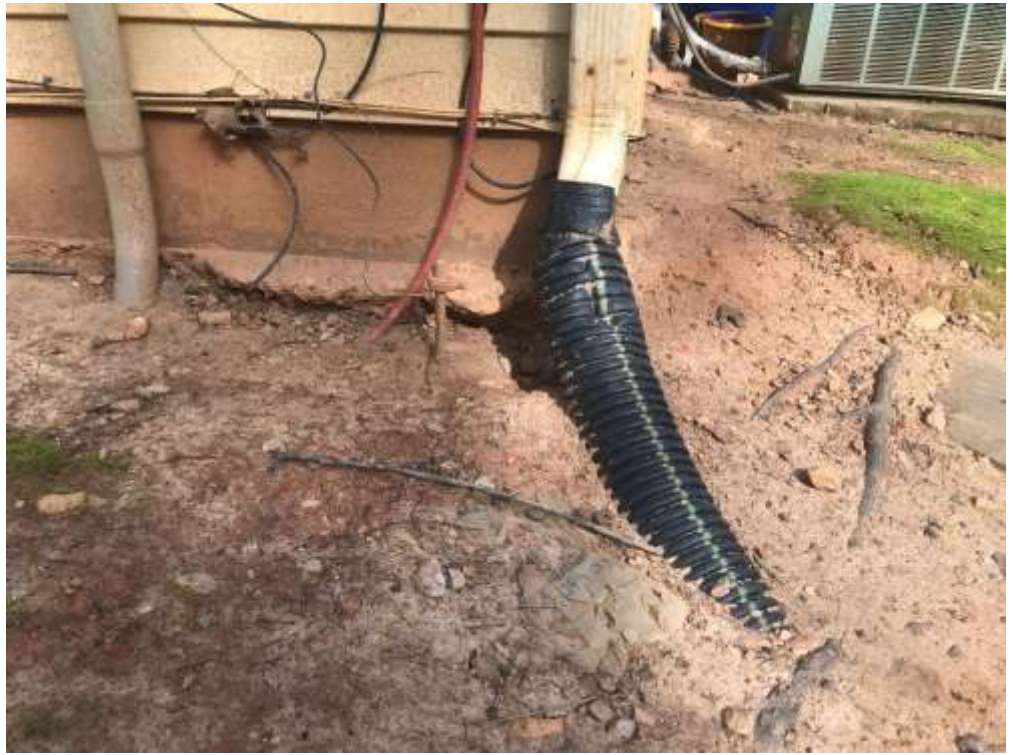
Photo No.
7

Undermined foundation
corner at rear-left of Unit
801

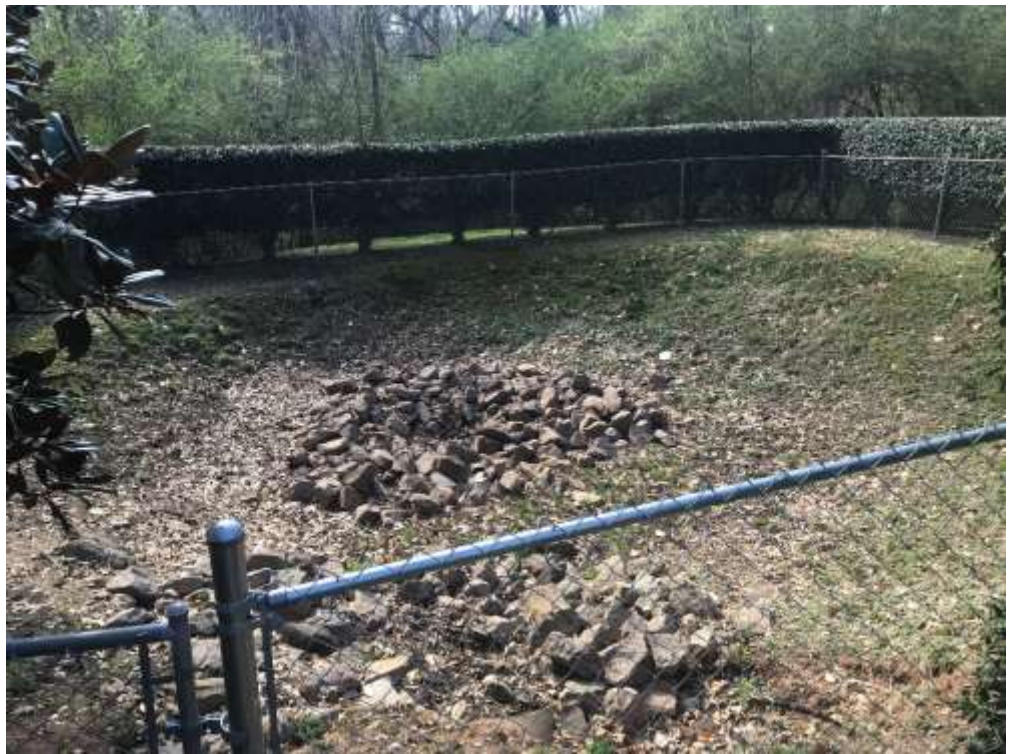
Photo No.
8

View of stormwater
retention pond

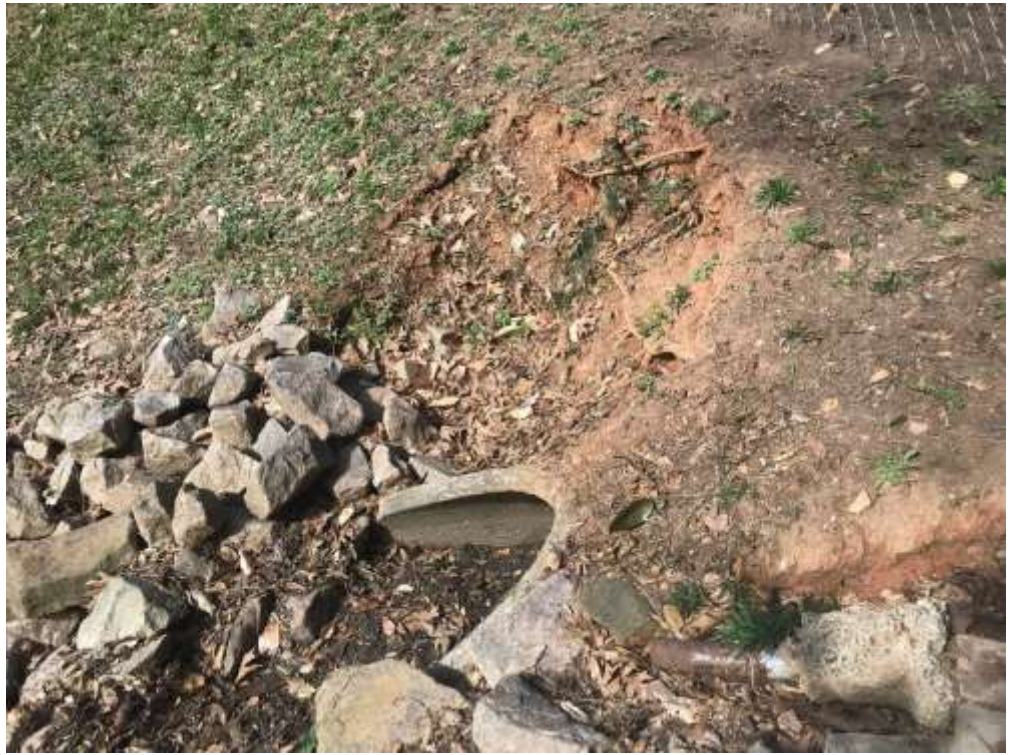
Photo No.
9

Erosion at stormwater retention pond inlet pipe

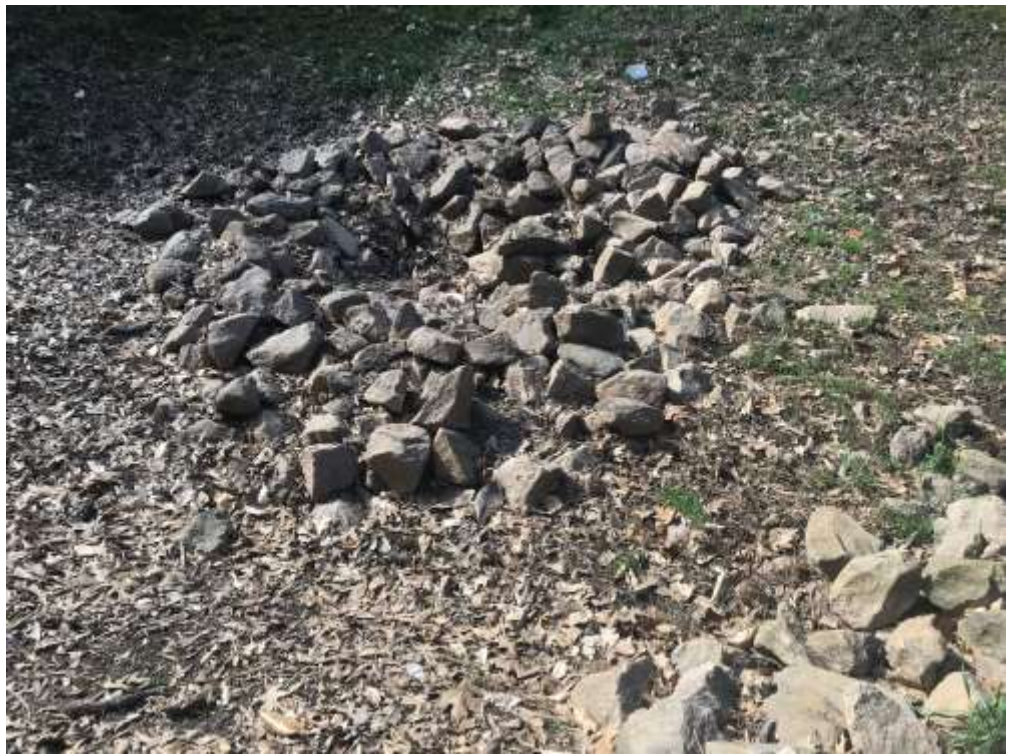
Photo No.
10

Drainage systems include gutter downspouts that discharge primarily to grade near the building foundations. Stormwater on the site drains via surface flow toward curb inlets in the paved areas. Inlets lead to buried stormwater piping that lead to a stormwater basin at the southern end of Bonnie Ridge Court. We assume there is an inlet grate at the low point in the storm retention basin, though it is likely covered with debris/sediment, as it was not visible on site. The basin appears to discharge to the south based on the Wake County GIS maps. Significant erosion was observed around the pond inlet, and the inlet pipe had significant sediment accumulation present. We recommend repairing the areas of erosion and removing sediment from the inlet/outlet pipes to ensure the proper flow of runoff through the system.

Outlet in retention pond likely covered in debris/sediment

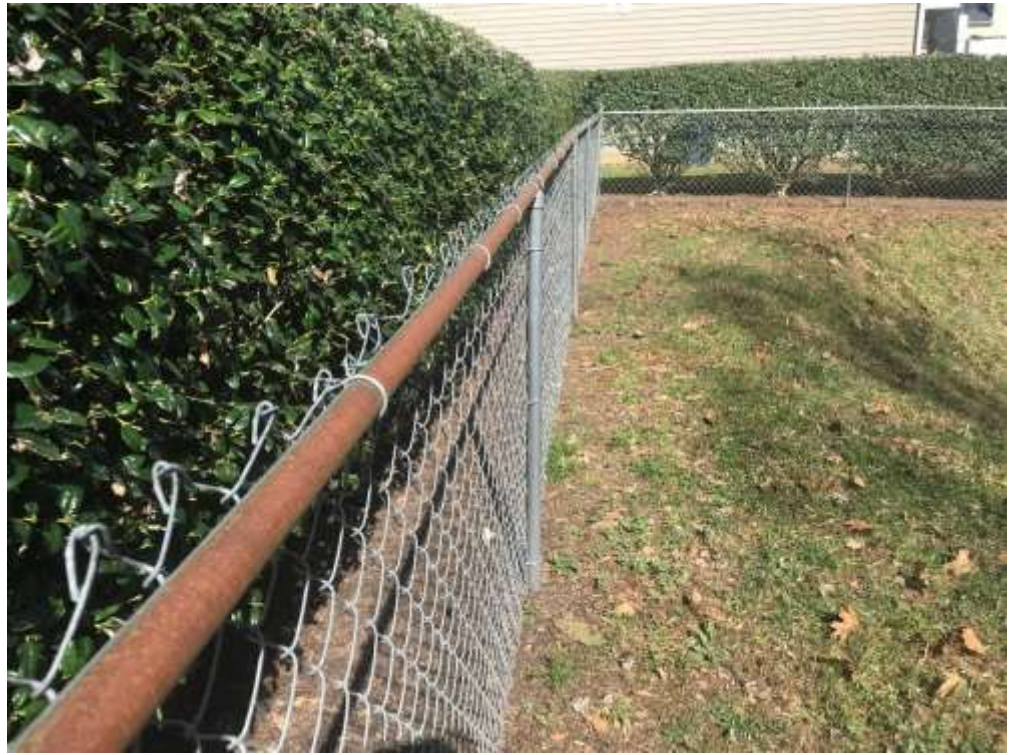
Photo No.
11

Chain link fencing is installed around the stormwater retention basin at the southern end of the community. The fencing was in generally good to fair condition with minor corrosion observed in select areas. We have provided an allocation of funds to replace the chain link fencing on an approximately 30-year cycle beginning in 2035.

Chain link fence with
minor corrosion around
stormwater pond

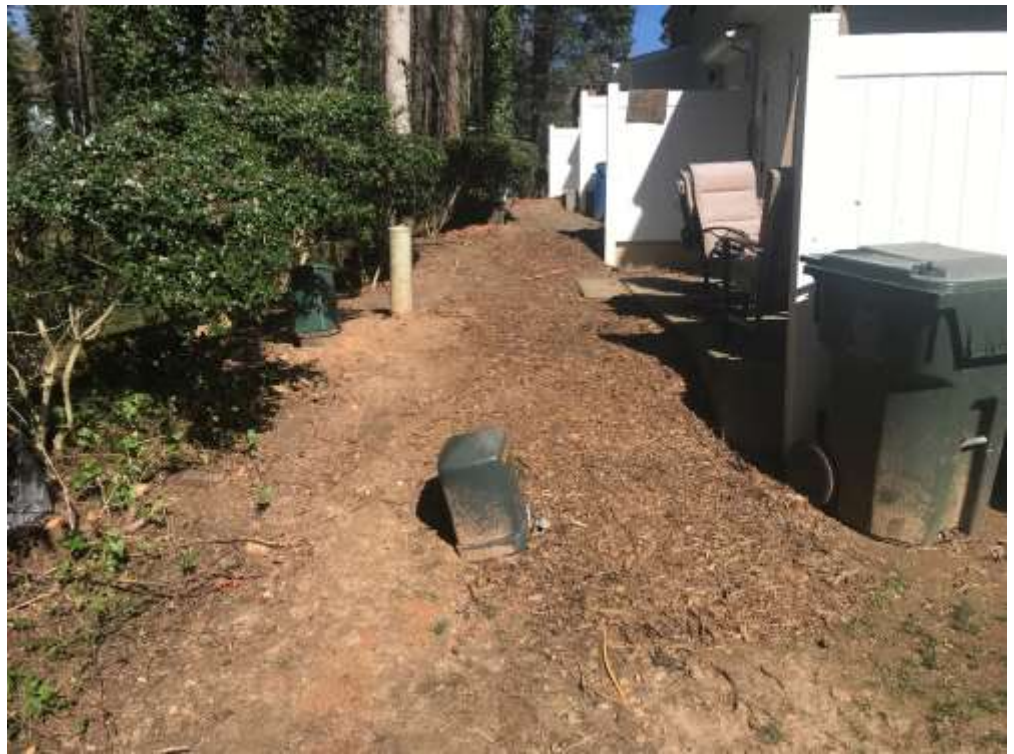
Photo No.
12

Fill previously added at
the rear of Building
7301-7313

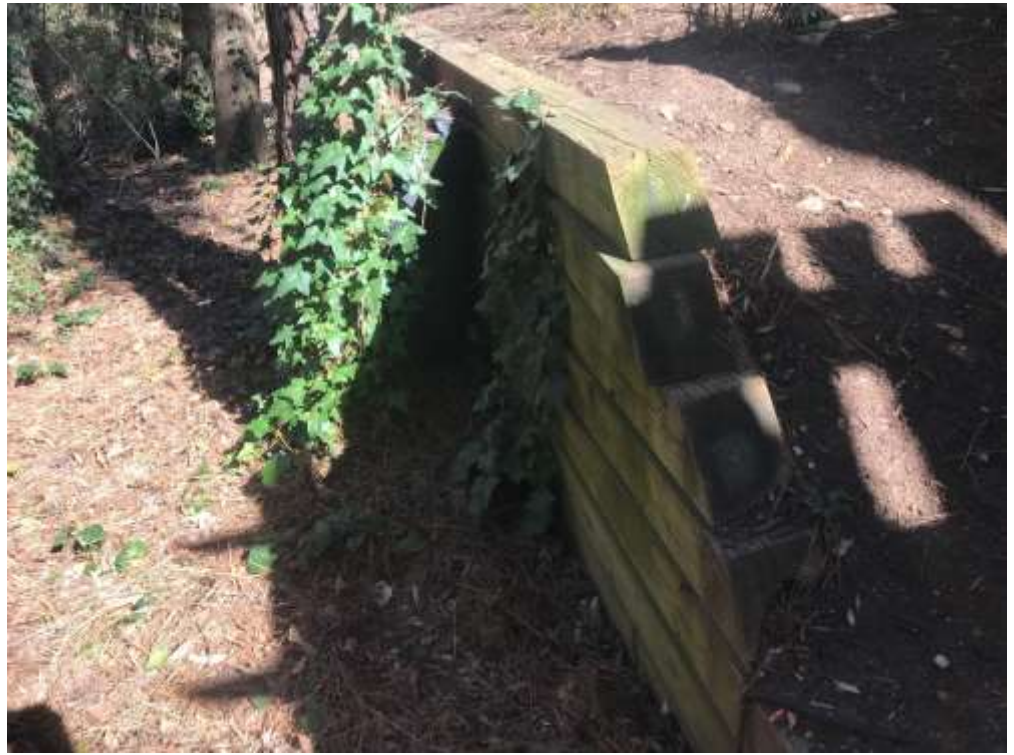
Photo No.
13

Wood timber retaining walls are located behind and adjacent to units to adjust for changes in topographical grade. The timber retaining walls were varying in condition, with sections of bowing, displacement, and rot observed. Many of the wood walls are likely original to construction. Wood timber retaining walls typically have an expected useful life of approximately 15-20 years. Sections of significantly deteriorated and/or leaning walls were observed to the rear of building 7301-7313, left of building 7312-7320, and rear of building 800-810. We have allocated funds to replace these sections of timber retaining wall in 2026. Note however, the walls should likely be replaced sooner, but we have delayed the project due to funding constraints. A section of timber retaining wall at the front-right of building 7321-7333 was in generally good condition, and we have allocated funds for replacement in 2037. The retaining walls should be monitored for additional movement and repaired, as needed, prior to the replacement dates allocated.

Deteriorated and leaning retaining wall rear of Building 7301-7313

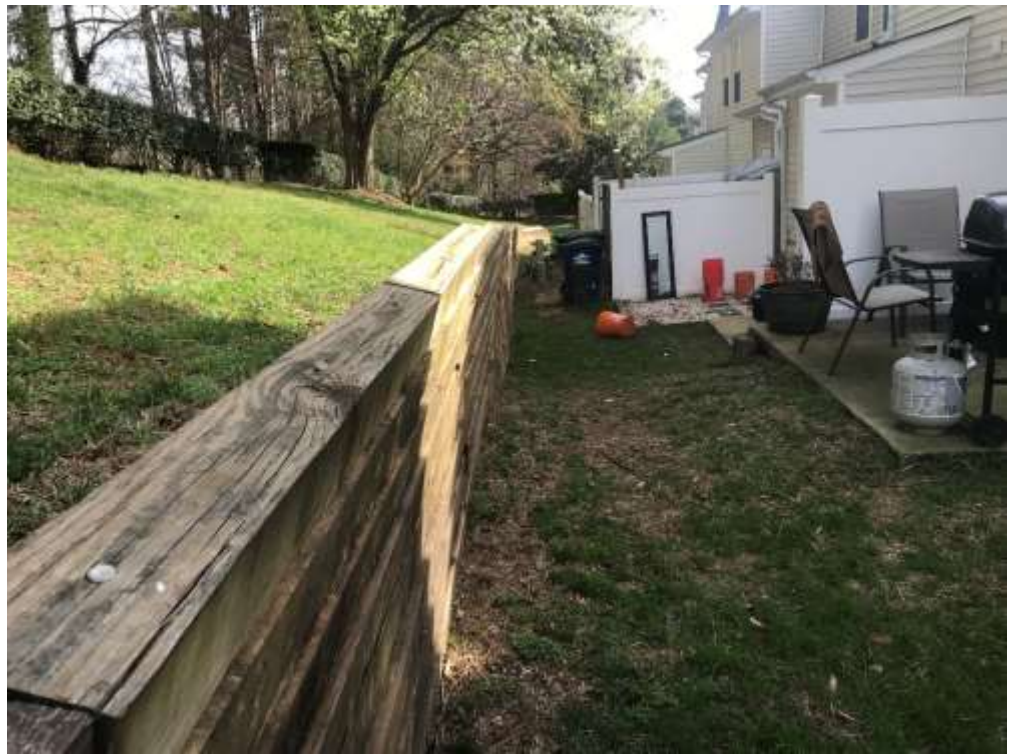
Photo No.
14

Deteriorated and leaning retaining wall rear of Building 800-810

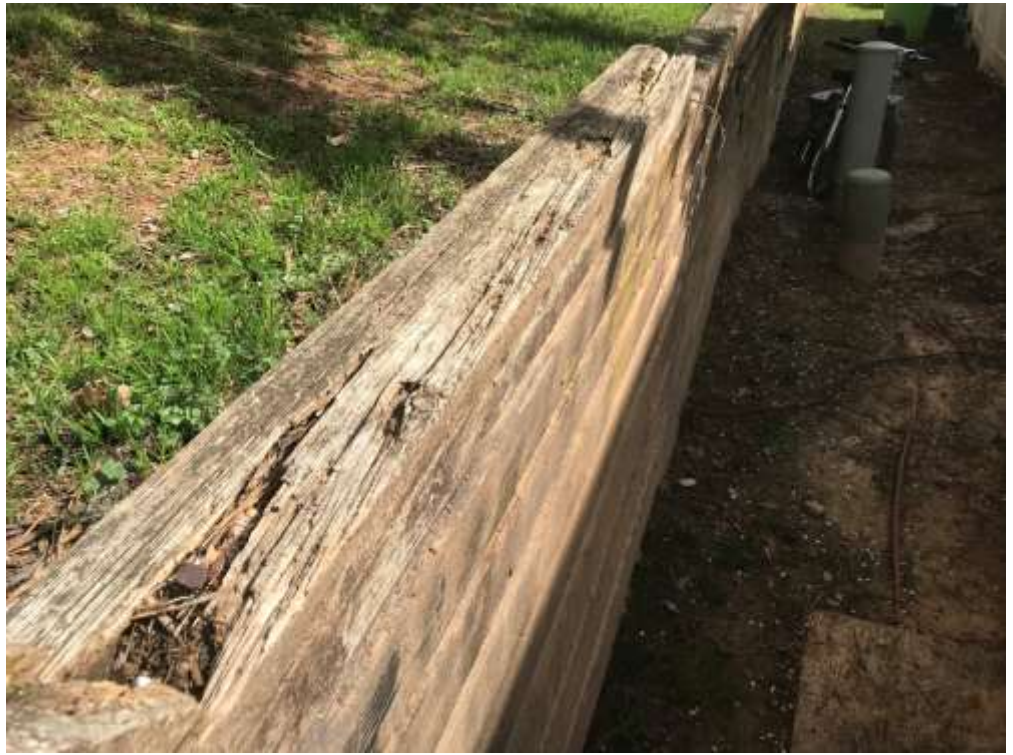
Photo No.
15

Typical rot/insect damage in retaining walls

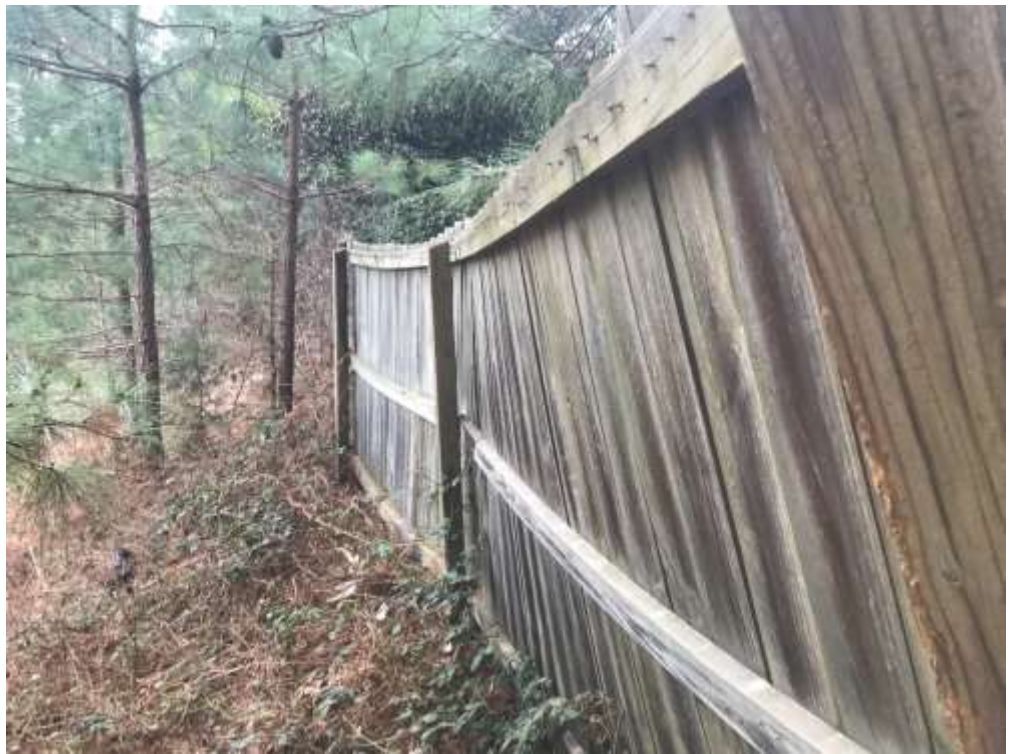
Photo No.
16

Wood privacy fencing is installed along the northern and northeastern perimeters of the community to separate neighboring properties. The fencing is approximately 6-feet in height and is in generally poor condition, with leaning and missing sections observed. We have allocated funds to replace the fencing on an 18-year cycle beginning in 2029. Note, the fencing should be replaced sooner, though we have delayed replacement due to funding constraints.

Deteriorated wood fencing an northern and eastern perimeters of the community

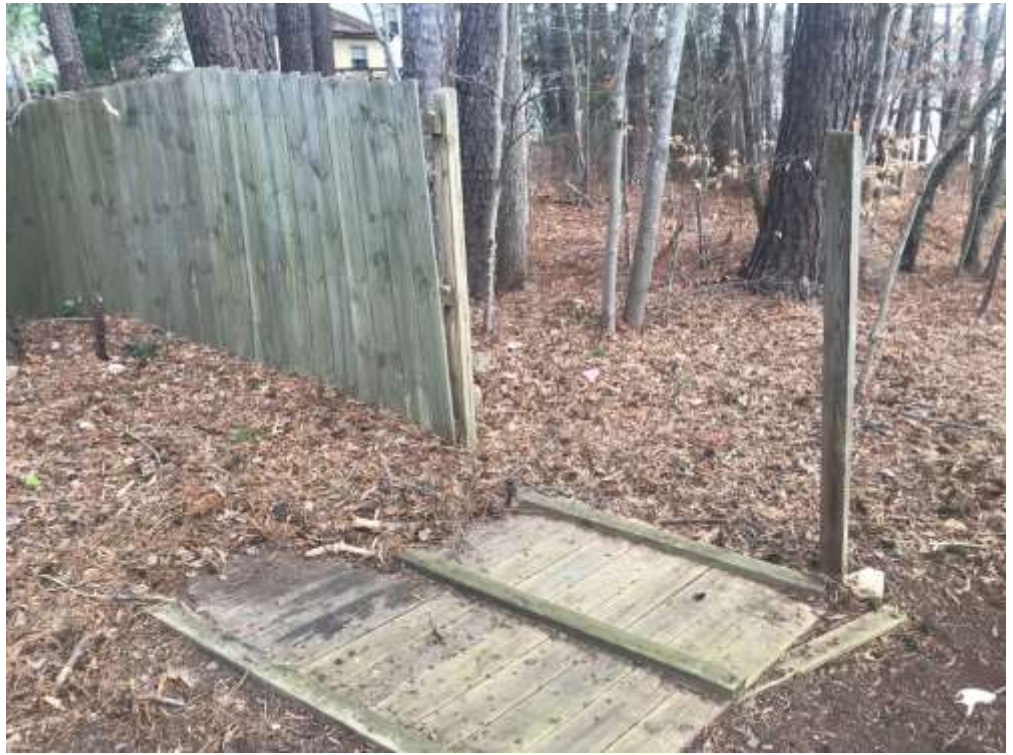
Photo No.
17

Deteriorated wood fencing an northern and eastern perimeters of the community

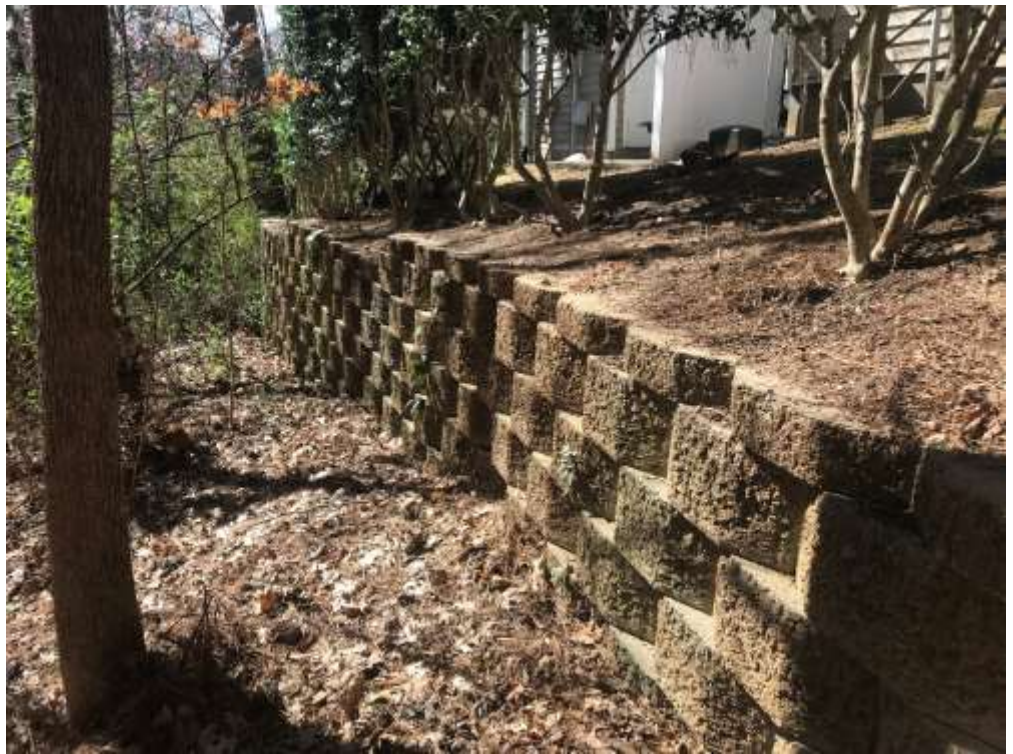
Photo No.
18

A section of segmental block retaining wall was located at the rear-right of unit 7312-7320 that appeared to be in generally good condition. These types of walls should provide a useful life beyond the term of this study, assuming proper drainage and geogrid reinforcement are in place, and the top of the wall is maintained clear of larger, woody vegetation.

Segmental block retaining wall at the rear-right of Building 7312-7320

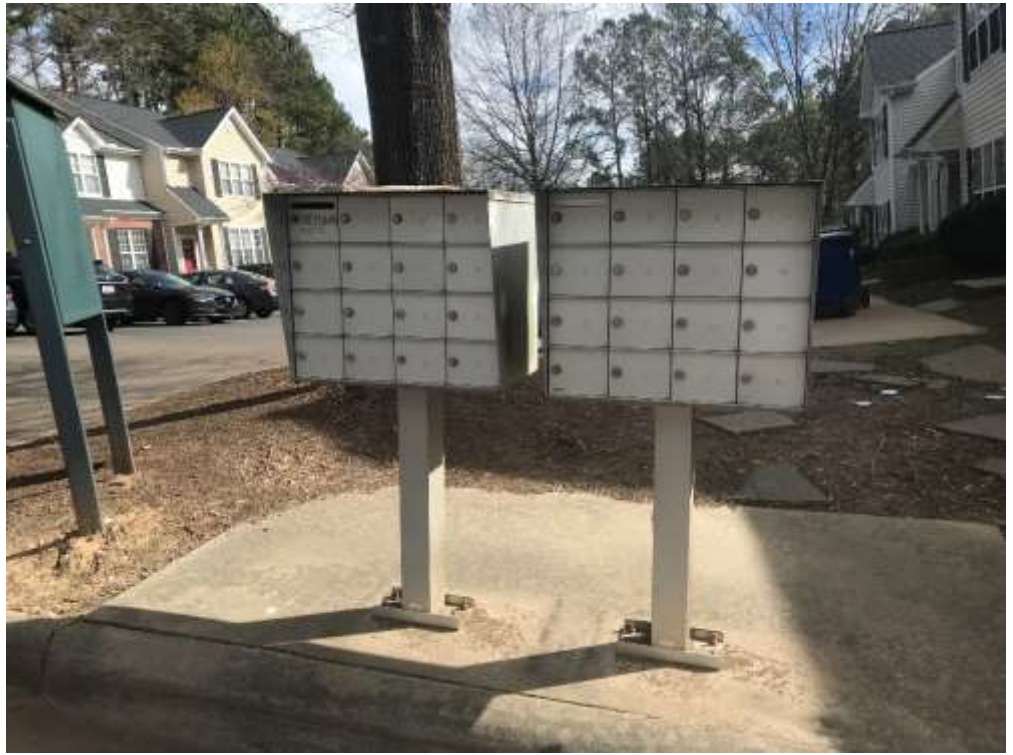
Photo No.
19

There are two exterior mailbox kiosks located within the community that are likely original to construction. Over time, the locking mechanisms and hinges will wear due to daily use and exposure to the exterior elements. These components should have an expected useful life of approximately 25 to 30 years. We have allocated funds for their replacement in 2033.

View of mail kiosks

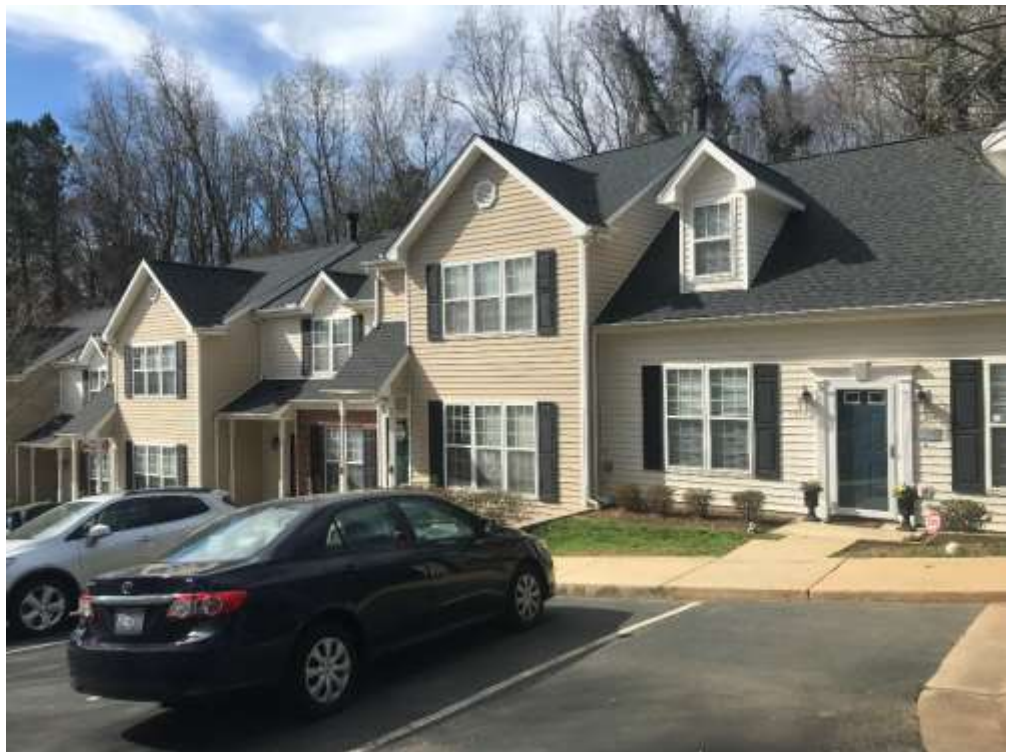
Photo No.
20

Typical building façade

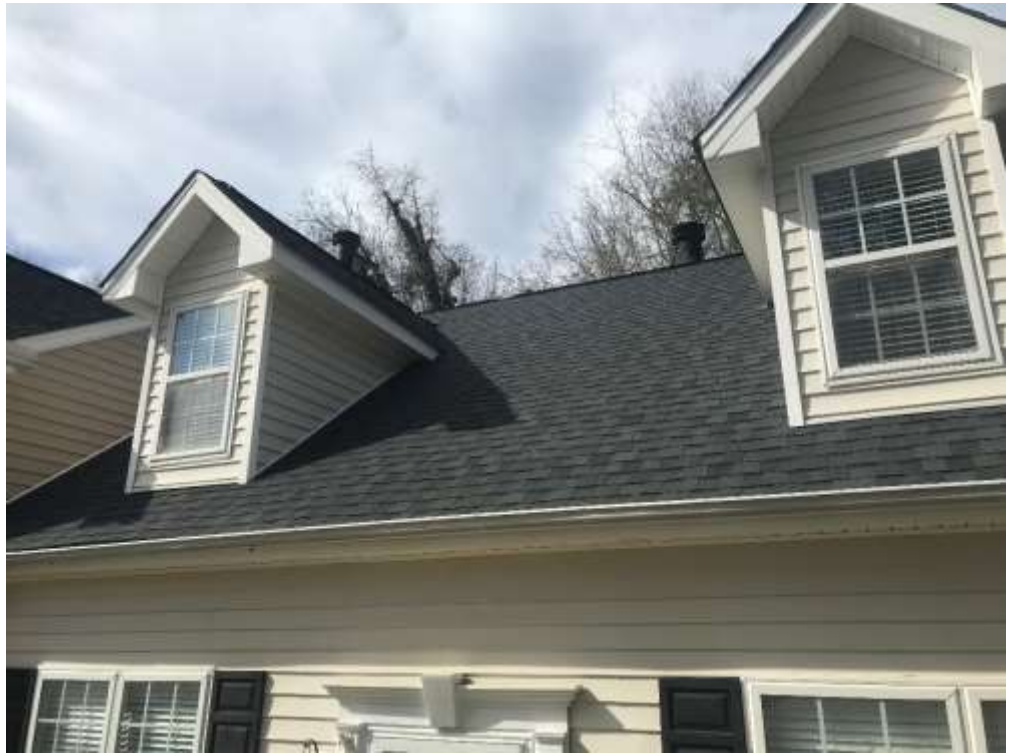
Photo No.
21

The predominant pitched roof surfaces over the townhome buildings are covered in architectural-grade, asphaltic-fiberglass shingles, which were reportedly replaced within the past two years. Typically, architectural-grade shingle roofing will last 20-25 years. We strongly recommend that any re-roofing project closely follow procedures outlined by the National Roofing Contractors Association's *Roofing and Waterproofing Manual*. A re-roofing sequence should include removal of the existing roofing material, replacement of any inadequate roof sheathing, damaged flashing, and drip edge components. We have

Building roofs recently replaced and in good condition

allocated funds for replacement of all the roofs in 2042 on an approximately 20-year cycle. We have also included funding for gutter and downspout replacement at the time of roof replacement.

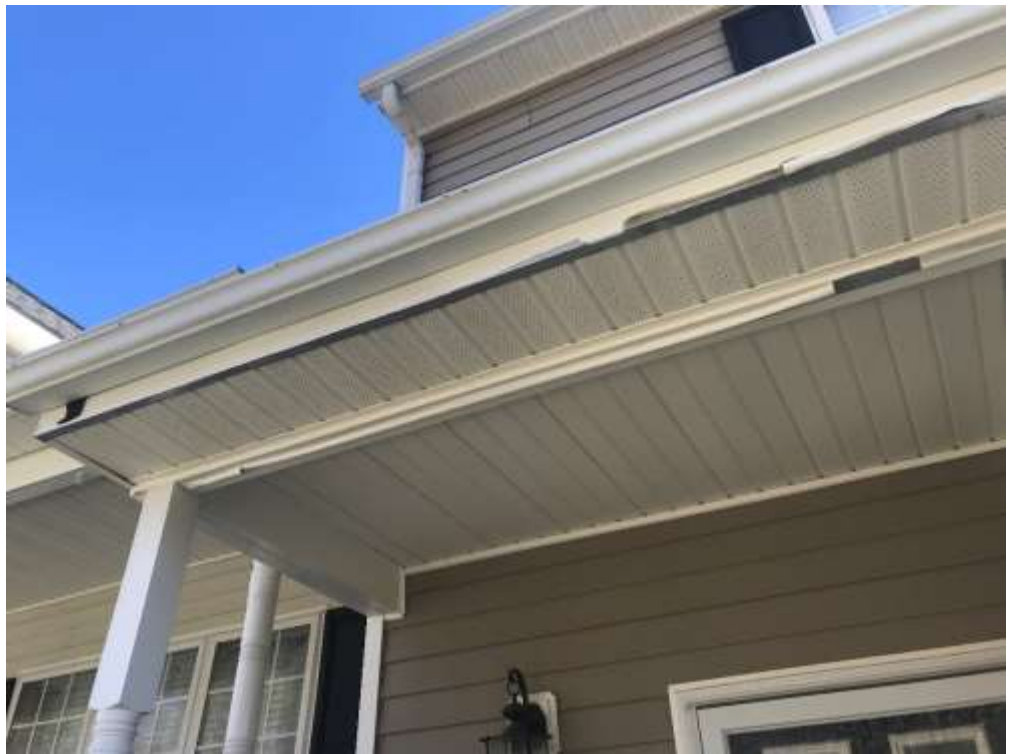
Photo No.
22

Flaking paint off of metal trim at Building 7312-7320

We typically recommend painting/repairing the wood and aluminum trim components on an approximately 5- to 7-year cycle. Paint cycles should include replacing sections of siding and trim components as needed (including front porch posts), repairing caulking/sealant as needed, adequate surface cleaning/preparations, and the application of two coats of a high-quality exterior grade paint. Doors and shutters will also likely require painting during each paint cycle. We have allocated funds to repair and paint Buildings 7312-7320, 800-810, and 801-811 beginning in 2025 on an approximately 7-year cycle. Similarly, we have provided funding to paint the remaining two buildings in 2028 on a 7-year cycle. Painting and repairs should likely be performed sooner than allocated, though we have delayed the projects due to funding constraints. We have included funds for replacing areas of trim during the painting cycles, as well as select wooden posts where rot is observed. The association should feel free to adjust which units are included in each cycle, based on deterioration at the time of the projects. We would like to note that we do not anticipate any large-scale repairs or re-pointing to be required to the brick veneer surfaces on the buildings over the term of this study.

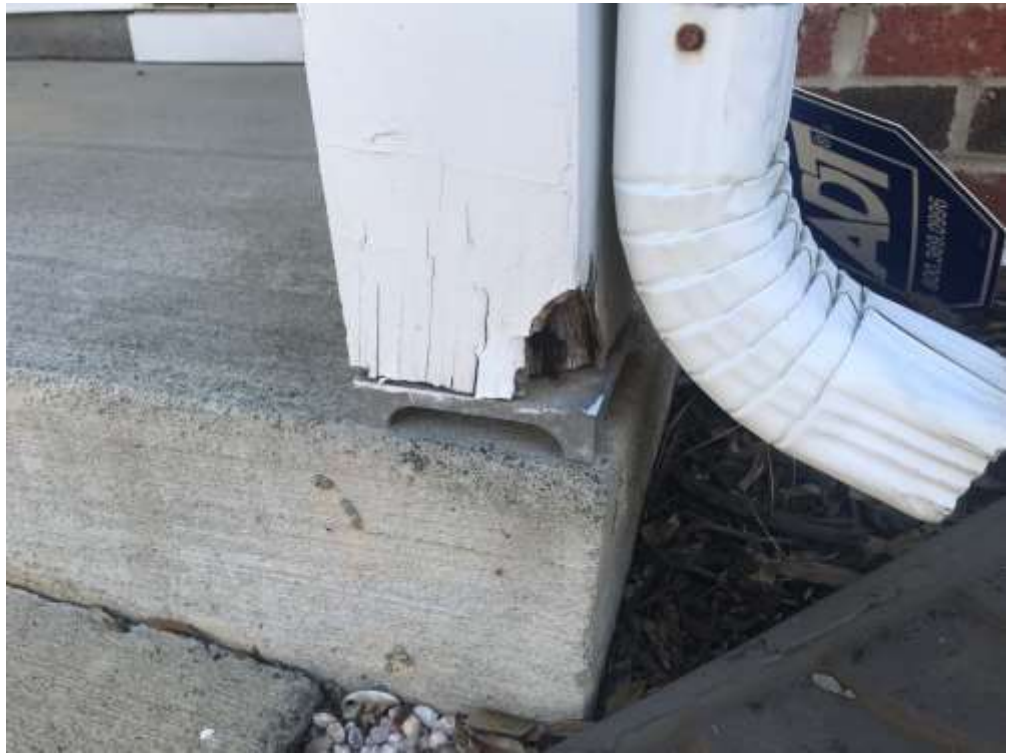
Photo No.
23

The buildings in the community are of wood-framed construction and are primarily clad in vinyl siding with wood trim components and aluminum wrapping. Exterior doors are of metal and skin construction, and vinyl shutters flank windows on the front of the buildings. The exterior surfaces were in generally good to fair condition with some deteriorating sections observed. The enamel finish on the aluminum trim wrapping was peeling/flaking on the fronts of the units in the 7312-7320 building. Repairs to similar deficiencies were recently made to Unit 7301 based on a quote provided by the Board President. Other deficiencies included rot damage to several of the front porch posts, such as at Units 809 and 7318.

Typical rot damage in front entry posts (Unit 7318)

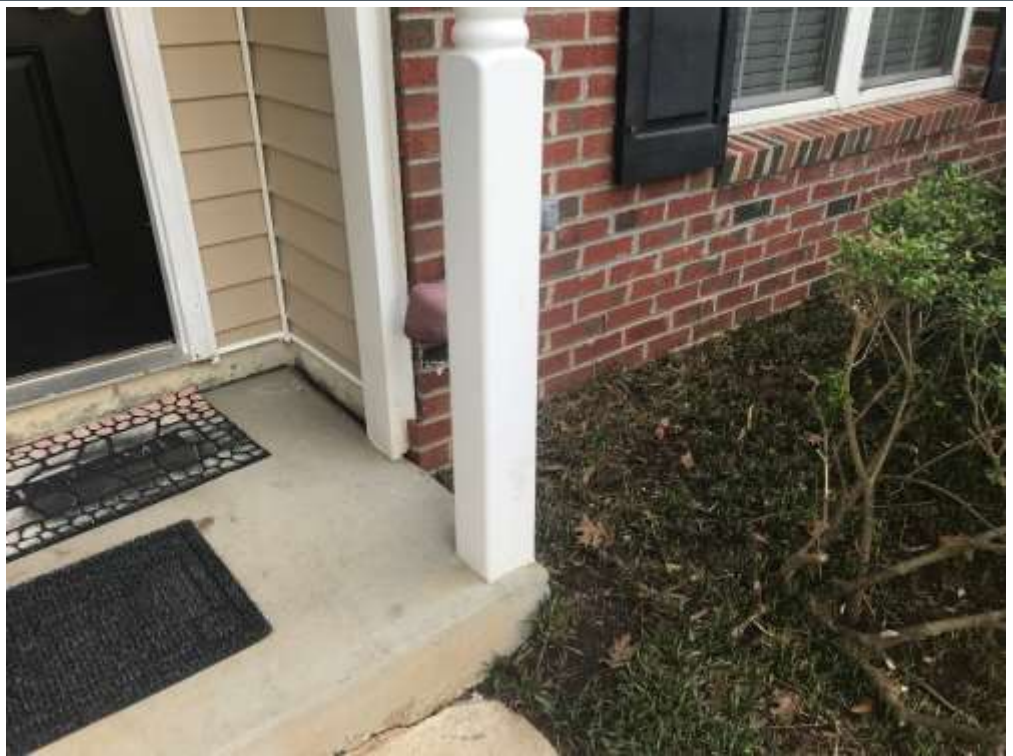
Photo No.
24

Previously replaced post at front of Unit 803

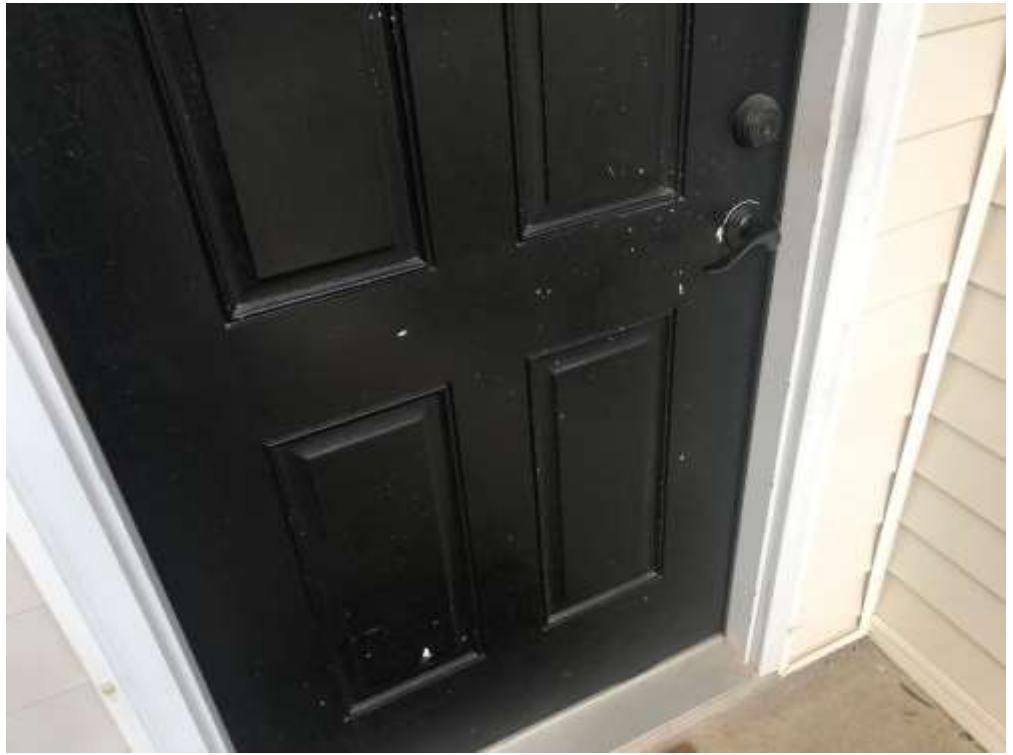
Photo No.
25

Typical front entry door
with flaking paint
