**PARK PLACE OWNER'S  
ASSOCIATION  
CARY, NC**

**OCTOBER 10, 2023**

**FULL RESERVE STUDY**

**GILES + FLYTHE**  
ENGINEERS

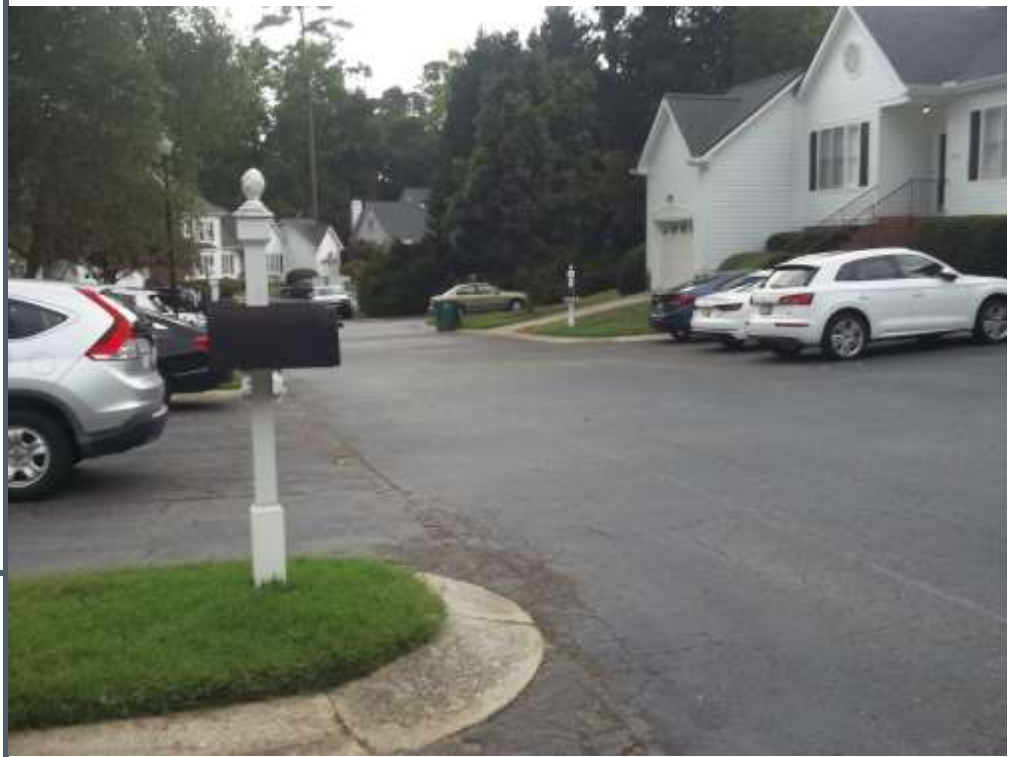
Photo No.  
1

General view of site improvements, asphalt paving, concrete curbing, mailboxes.

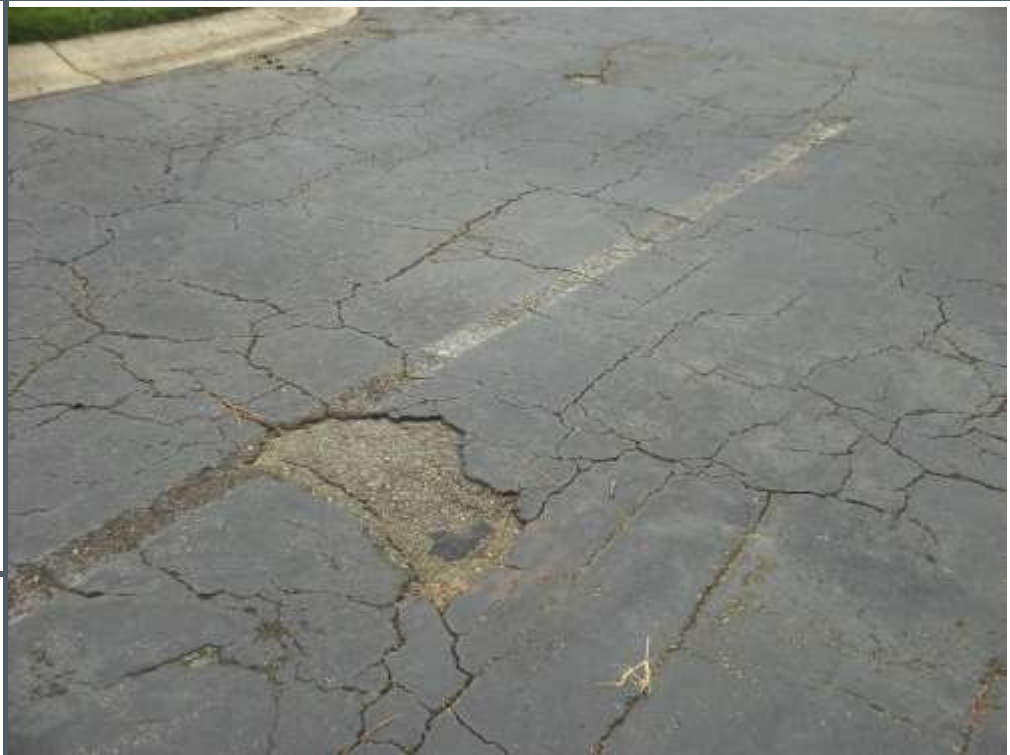
Photo No.  
2

The asphalt paved parking areas located throughout the community are maintained by the association and varied in condition. We observed substantial areas with significant fatigue cracking (alligatoring). Fatigue cracking is evidence of base course/sub-grade failure and will require full depth reclamation to repair or full resurfacing to repair. Several areas of asphalt delamination and failure were also observed.

Example of deterioration in asphalt paving.

We have allocated funds for full depth repairs of sections of the asphalt paving on a 5-year cycle beginning in 2024. This would include saw-cutting and removing asphalt paving in limited areas of the most significant fatigue cracking and failure. After removing the asphalt paving in sections, the sub-grade/base-course may require improvement prior to installation of a 3- to 4-inch-thick asphalt patch. Note that we have allocated funds for repairing limited areas of the most significant failures in the asphalt paving. Ideally, full milling and resurfacing would be completed in the near term.

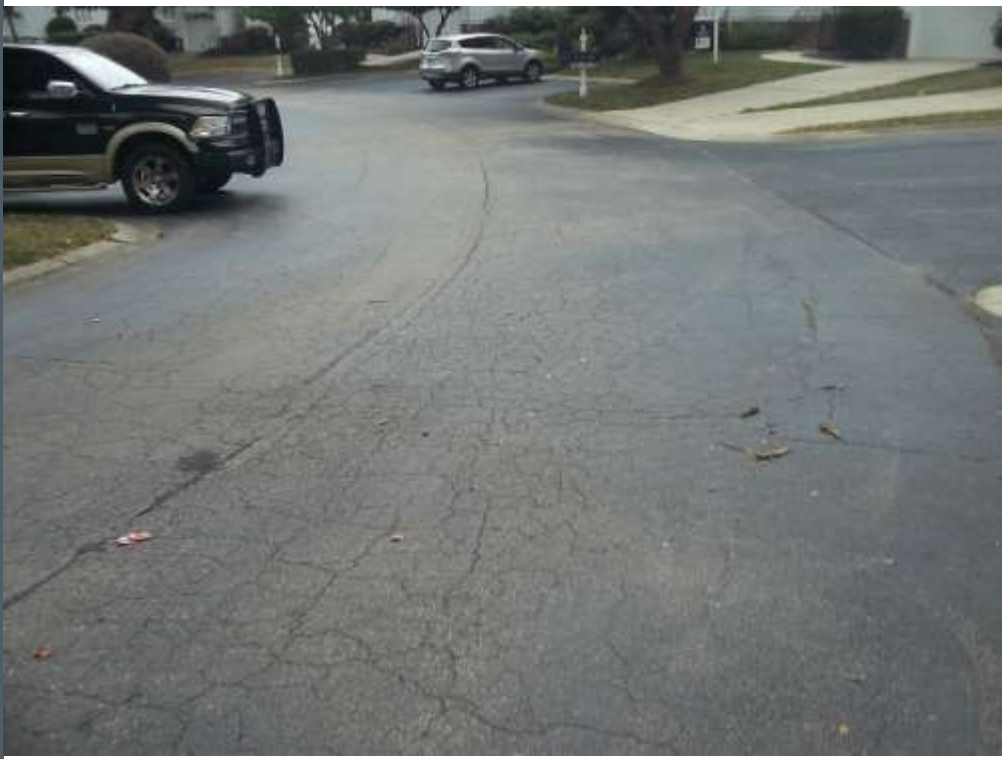
Photo No.  
3

Example of fatigue cracking in asphalt paving.

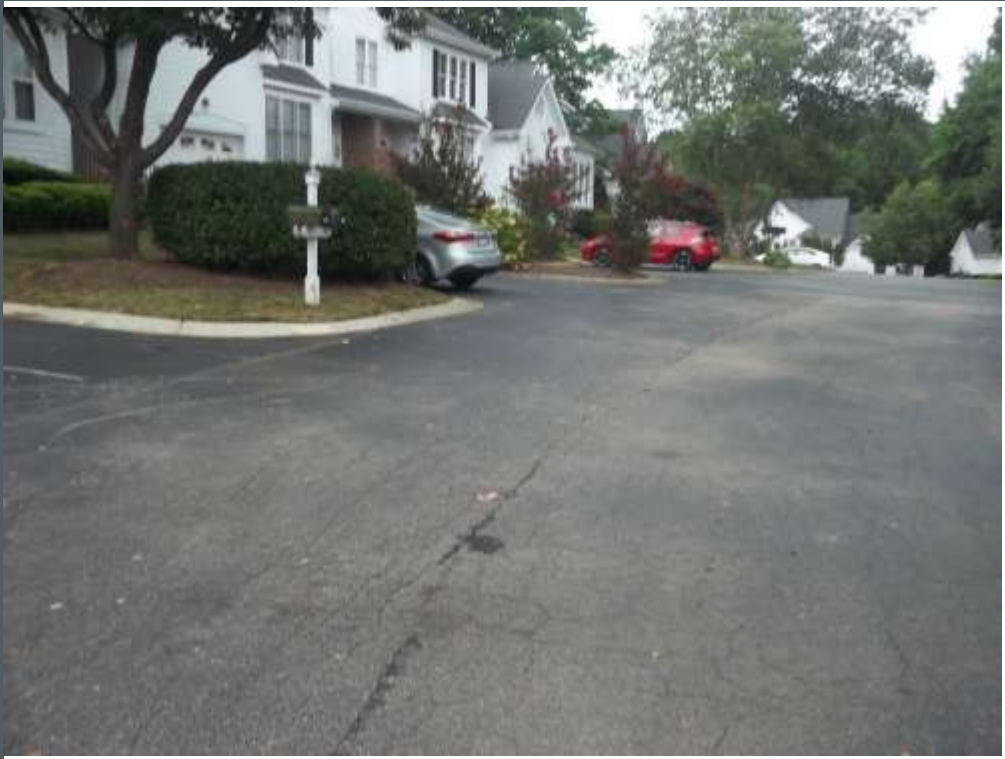
Photo No.  
4

Example of fatigue cracking in asphalt paving.

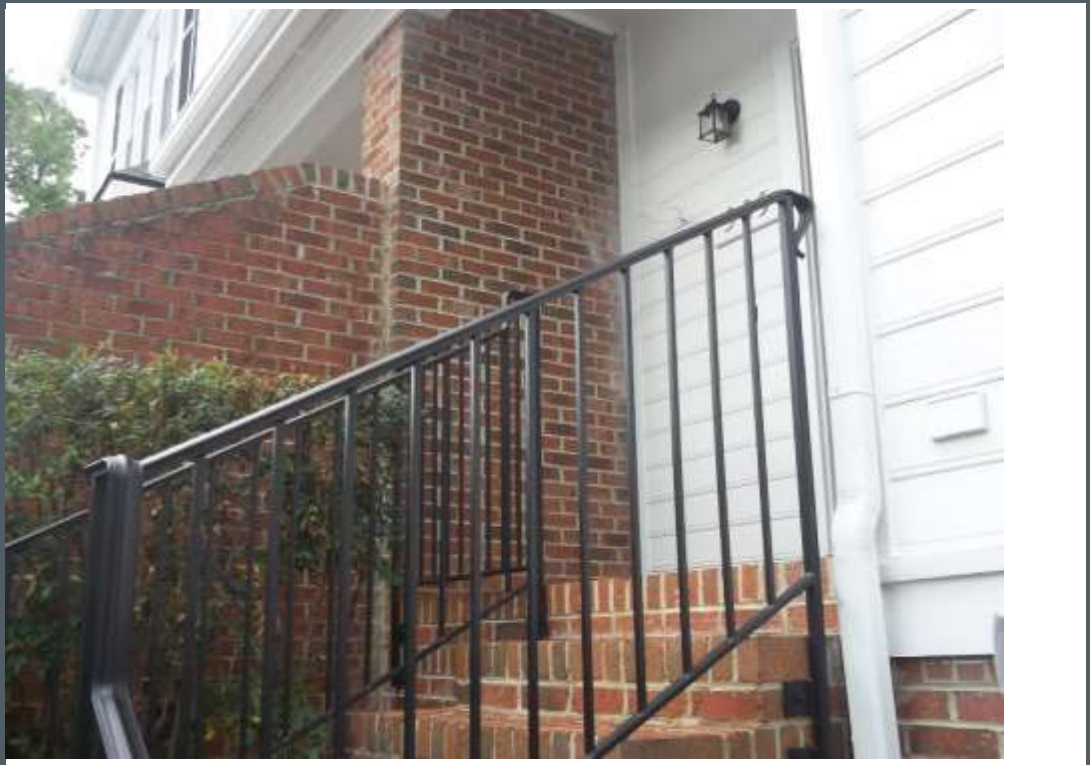
Photo No.  
5

Masonry steps lead to front porches on the units and masonry accent/privacy walls are installed between units on the front of the buildings. We noted settlement cracking and concerns in limited areas and reportedly the association has been repairing/replacing sections of brick steps and accent walls periodically. We have allocated funds to continue to repair/replace sections of brick steps and accent walls in the community on a 2-year cycle.

Description  
Typical brick steps,  
accent walls.

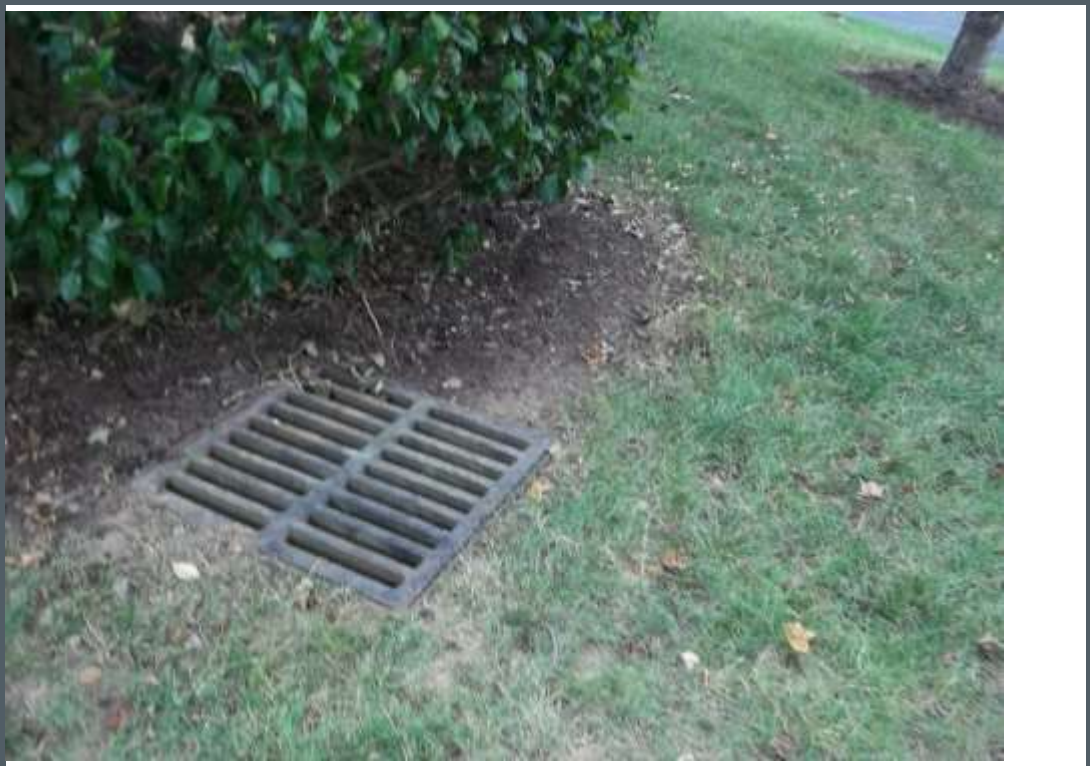
Photo No.  
6

Description  
Drainage inlet basin in  
landscaped area.

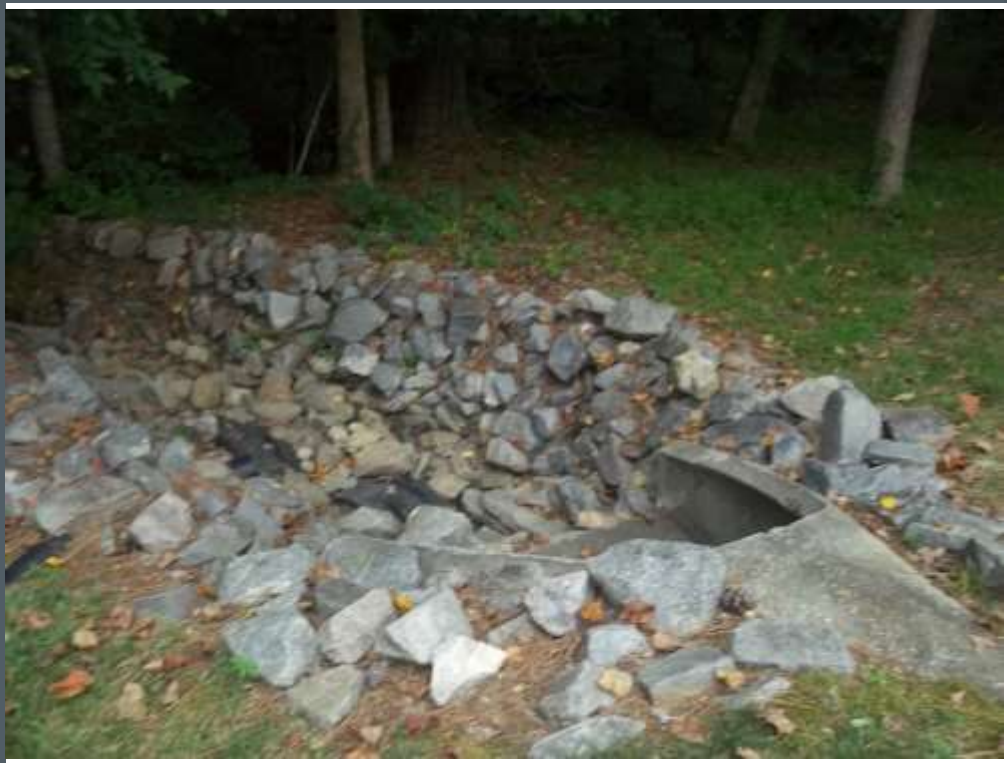
Photo No.  
7

Stone rip rap armoring at stormwater pipe discharge.

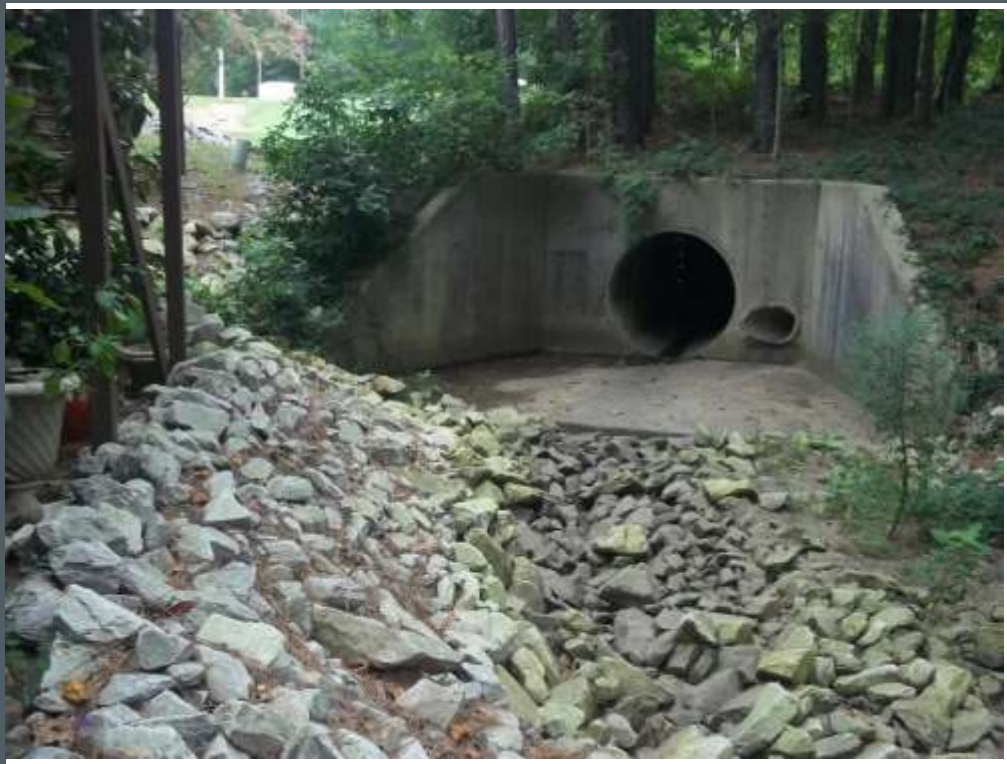
Photo No.  
8

Stone rip rap armoring on sloped areas at drainage swale.

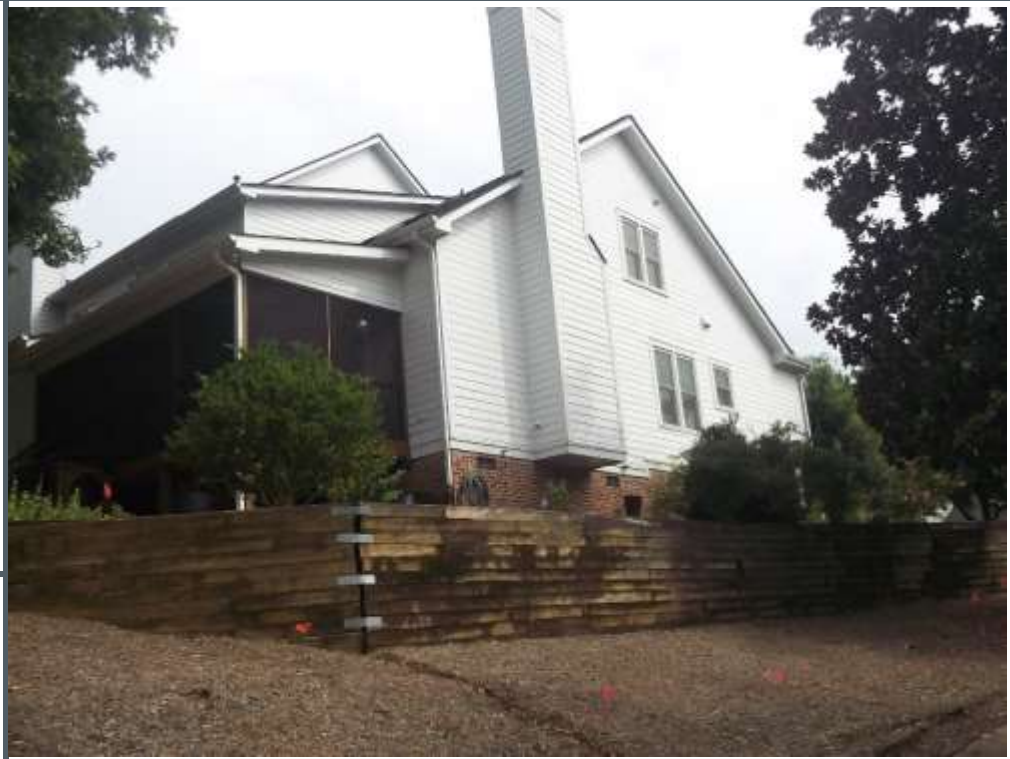
Photo No.  
9

A wood timber retaining wall is located adjacent to 506 Center Pointe Drive along the street. The wood timber retaining wall is in poor condition and is planned for replacement in 2023. Replacement is reportedly to include the installation of a mechanically stabilized earth (MSE) concrete block retaining wall system. The funding of this project is planned through the current 2023 capital repair budget. Assuming this type of wall system is installed correctly and drainage systems around the wall are well maintained, the new retaining wall should have an expected useful life well beyond the term of this study. We observed other small sections of wood timber retaining walls in the community, we have assumed these wall sections would be repaired/replaced through an annual maintenance budget.

Section of retaining  
planned for replacement  
in 2023.

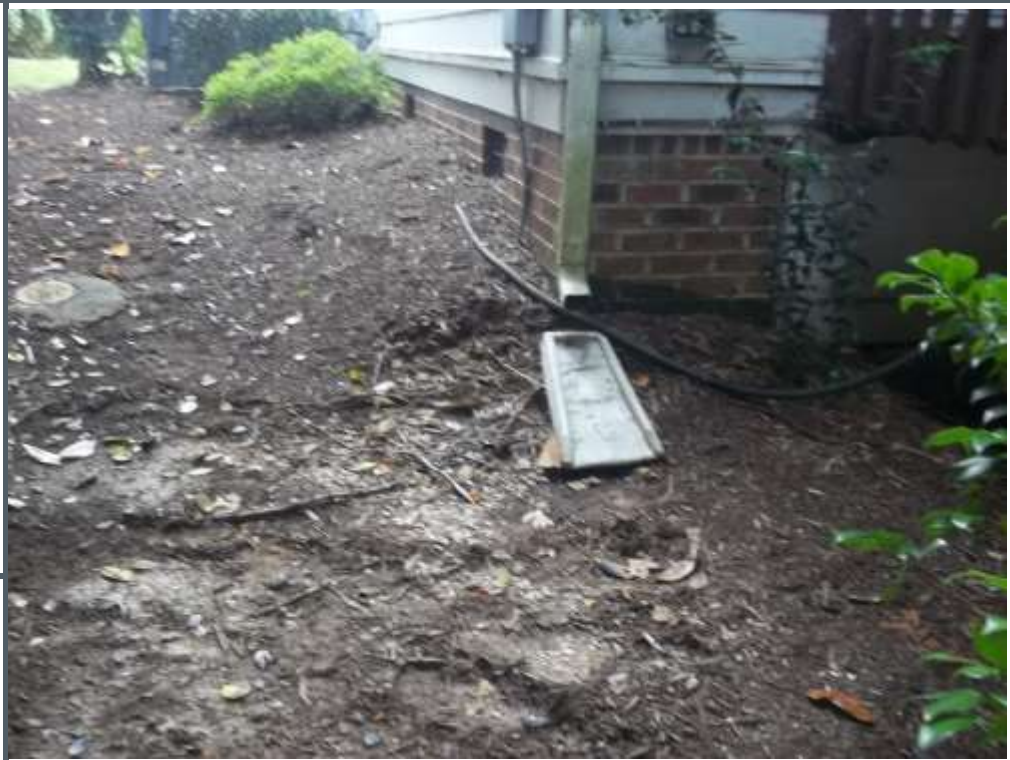
Photo No.  
10

Area of bare  
soils/erosion developing  
near foundation wall.

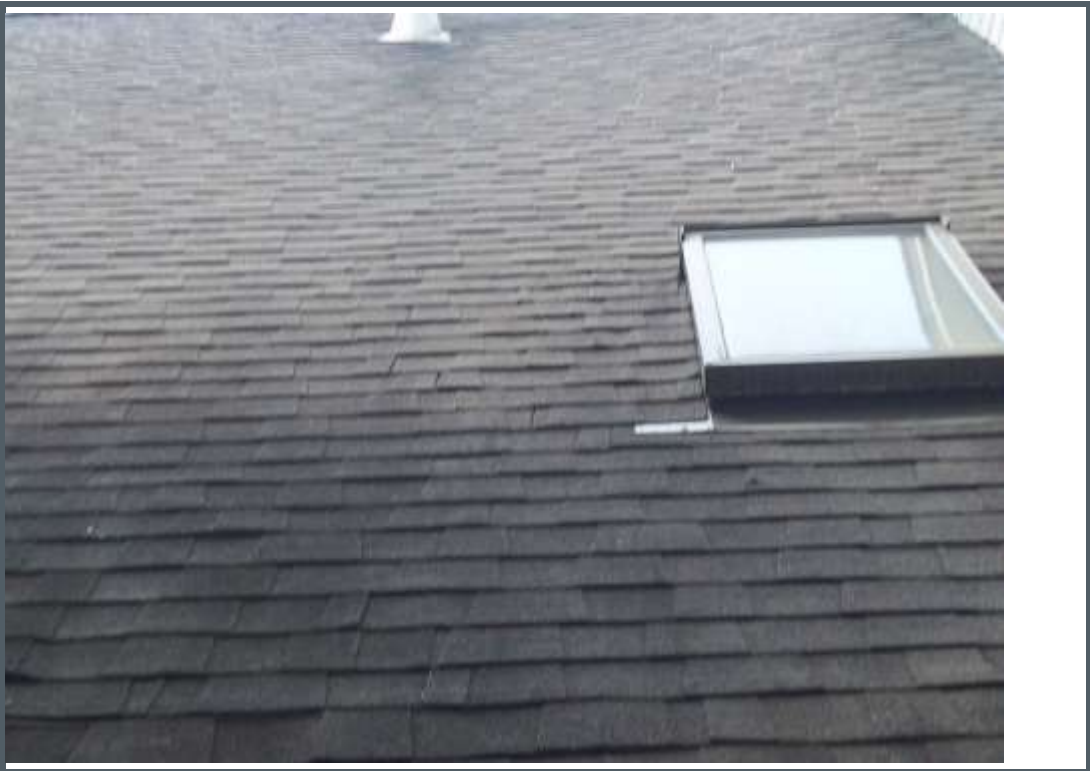
Photo No.  
11

The townhome and clubhouse building roof surfaces are clad in architectural grade shingles. Architectural grade shingles have an expected useful life of approximately 25-years. The roofing on the following units appears to be of original construction: 442 and 444 Center Pointe Drive; 200, 202, 204, 206, 312 and 314 Vinca Circle. We have allocated funds to replace these unit roofs in 2024 and on a 25-year cycle. The roofs on the all the remaining buildings were reportedly replaced in 2016 and 2017 as a result of hail/storm damage and generally appeared to be in good condition. We have allocated funds to replace these remaining shingled roofs in 2041 and on a 25-year cycle. Note that minor repairs to flashing, vent boots, curbs, and other transitions may be required in the interim. We have assumed these repairs would be funded from an operating or maintenance budget.

Description  
View of roof shingles.

We strongly recommend that any re-roofing project closely follow procedures outlined by the National Roofing Contractors Association's *Roofing and Waterproofing Manual*. A re-roofing sequence should include removal of the existing roofing material, and the replacement of any damaged flashing.

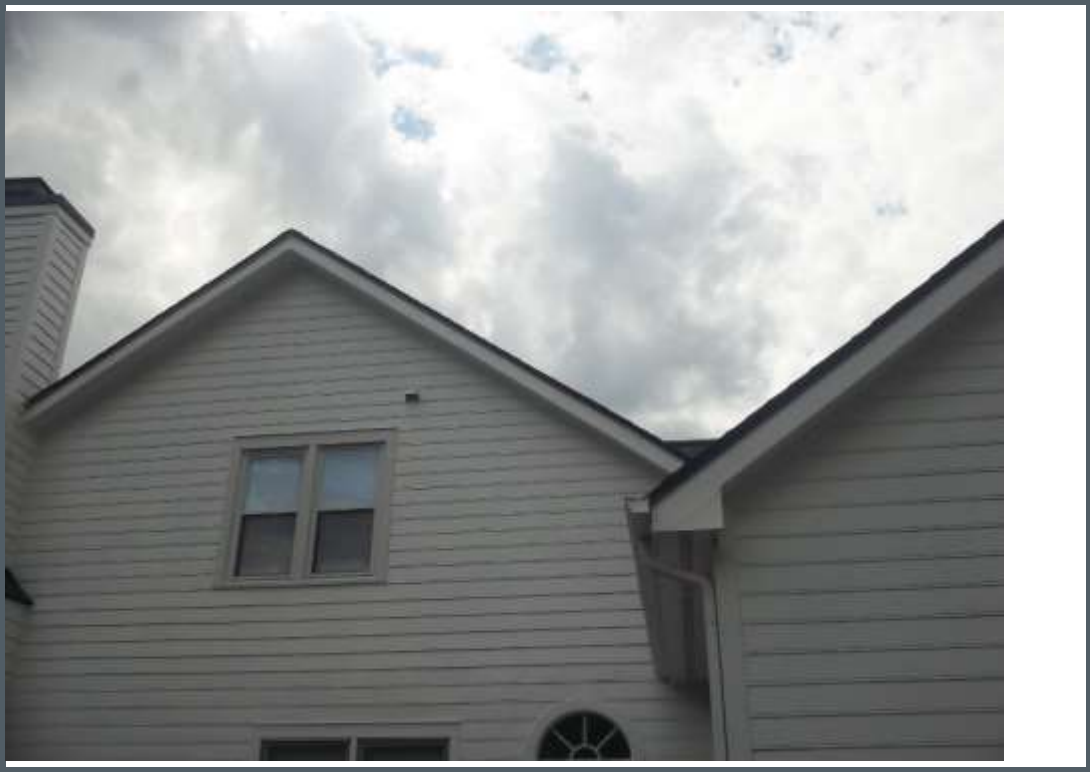
Photo No.  
12

Description  
General view of siding and trim.

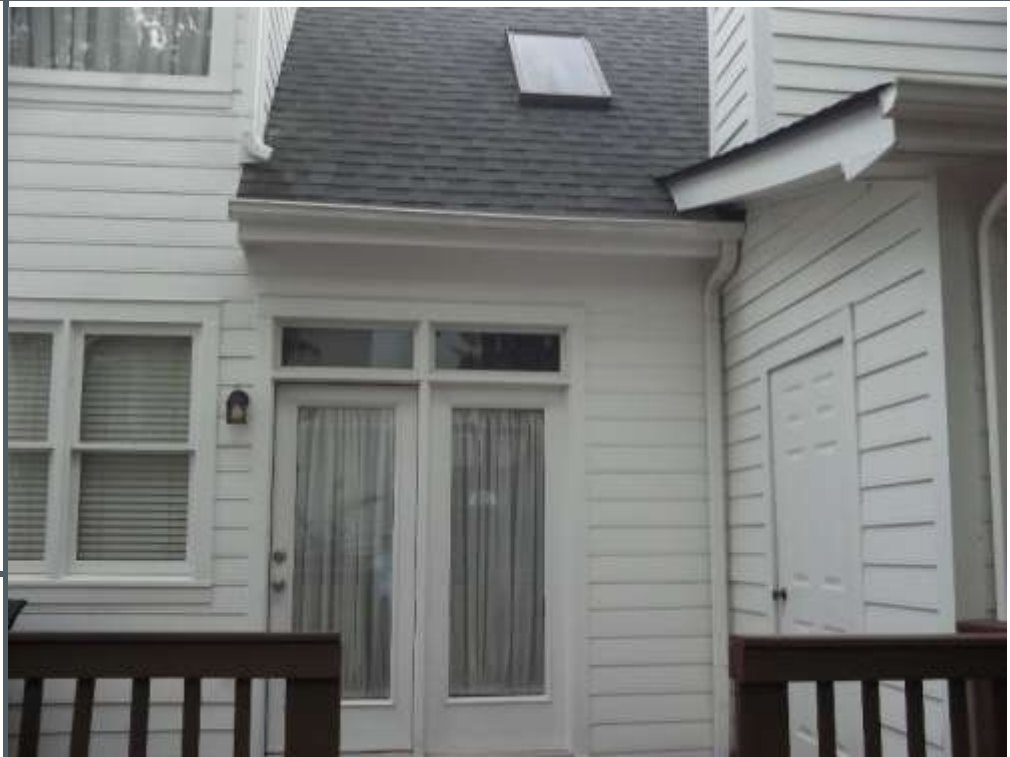
Photo No.  
13

The gutters on the buildings generally appeared to be in adequate condition and typically have an expected useful life of approximately 40-years assuming minor repairs and maintenance are completed in the interim. However, the association has experienced premature failure in wood trim and patio door units on the rear of select units. At the rear of select units, a steep section of roofing drains to gutters directly above rear patio door units with minimal overhang. At these locations, gutter downspouts from upper-level roofs discharge onto the roof directly above the patio door units. It is likely that the combination of the large steep sloped roof area and the gutter downspouts from upper-level roofs in the same area has resulted in gutters overflowing

above the patio door units during significant rain events. The gutters in this area appear to be standard 5-inch k-style gutters with 2"x3" downspouts. Repair options would likely include installing larger gutters (6-inch or larger) and larger downspouts (3"x4" or larger). Additionally, the downspouts from upper-level roofs discharging in this area may be routed all the way down to discharge at grade to reduce volume of water in the gutters above the patio doors. Finally, the gutters and downspouts should be maintained free for debris and adequately sloped to ensure adequate flow of water. Gutter guards may also be installed to reduce the need for cleaning/maintenance. We have allocated funds in 2024 to replace these sections of gutters above patio doors on select units. The remaining gutters and downspouts generally appeared adequate, and we have allocated funds for their replacement in conjunction with roof replacements in 2041.

View of area at rear patio door with steep roof and upper level downspout leading to gutter section and limited overhang above rear patio door.

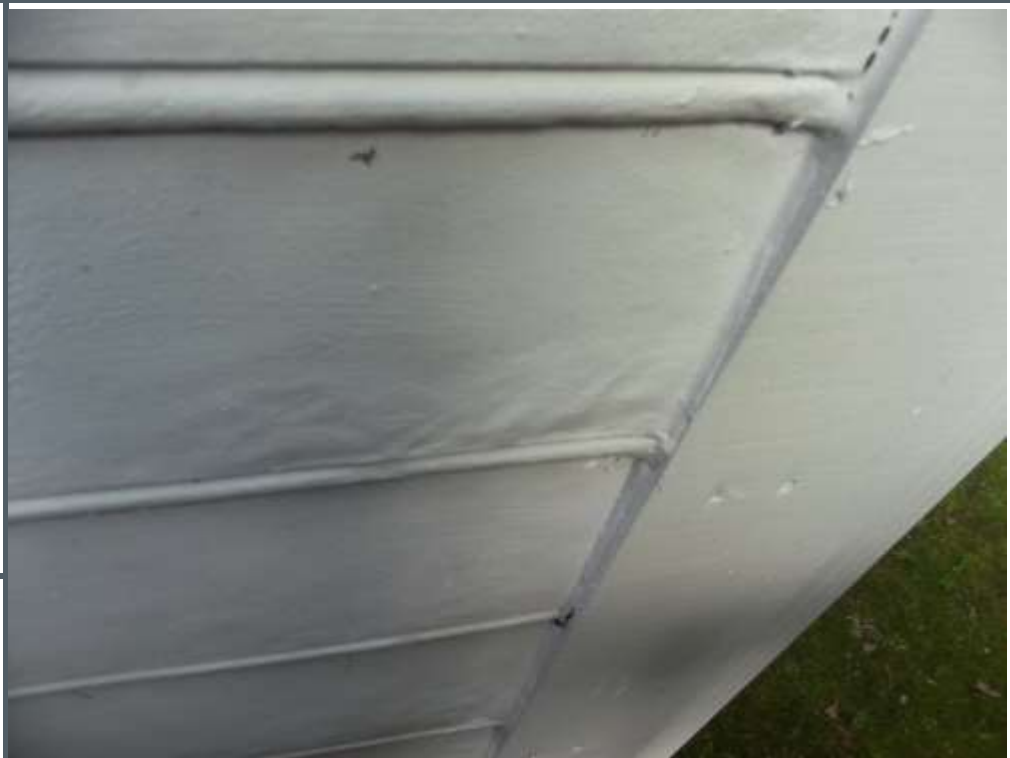
Photo No.  
14

The buildings are predominantly clad in lap siding. It appears the original siding was a Masonite type composite siding. Previous paint cycles have included sectional replacement with more moisture resistant fiber-cement type lap siding. Painted wood and composite trim were observed on the buildings. We recommend continuing with exterior siding repair and paint cycles on a 6-year cycle. Each paint cycle should include replacing damaged sections of siding and trim with moisture resistant fiber cement components or possibly rot proof PVC trim components. Paint cycles should also include removing and replacing damaged caulking and sealants as needed, adequate surface preparations and the application of 2-coats of a high-quality exterior latex paint on the painted surfaces of the buildings. The association provided a schedule for exterior painting/repair projects and the condition of the siding and trim generally appeared consistent with the provided schedule. We have allocated funds to continue exterior repairs and painting cycle in 4 phases on a 6-year cycle with the first phase beginning in 2025. We have allocated funds on the following phases by unit:

Close up view of section of swelling/moisture damage on exterior siding.

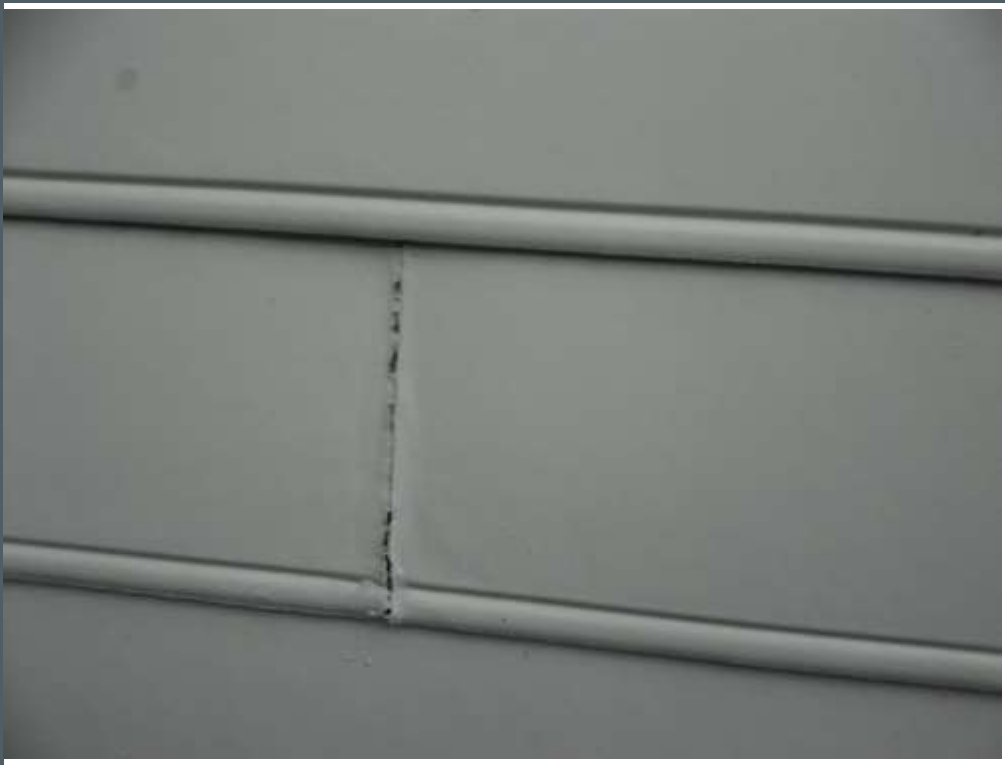
Photo No.  
15

Description  
View of caulking at butt joint and minor swelling in lap siding at butt joint.

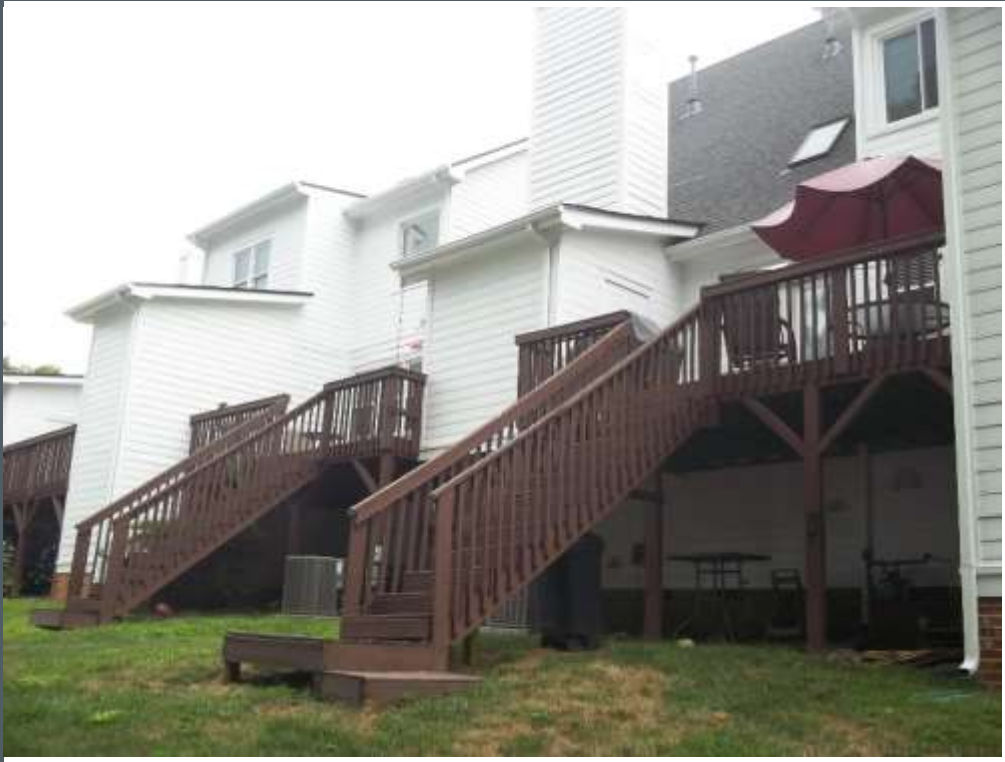
Photo No.  
16

Description  
Typical rear decks.

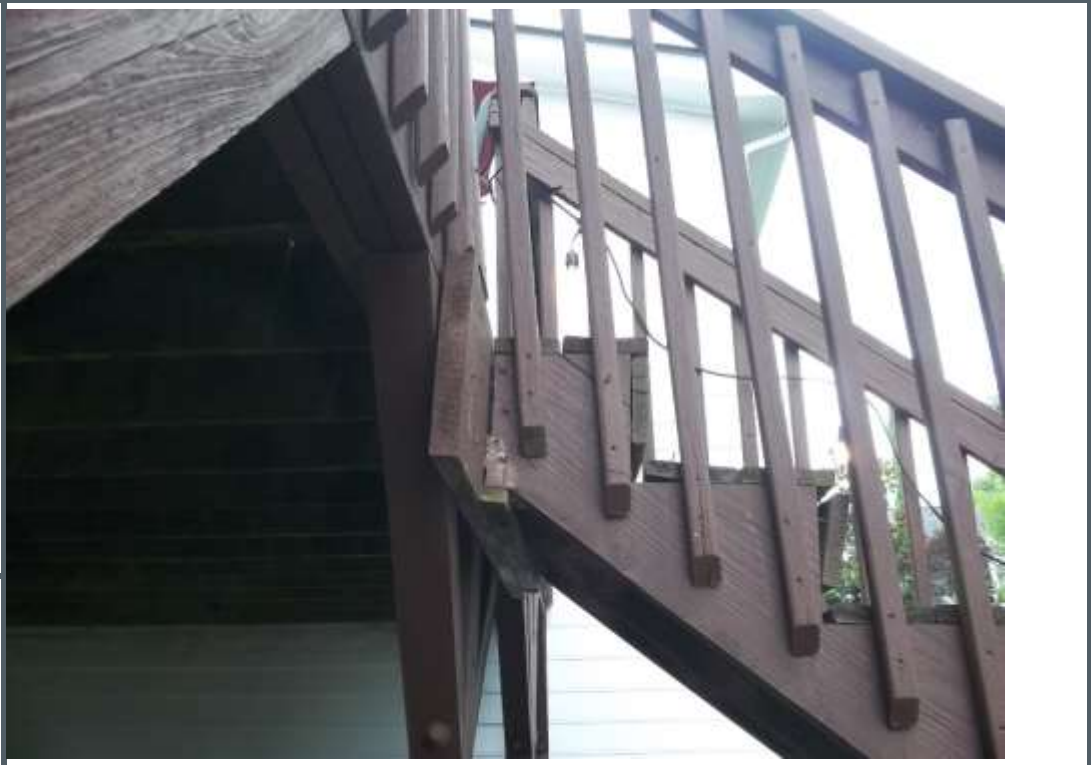
Photo No.  
17

Rear wood framed decks are installed on most of the units in the community. We observed 19 of the units with enclosed rear decks which are reportedly the responsibility of the individual unit owner to maintain. The rear decks varied in condition and appeared to have been periodically stained with repairs completed as needed. We observed approximately 24 unit decks in poor condition with significant deterioration in deck boards, loose/damaged railings and structural framing concerns. Note that the reserve study inspection is a general inspection of the condition of the components, we did not perform a full evaluation of the condition of all the decks in the community. There may be other significant structural concerns with other unit decks that were not observed during the reserve study inspection. We recommend the association routinely inspect the condition of the rear decks and steps and complete any structural repairs as needed. We noted the following unit decks to generally be in poor condition during our inspection: Center Pointe Drive: 400-406, 420-426, 437-443, 500-506; Vinca Circle: 210-216, 220-226. Considering the age of the decks and the significance of the concerns observed, we recommend fully replacing these units' decks in the immediate term and have allocated funds for replacement in 2024. We have allocated funds to replace all the remaining unit decks on a schedule to include approximately ¼ of the remaining decks every 7-years. We have also allocated funds to stain and repair the decks on a schedule to include ½ of the unit decks every 3-years beginning in 2024. Deck replacements should be completed in accordance with the North Carolina Building Code and include new footings, posts, girders, floor joists, railings, steps and decking. Stain/repair projects should include structural repairs as needed, repairing railings, steps and decking as needed and the application of an exterior wood stain to exposed components.

View of example of deck stair framing in poor condition.

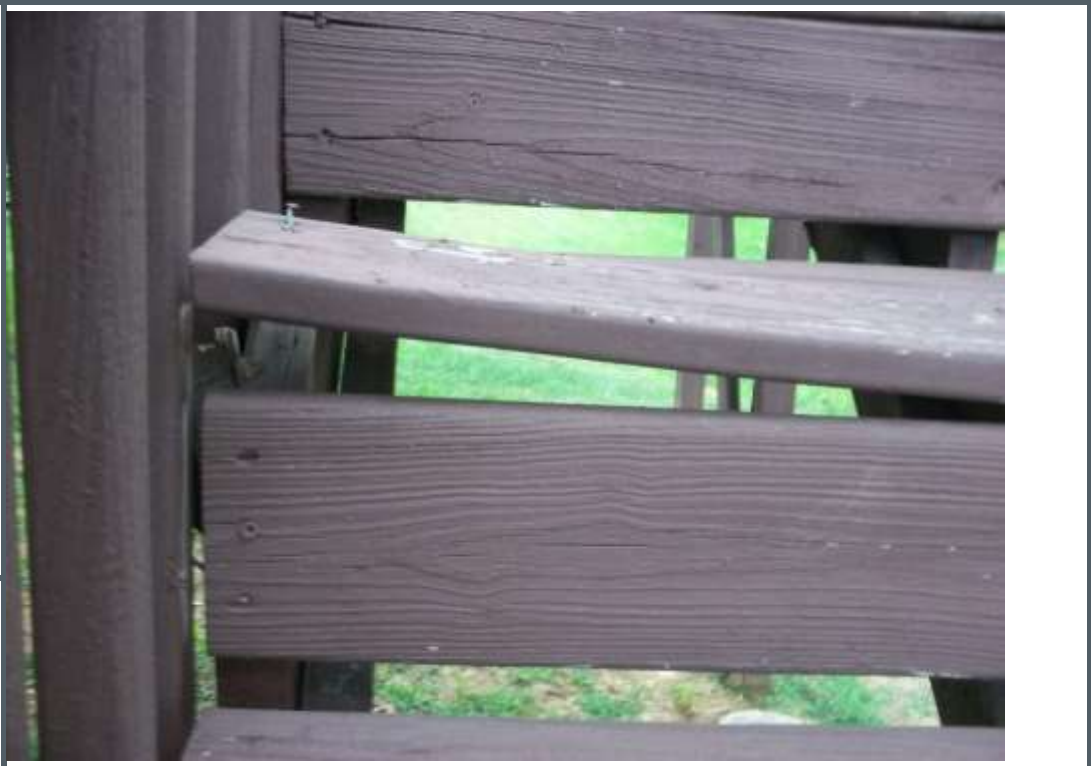
Photo No.  
18

Example of decking in poor condition.

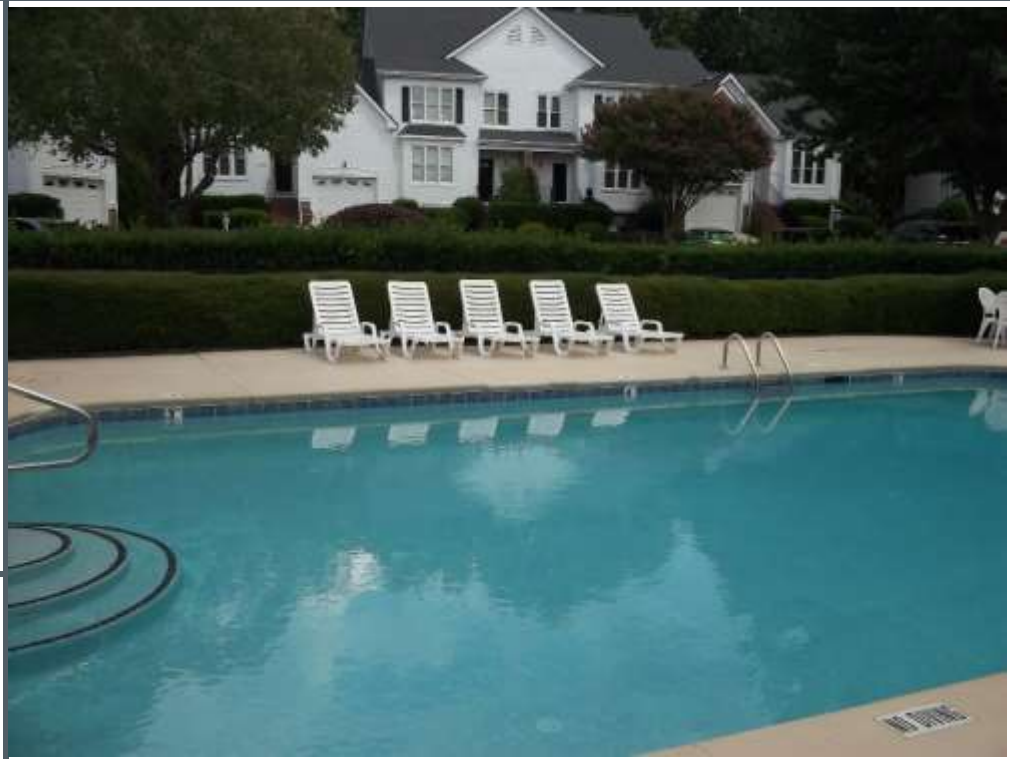
Photo No.  
21

General view of swimming pool area.

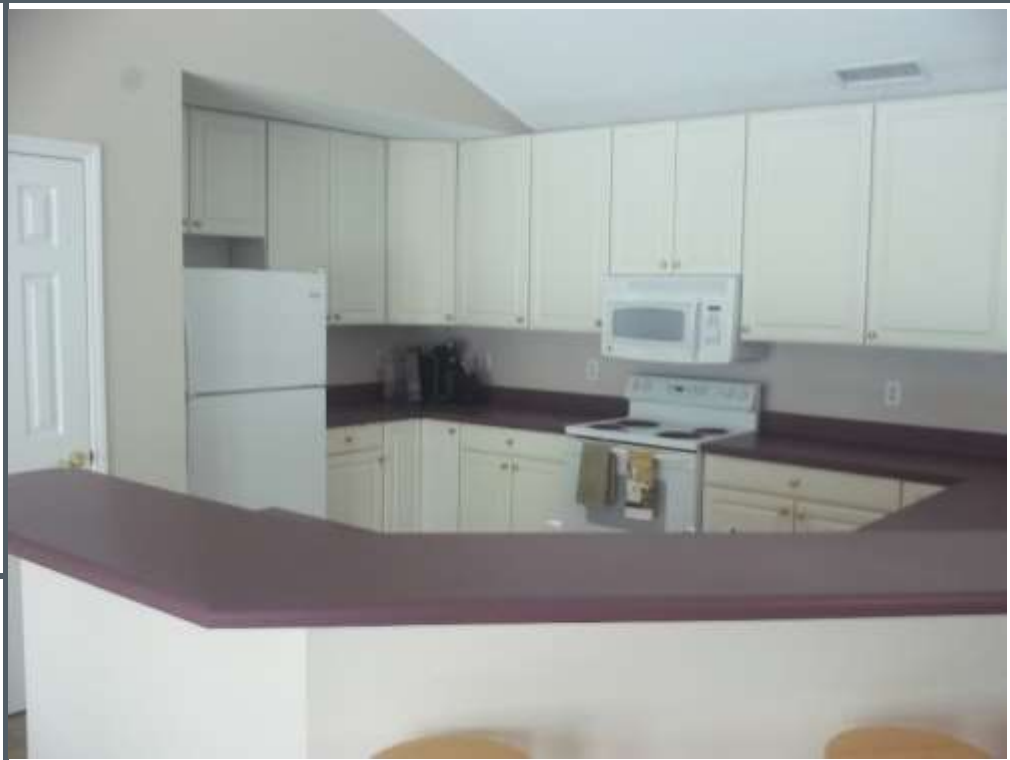
Photo No.  
22

General view of clubhouse interior.

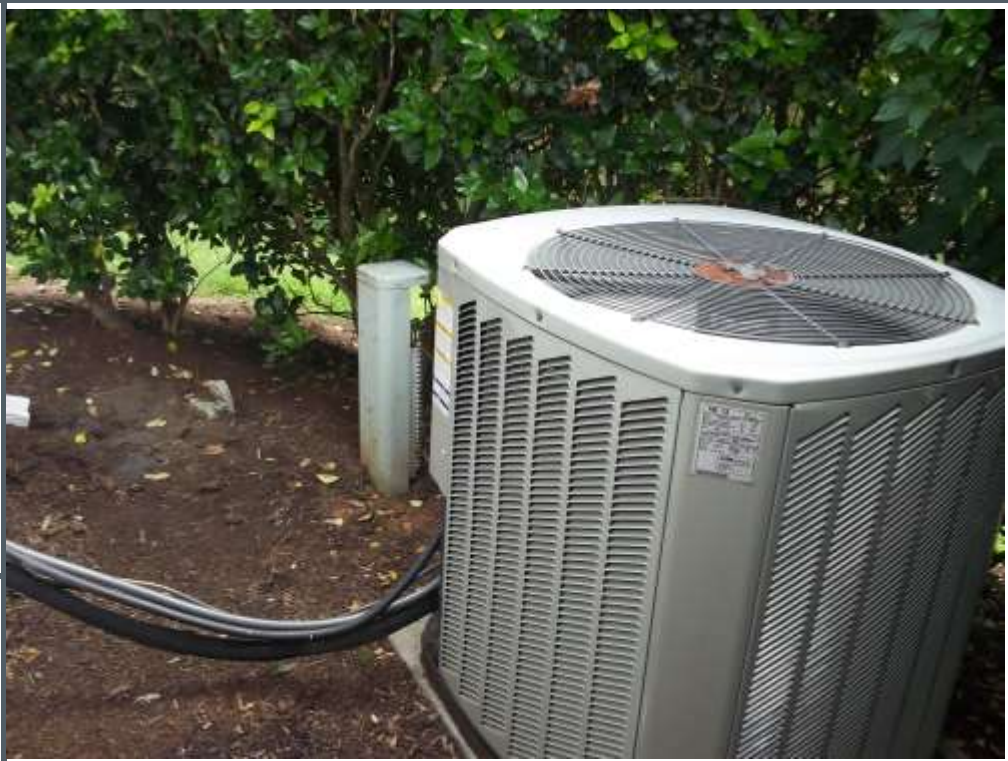
Photo No.  
23

Heating Ventilation and Air Conditioning (HVAC) systems include a Trane 3.5-ton capacity heat pump located on the exterior of the building with a fan coil unit located in the attic space. The heat pump was manufactured in 2011 and has an expected useful life of approximately 15 years. We have allocated funds for replacing the HVAC equipment in 2026 and on a 15-year cycle.

Heat pump serving clubhouse.

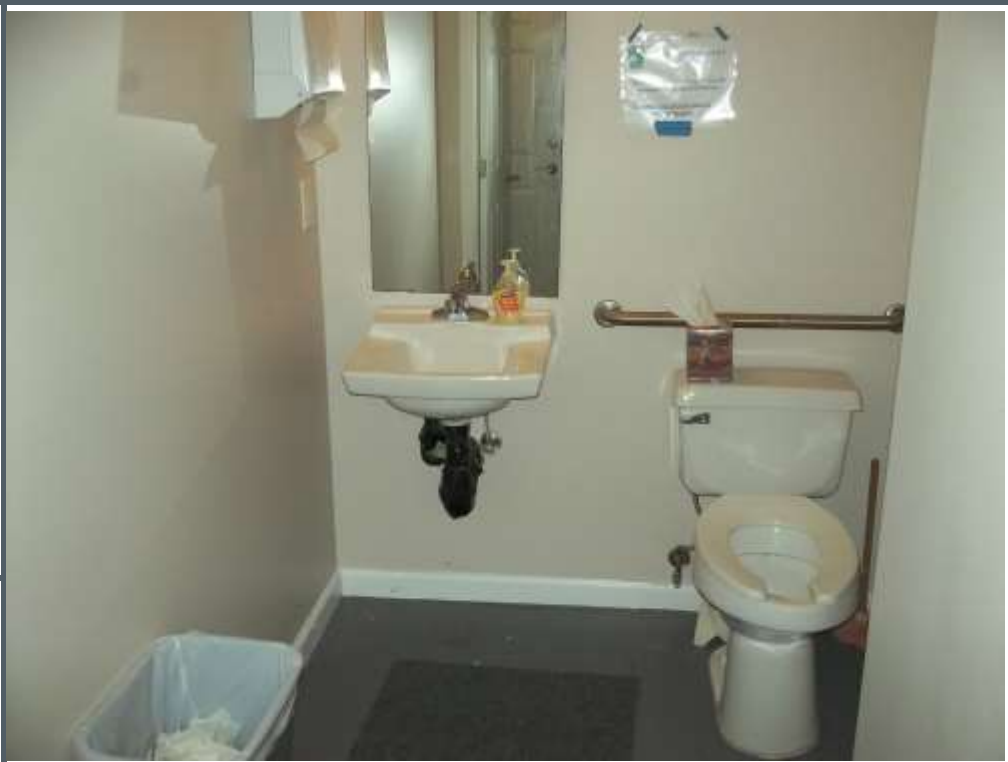
Photo No.  
24

The clubhouse includes men's and women's restrooms with a standard toilet and sink in each. We have allocated funds to replace the restroom fixtures in 2025 and on a 15-year cycle.

Typical bathroom fixtures at clubhouse.
