**HARRISON PLACE OWNERS
ASSOCIATION
CARY, NC**

**DATE:
OCTOBER 30, 2024**

**FULL RESERVE
STUDY**

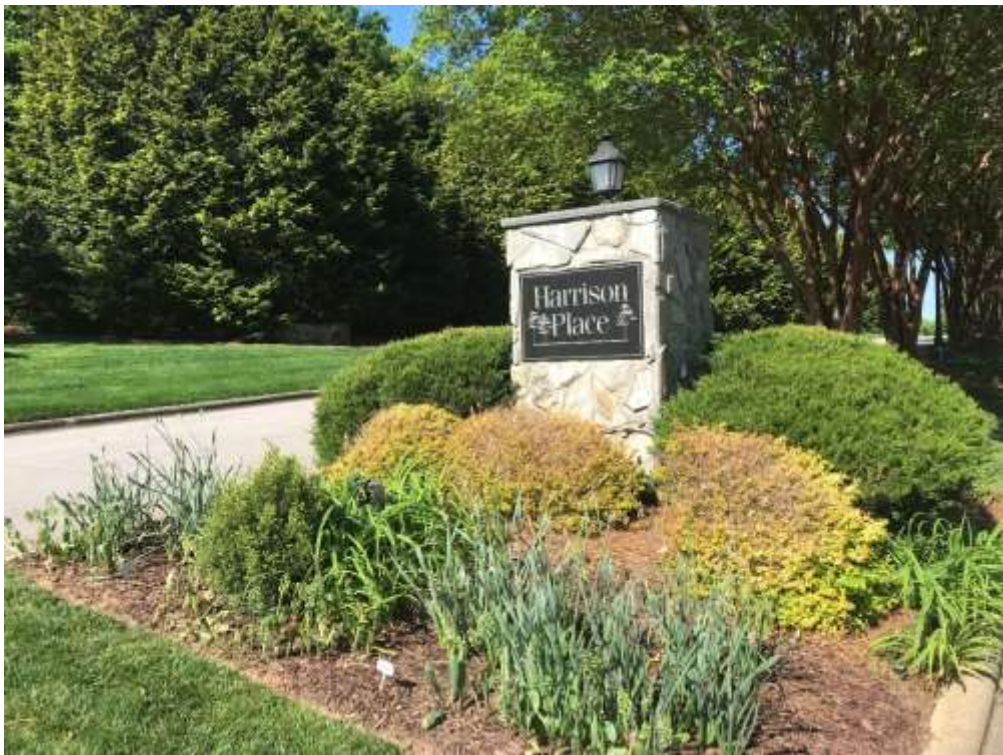
Photo No.
1

View of entrance monument in median

Stone entrance monument walls are located on both sides of the entrance to the community off of North Harrison Avenue, and a stone monument with an engraved sign is located in the median. The monuments generally consist of stone veneer with decorative lighting on the caps. Three pole lights are also located in the median. The signage and monuments appeared to be in good condition and should require minimal maintenance over the term. We do not anticipate a large-scale replacement project of the monuments. However, refurbishment may be periodically required. Refurbishment may include replacement/repairs of the signage, repairs to the stone veneer, and replacement of the decorative light fixtures. We have included an allocation of funds for repairs to the entrance monument every 12 years beginning in 2031.

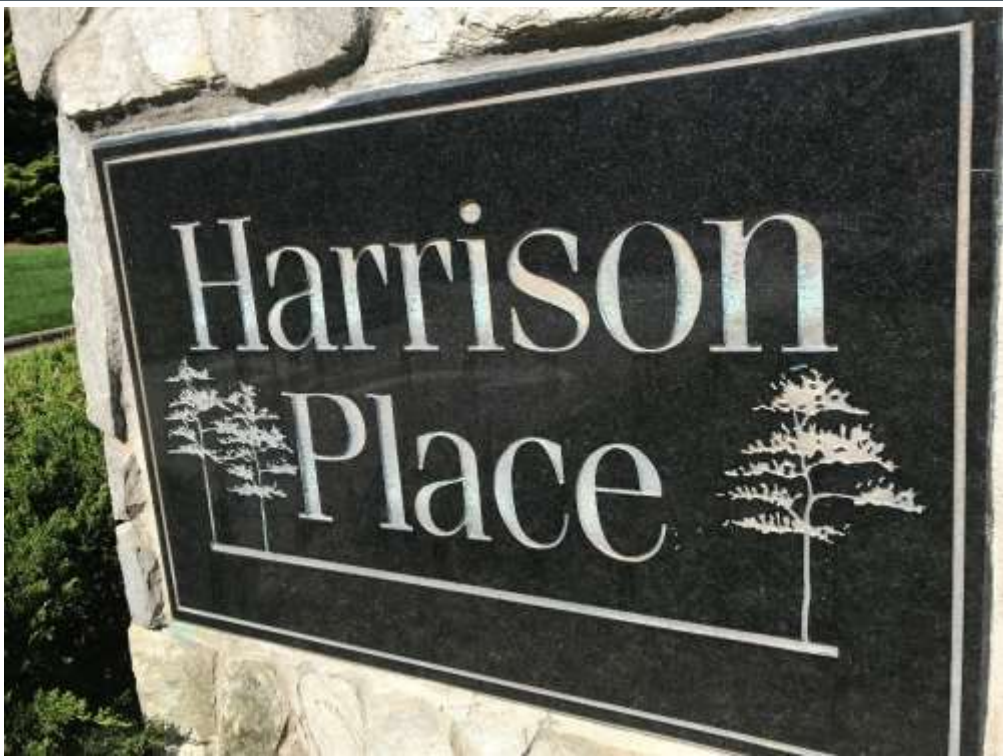
Photo No.
2

Engraved entrance sign

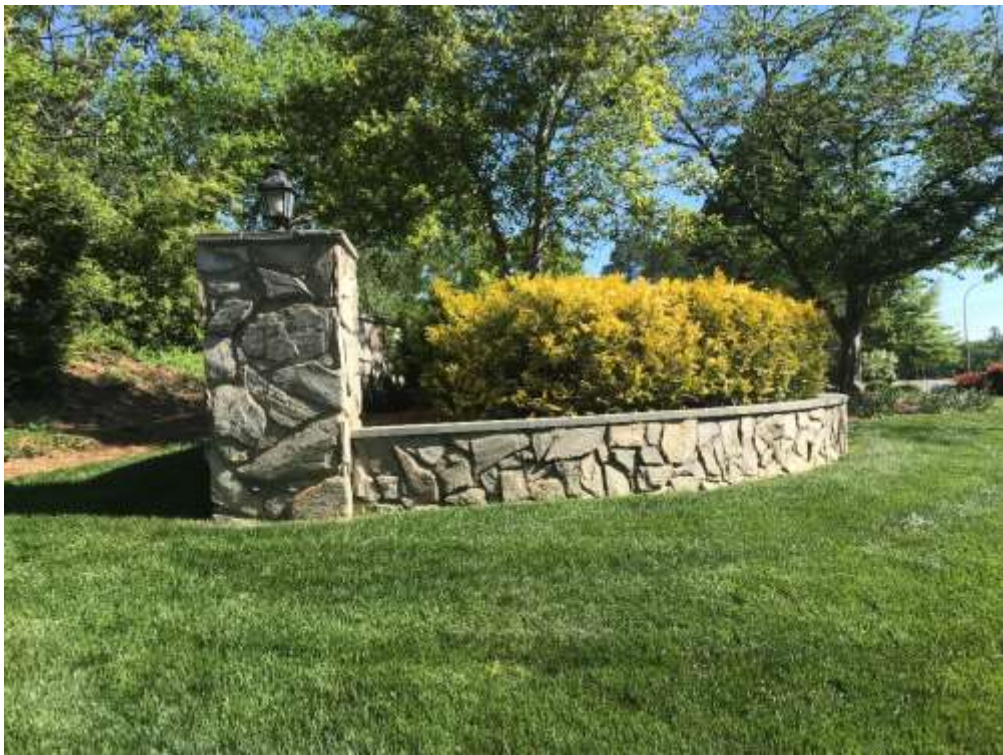
Photo No.
3

Typical entrance
monument wall

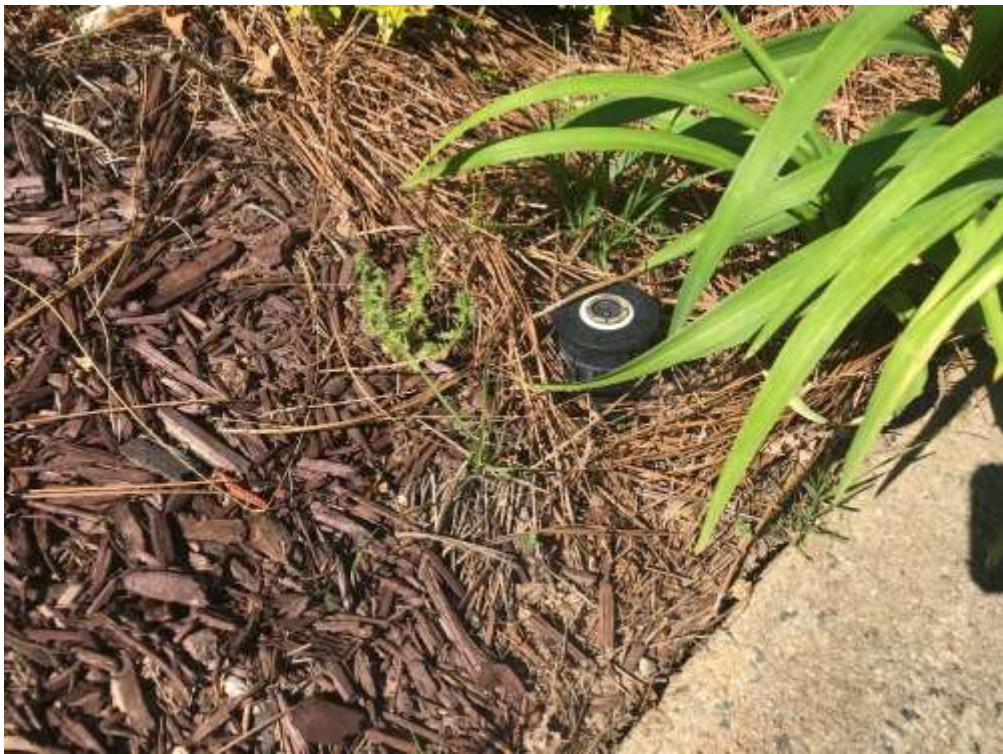
Photo No.
4

Irrigation sprinkler head
at monuments

Landscape irrigation systems are installed at the entrance to the community and the amenity area. We have included funds to replace the controllers, timers, repair backflow preventers, and make valve/pipe repairs to the existing systems, as necessary, every 10 years beginning in 2030. We have assumed minor repairs (irrigation head replacement, minor pipe repairs, adjustments, etc.) would be funded from an annual maintenance budget. Note, costs of these repairs can vary depending on the scope of work, quantity of repairs needed, etc.

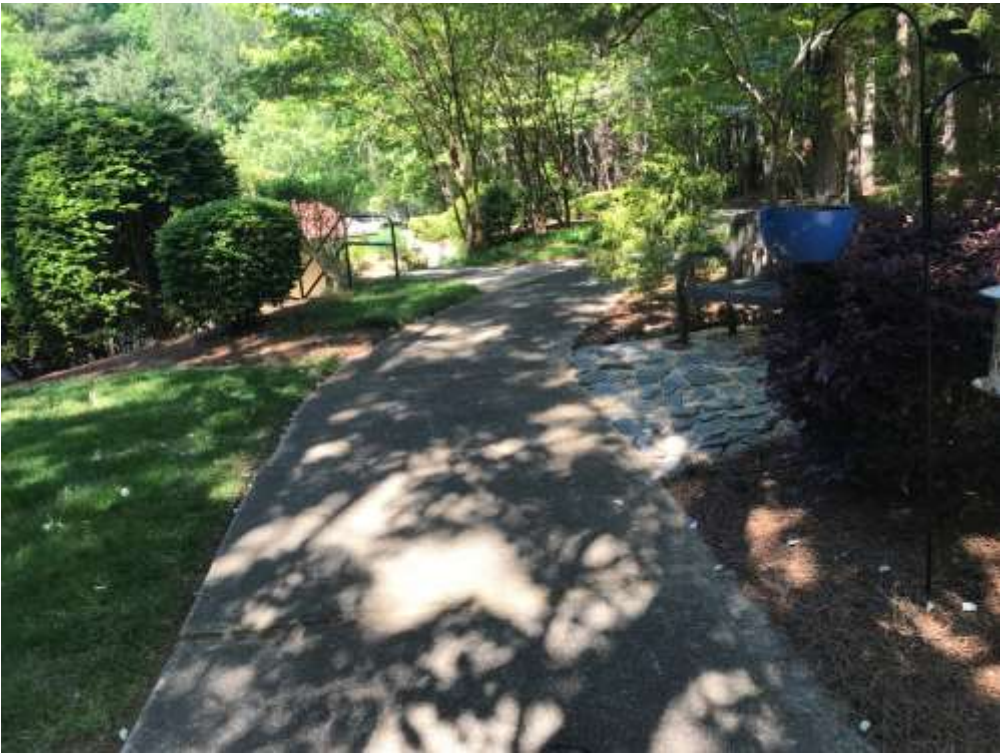
Photo No. 9

Description Typical concrete flatwork

We understand the association has responsibility for the concrete walkways around the amenity center, the pool decking, and the concrete curb and gutter surrounding the parking area. The concrete curbing and flatwork at the amenity center generally appeared to be in good to fair condition. Minor cracking was observed in the pool decking with previous repairs evident, and minor heaving was observed in the sidewalk above the stairs leading towards the pool restroom building. Over time, it is likely that cracking/movement will continue to develop and worsen in concrete surfaces due to differential settlement. As cracking develops, it is likely that sections of the flatwork will require repairs. We have allocated funds for repair/replacement of portions of the concrete flatwork around the amenity center, as needed, on an approximately 8-year cycle beginning in 2025. Repairs may include grinding to reduce unevenness at cracking or saw-cutting, removing and replacing sections of the concrete. We have assumed isolated areas of upheaval or possible trip hazards would be repaired through an annual maintenance budget in the interim. Due to the limited quantity, we assume repairs to the concrete curbing around the parking area will be funded from an annual maintenance budget, as needed.

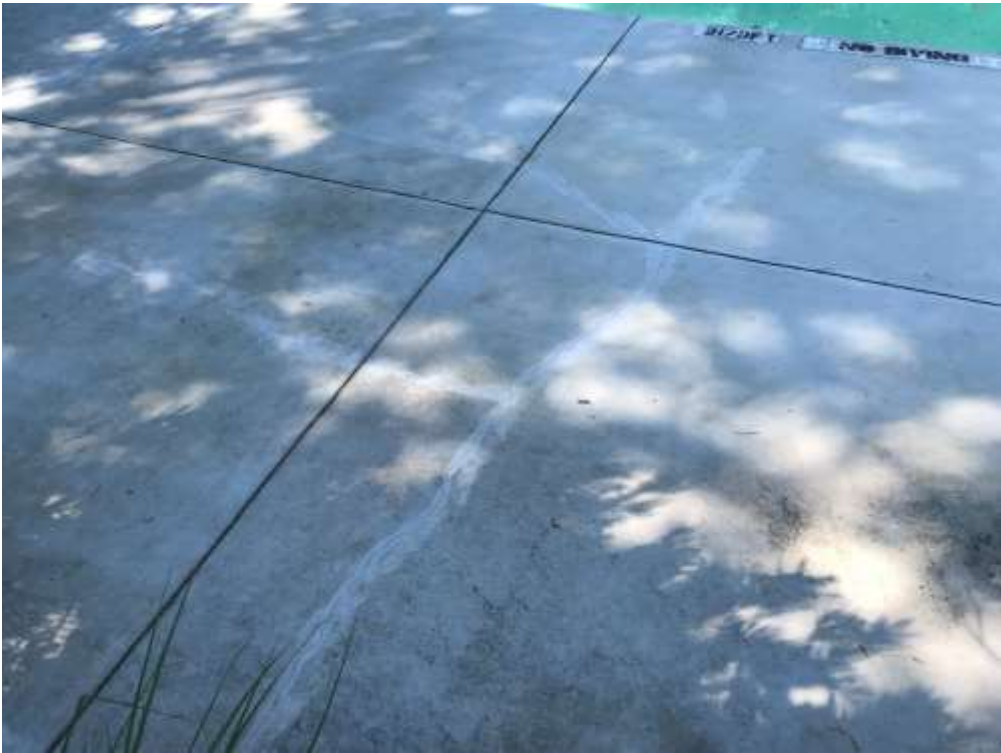
Photo No. 11

Description Typical cracking in pool decking

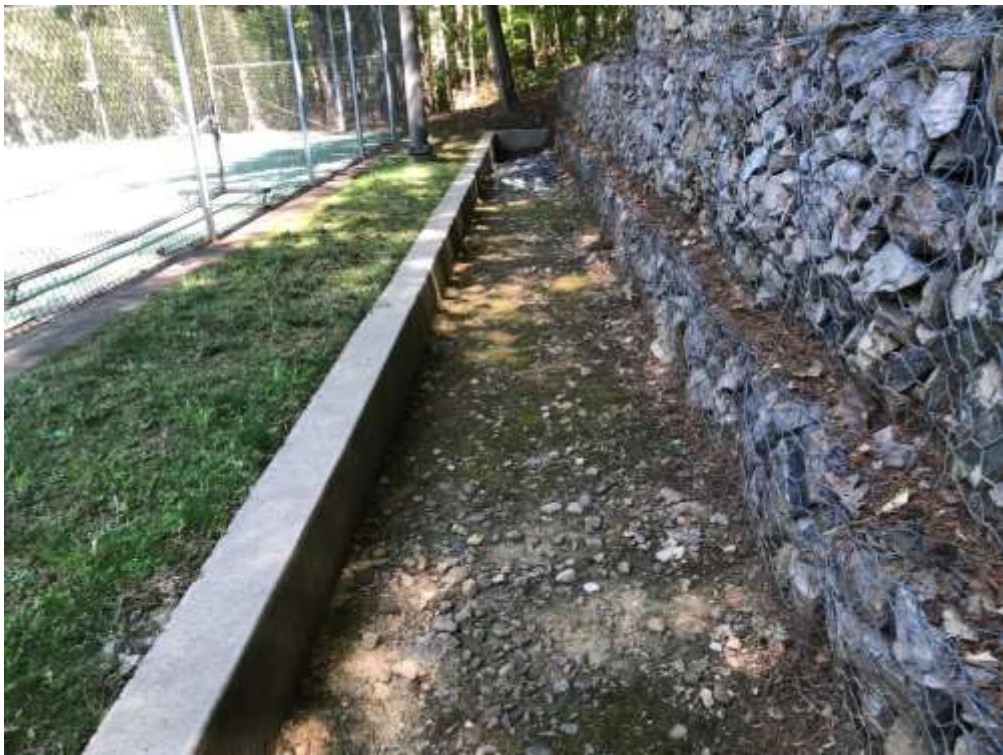
Photo No.
13

Drainage swale with
concrete level lip

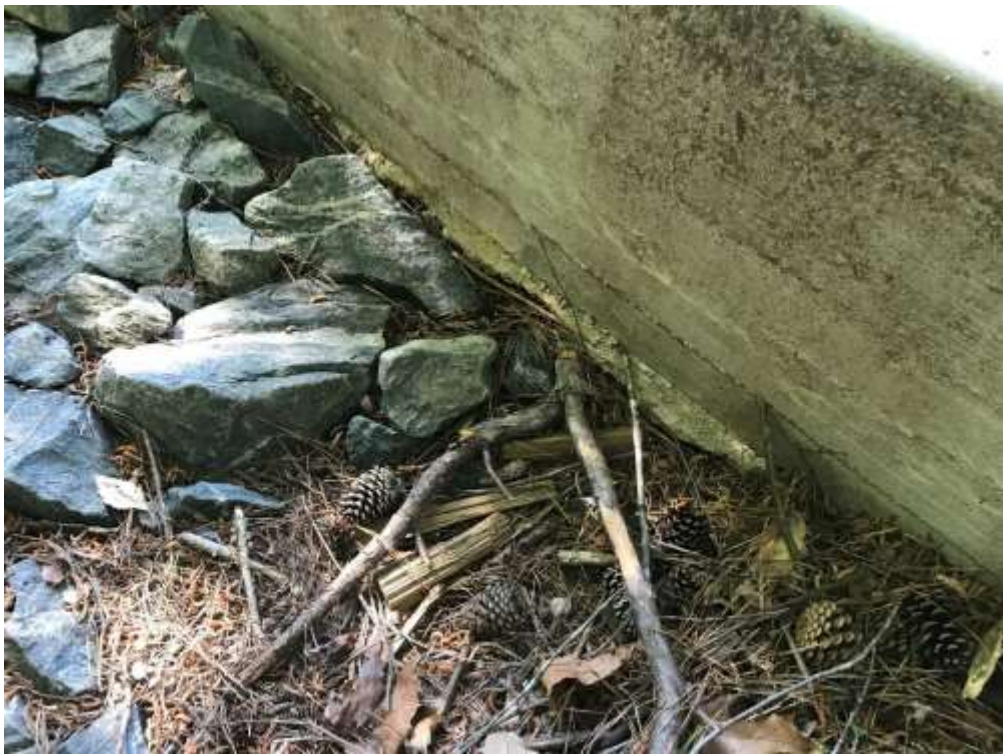
Photo No.
14

Storm water on the site drains via surface flow or via landscaped swales toward catch basins in the landscaped and paved areas. The common area drainage systems were in generally good to fair condition at the time of the inspection. A drainage swale with a concrete level lip is located adjacent to the tennis court, and rip rap is installed at the downstream end. The downstream end of the concrete level lip was slightly undermined, and we were unable to verify if a pipe/catch basin outlet exists in the swale. However, a clogged pipe was observed in the wooded area downstream of the swale. We recommend ensuring all pipes/catch basins in the drainage

Undermined section of
concrete in drainage
swale

systems are clear of debris and properly functioning to convey stormwater through the systems. We also recommend adding a suitable fill beneath the undermined section of the concrete level lip.

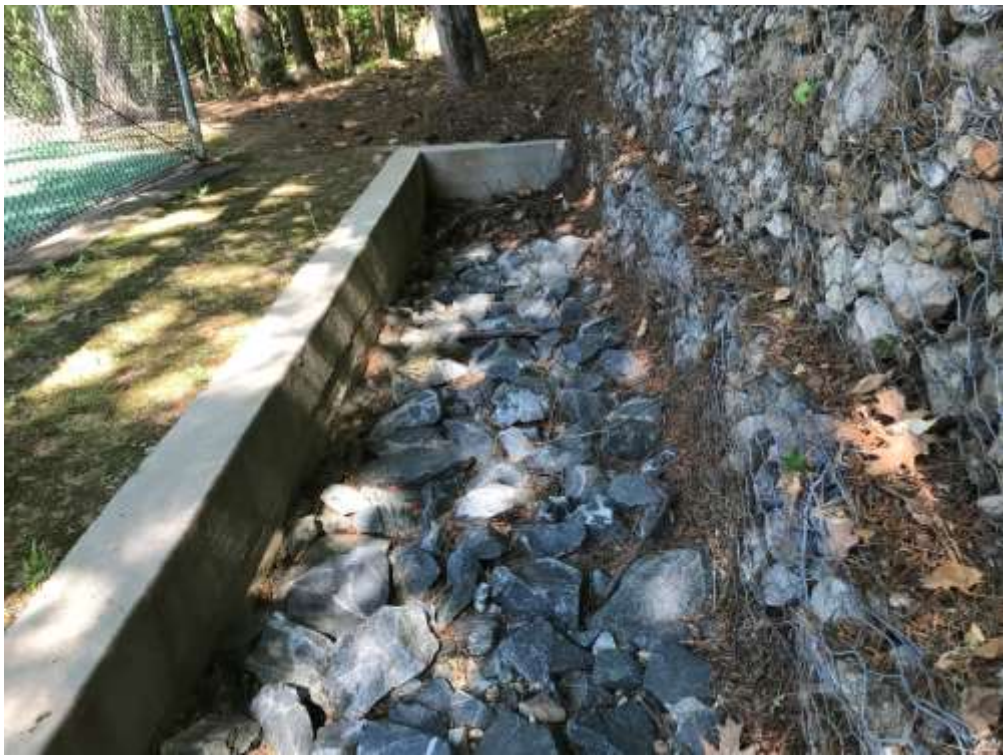
Photo No.
15

Assumed buried outlet
pipe/catch basin in
drainage swale

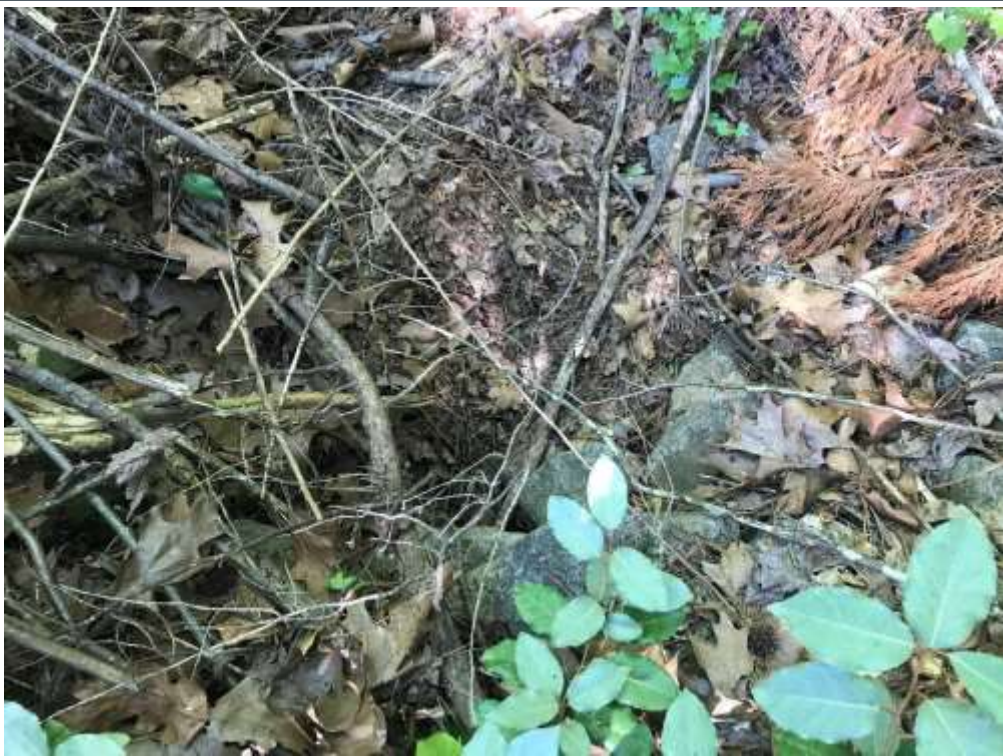
Photo No.
16

Outlet pipe in wooded
area filled with debris;
assumed from drainage
swale along tennis court

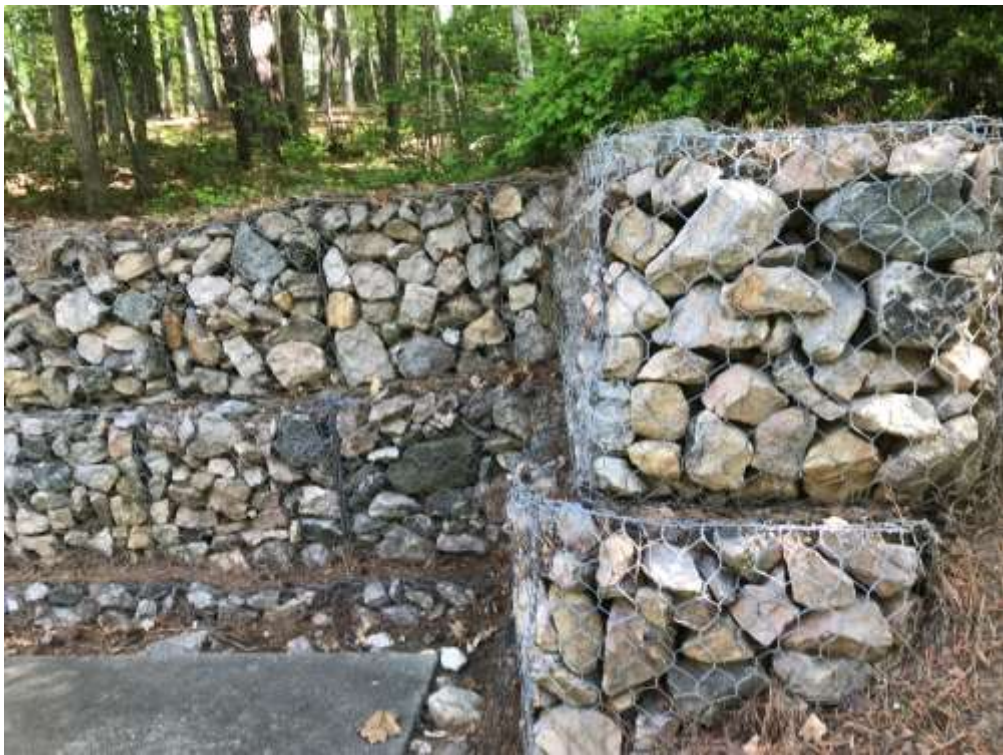
Photo No.
17

Gabion basket retaining walls are located at the amenity center near the end of the parking area and along the tennis court. While it is unlikely, failure of this wall would likely require a specialized solution as provided by a geotechnical engineer. It is assumed this type of failure and repair would be addressed through special assessments or other outside funding, due to the unpredictability and unlikelihood of failure. These walls

Gabion basket retaining wall

typically provide a useful life of 40+ years before significant repairs are required. We recommend adding funding for eventual repairs as a part of a future reserve study update. We recommend monitoring the walls periodically for signs of movement/structural concerns in the interim.

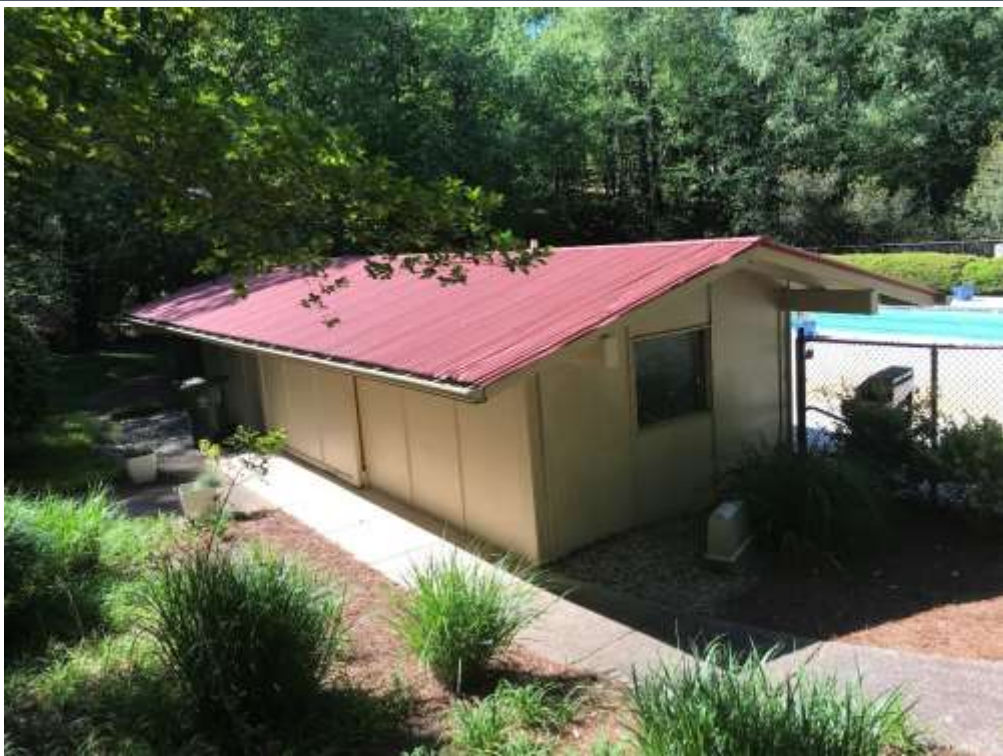
Photo No.
18

View of pool building

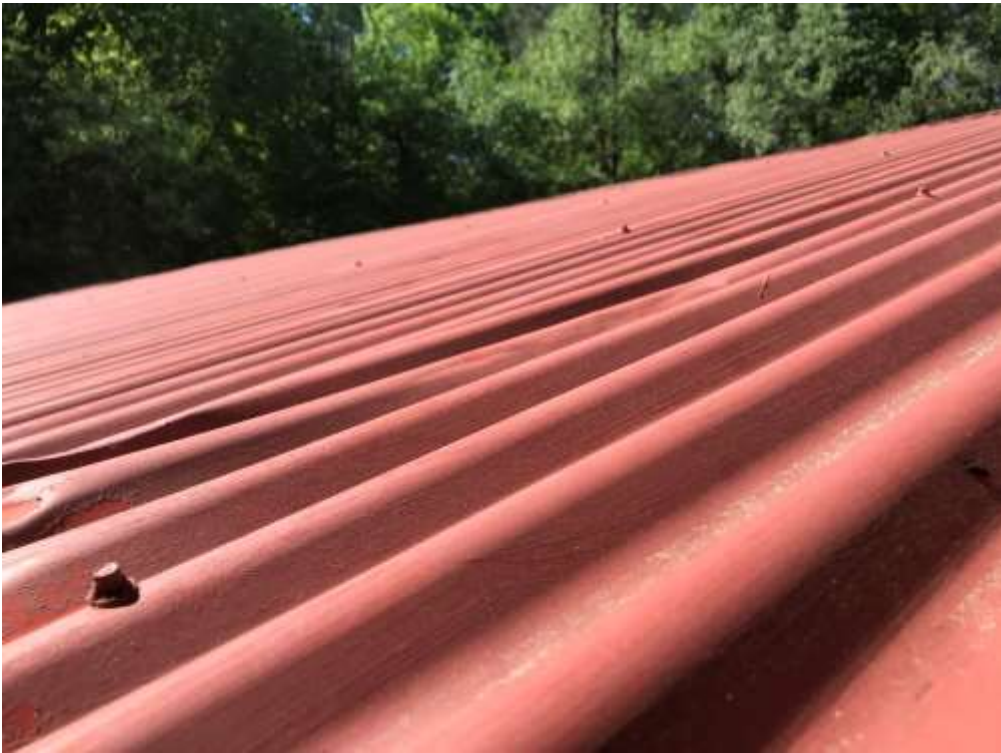
<p>Photo No.</p> <p>19</p>

The predominant pitched roof surfaces over the pool and equipment buildings are covered in metal paneling. Typically, this type of roofing will last 40 years or more if properly maintained. Minor damages were observed around edges, though the roof was in overall good condition. Eventually, the metal panels will corrode and fasteners will wear, and the roof will require replacement. We strongly recommend that any re-roofing project closely follow procedures outlined by the National Roofing Contractors Association's *Roofing and Waterproofing Manual*. A re-roofing sequence should include removal of the existing roofing material, replacement of any inadequate roof sheathing, damaged flashing, and drip edge components. We have provided an allocation of funds to replace the pool and equipment building roofs in 2035. It is likely that minor roofing repairs will be required in the interim, including replacement of exhaust vent boots and minor flashing repairs. We have assumed these types of repairs will be funded from a general operating budget.

<p>Description</p> <p>Pool building roof with minor dents</p>

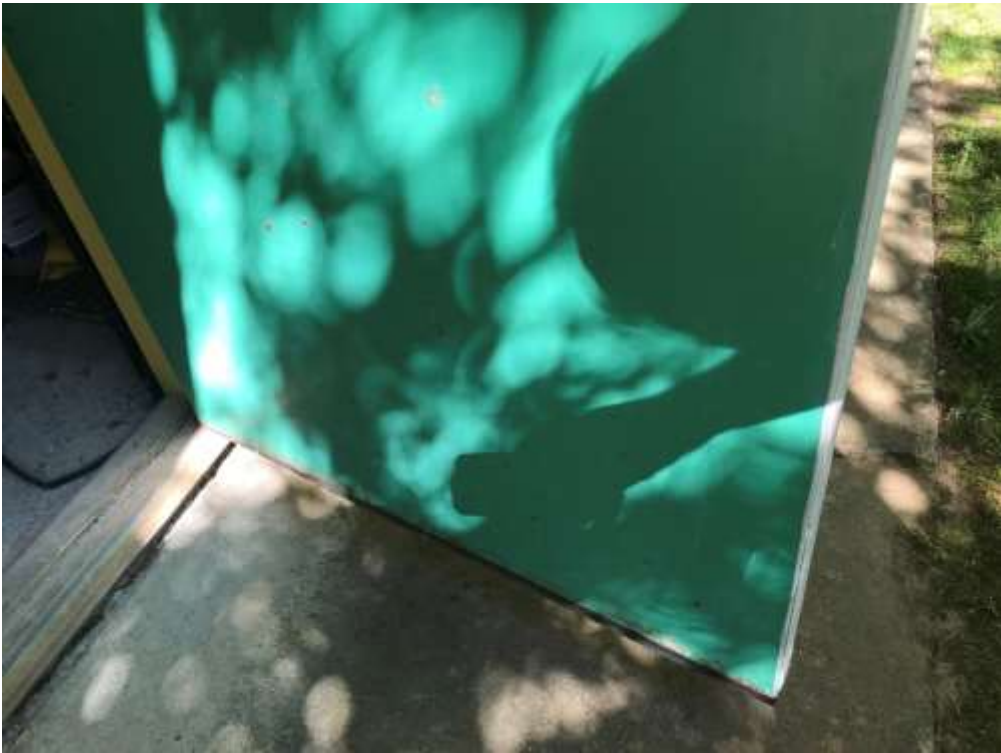
<p>Photo No.</p> <p>21</p>

<p>Description</p> <p>Deterioration in mechanical room door</p>

The pool building includes sliding exterior gate doors at the front and rear, a metal gate at the front, and metal-skin exterior doors for the restrooms and equipment building. The doors were operable and appeared to be in good to fair condition. The pump and chemical room door will tend to wear faster due to exposure to the chemical elements. We recommend replacing the pump and chemical room door on an approximately 15-year cycle beginning in 2032. We have also provided an allocation of funds to replace the restroom doors at the pool building on an approximately 30-year cycle beginning in 2040. We assume repairs to the hardware

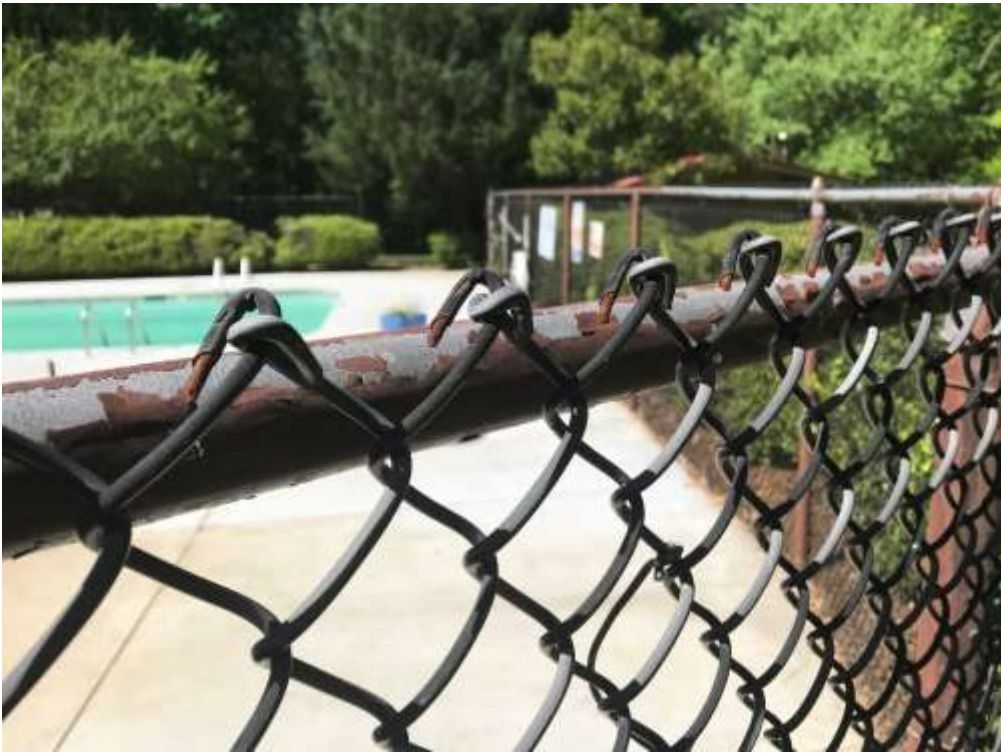
Photo No. 24

The fencing around the pool is comprised of a painted/coated chain link fence that appears to be original to construction. Significant flaking paint was observed, though the fence was generally plumb and in fair structural condition. However, due to the deterioration in the finish, we have allocated funds to replace the pool fencing on an approximately 30-year cycle beginning in 2025 with anodized aluminum fencing based on cost information provided.

Description Chain link fence around pool with flaking paint

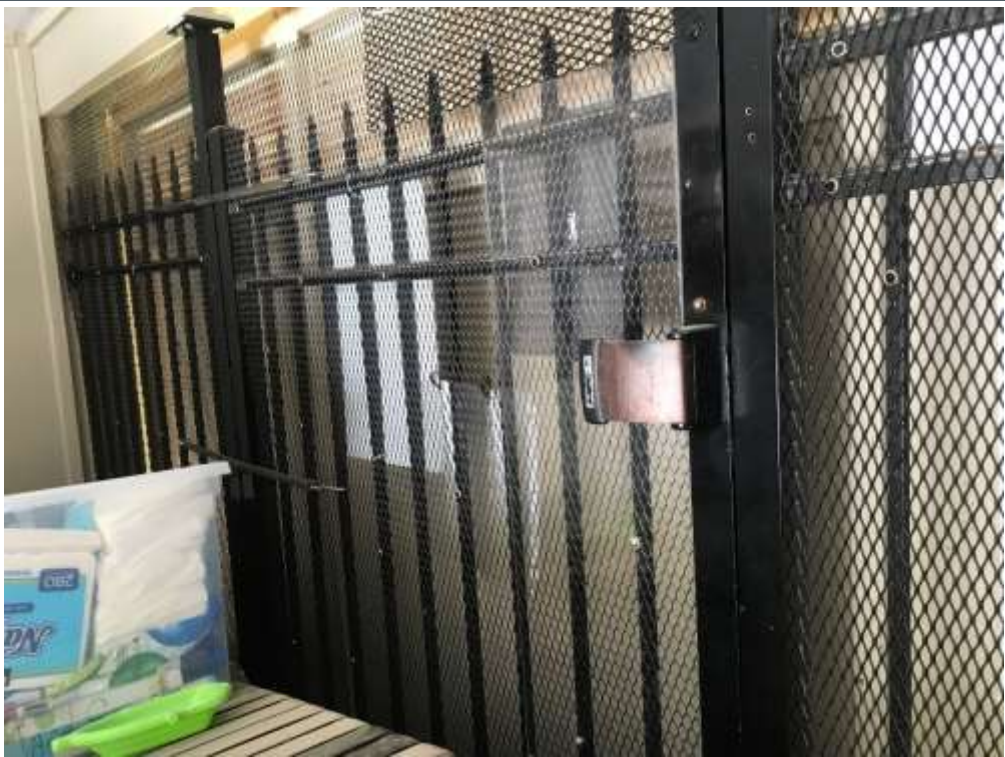
Photo No.
25

Pool building entry gate

The pool area includes a locking access gate behind the front sliding door. These types of systems are typically repaired/upgraded every 8-12 years, and we have allocated funds for repairing/upgrading the access control systems on a 10-year cycle beginning in 2030.

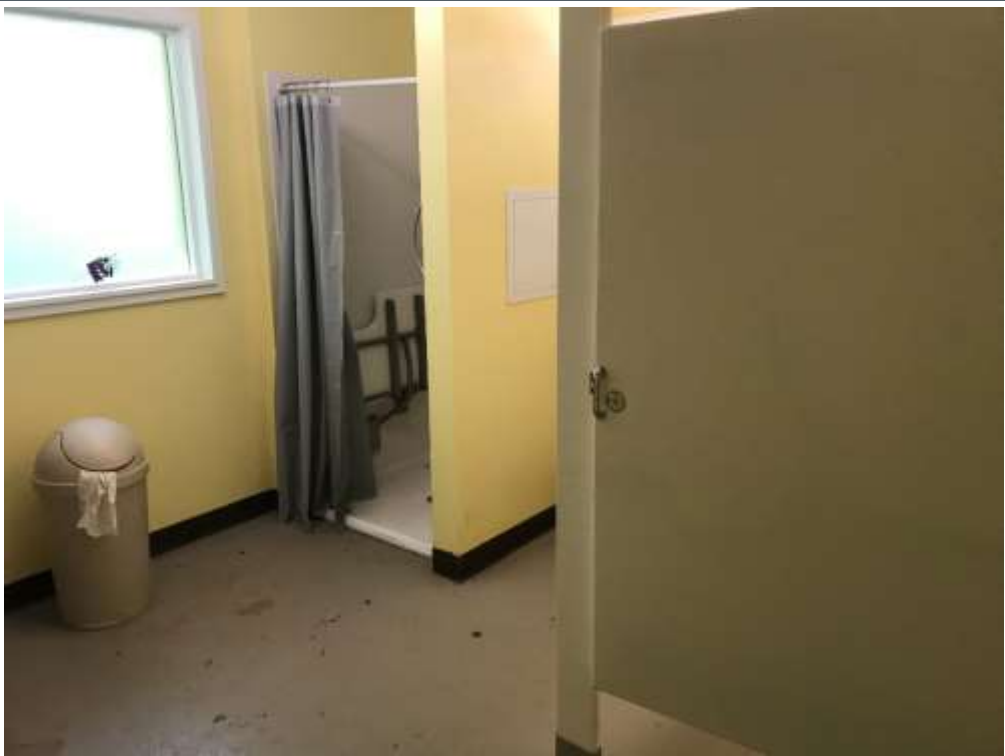
Photo No.
26

Typical pool building
restroom

The pool building includes two restrooms that each include painted/coated flooring, painted metal partition walls, toilets, and sinks. The walls are covered in painted gypsum wallboard with wood baseboards. We assume interior painting of the restrooms will be funded from an annual maintenance budget, as needed. Over time, the restrooms will require refurbishment, which may include replacing partitions, fixtures, and plumbing components. Per the previous study provided, the fixtures were replaced around 2012. We have provided an allocation of funds to refurbish the pool building restrooms on an approximately 25-year cycle beginning in 2037.

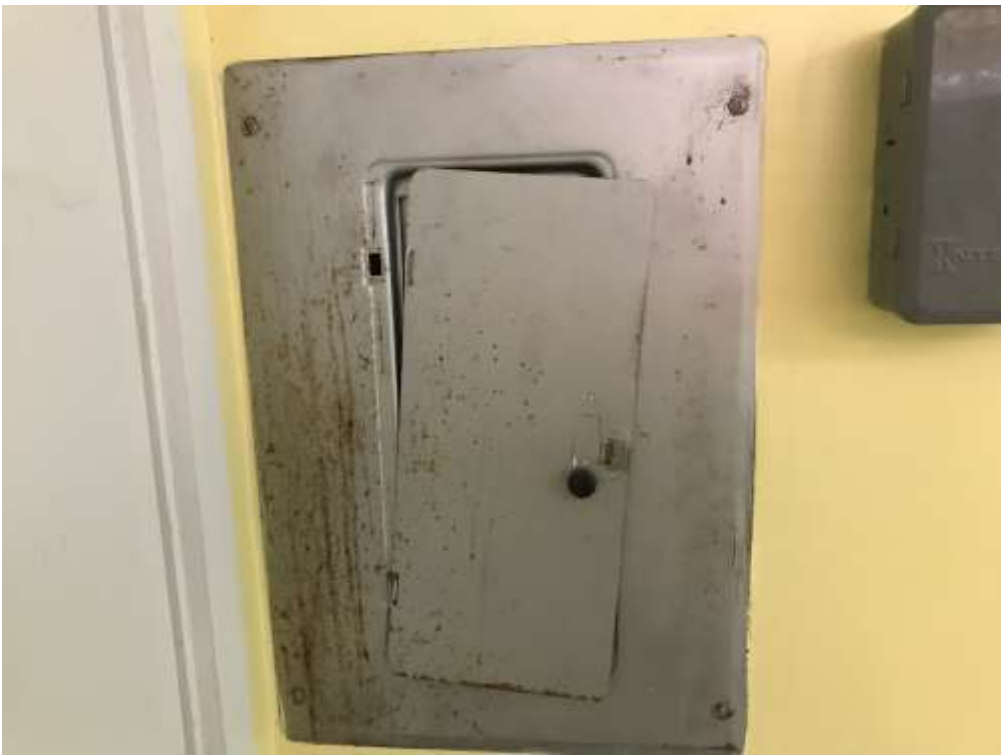
Photo No.
27

Building and pool area electrical and plumbing systems were functional during our inspection. Corrosion was observed on the panel in the pool pump building, and the panel door was detaching from the panel in the pool restroom building. We assume the panel door will be reattached for safety using funds from a general maintenance budget. These systems generally have an expected useful life of approximately 40+/- years. However, we have provided an allocation of funds in 2030 for long term repairs to these systems. This would likely include replacing breaker panels, repairing electrical wiring, and replacing sections of plumbing supply and waste piping as needed.

Electric panel door
hanging off in restroom

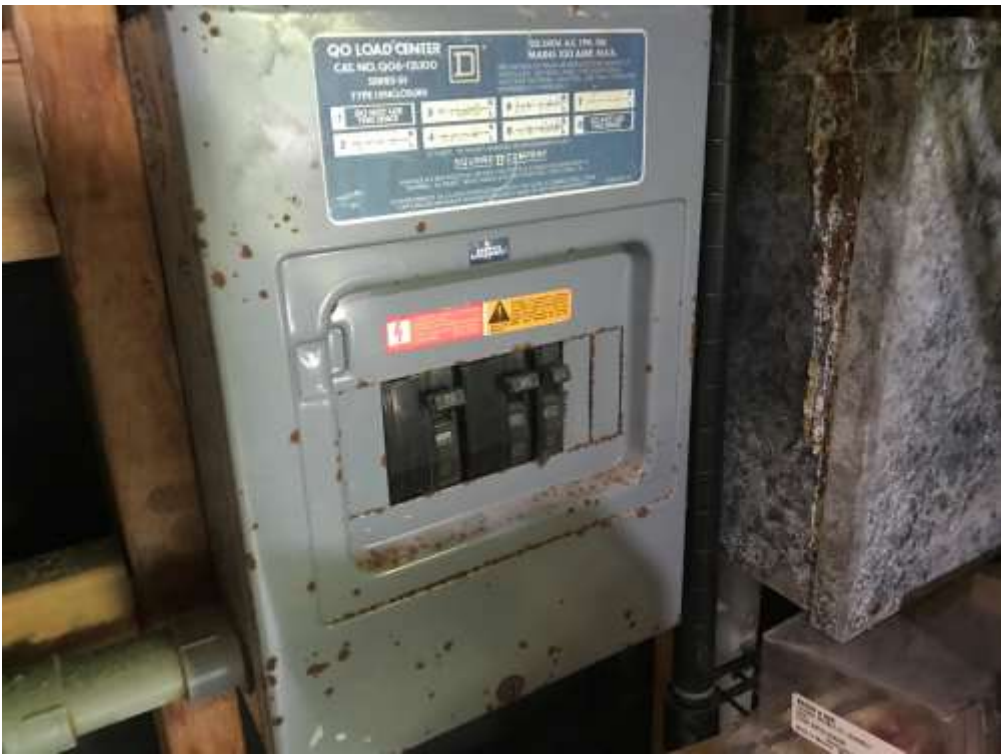
Photo No.
28

Minor corrosion in
equipment building
electrical panel

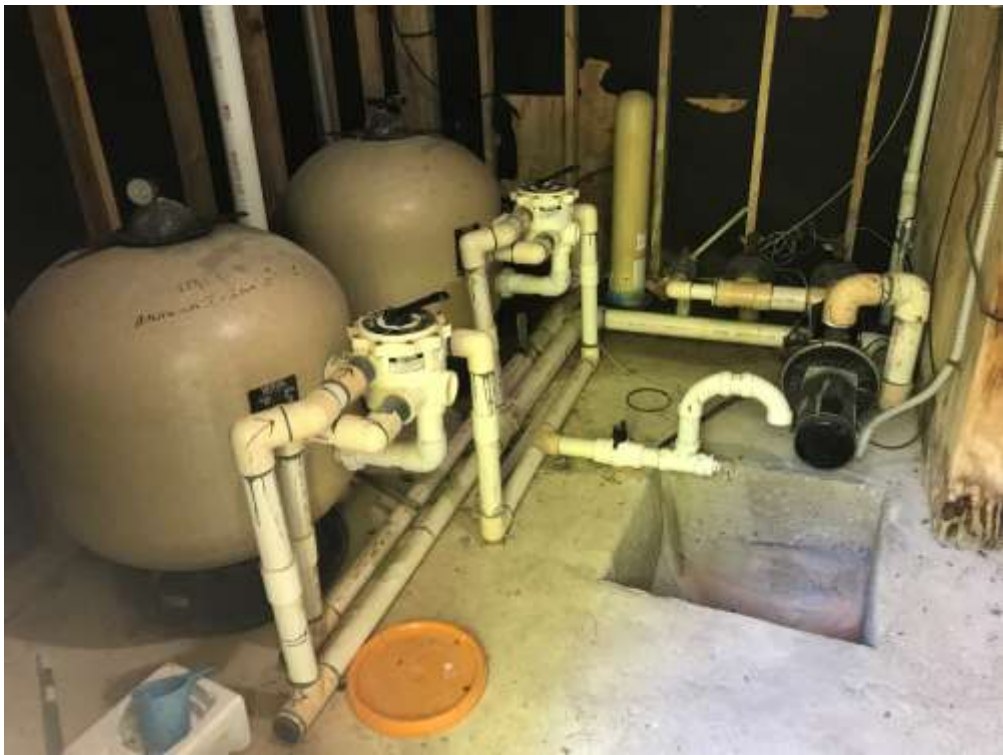
Photo No.
29

Pool pump and filtration equipment

The pool pump and filtration room includes a 3-horsepower pump for the swimming pool and two Triton sand filters. Pool pump and filtration equipment is typically replaced as components fail. The sand in the filters typically requires replacement on an approximately 5-year cycle. We have provided an allocation of funds to replace portions of the pool pump and filtration equipment on an approximately 3-year cycle beginning in 2026.

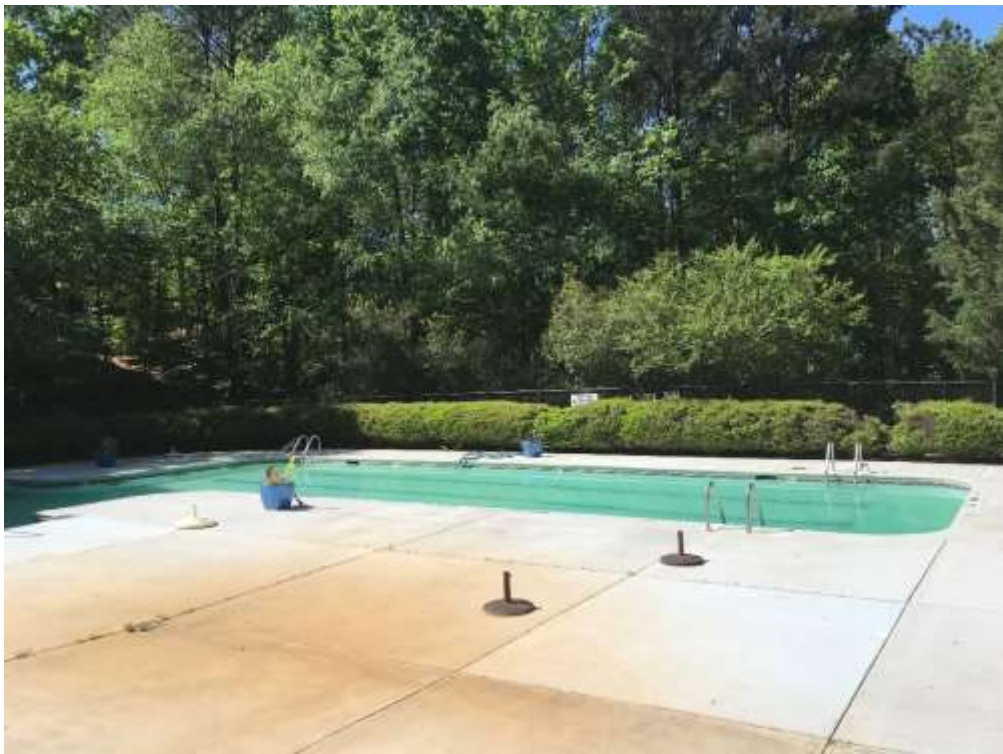
Photo No.
30

View of swimming pool

The swimming pool was filled at the time of the site visit, and inspection of the surfaces was limited. Based on the previous reserve study, the pool was resurfaced in approximately 2014. Pools typically require resurfacing on an approximately 10- to 15-year cycle. We have allocated funds for resurfacing the pool on a 12-year cycle beginning in 2027. This would include draining the pool, removing damaged/delaminated plaster work, repairing waterline tile, and re-plastering the pool surface (possibly quartz plaster). We assume pool ladders and rails will be replaced using funds from an annual maintenance budget, as needed.

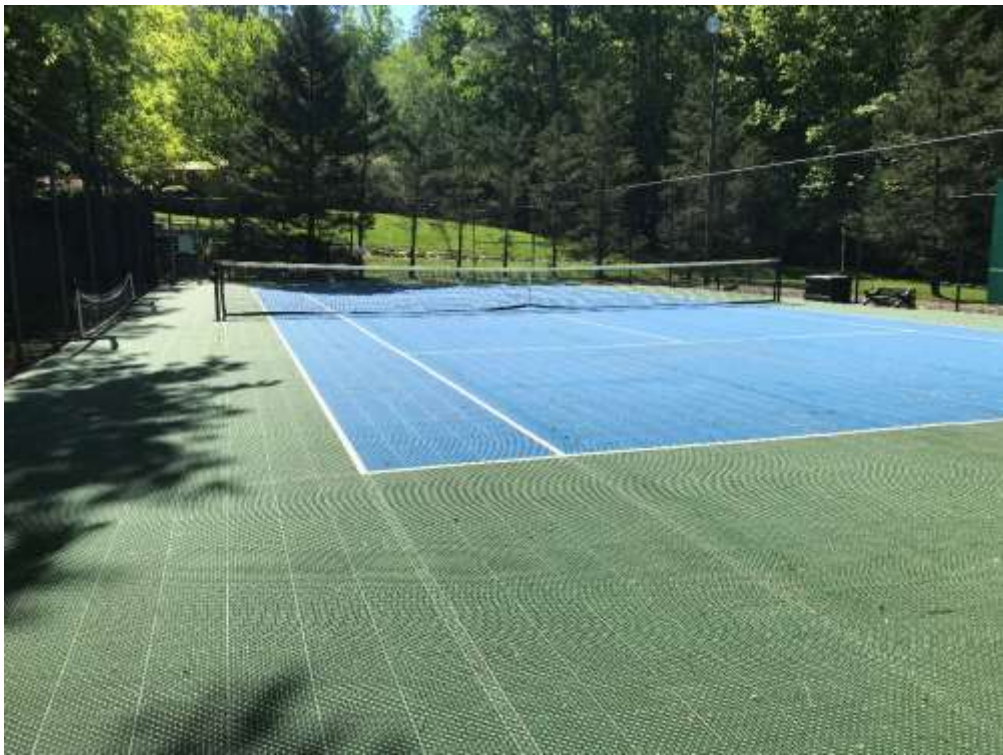
Photo No.
33

The association is also responsible for a tennis court comprised of a composite tile surface and chain link perimeter fencing. Based on the previous reserve study, the tennis court fencing is reportedly original to construction, and the tiles were installed in approximately 2013. Both components appear to be in generally good condition. We have allocated funds to replace the tile surface and chain link fencing on a 20-year cycle beginning in 2033. Note, resurfacing costs can vary significantly depending on condition of the underlying asphalt beneath the tiles. If full depth repairs or full reconstruction are deemed required upon removal of the tiles, the cost can increase significantly.

Composite tiles at tennis court

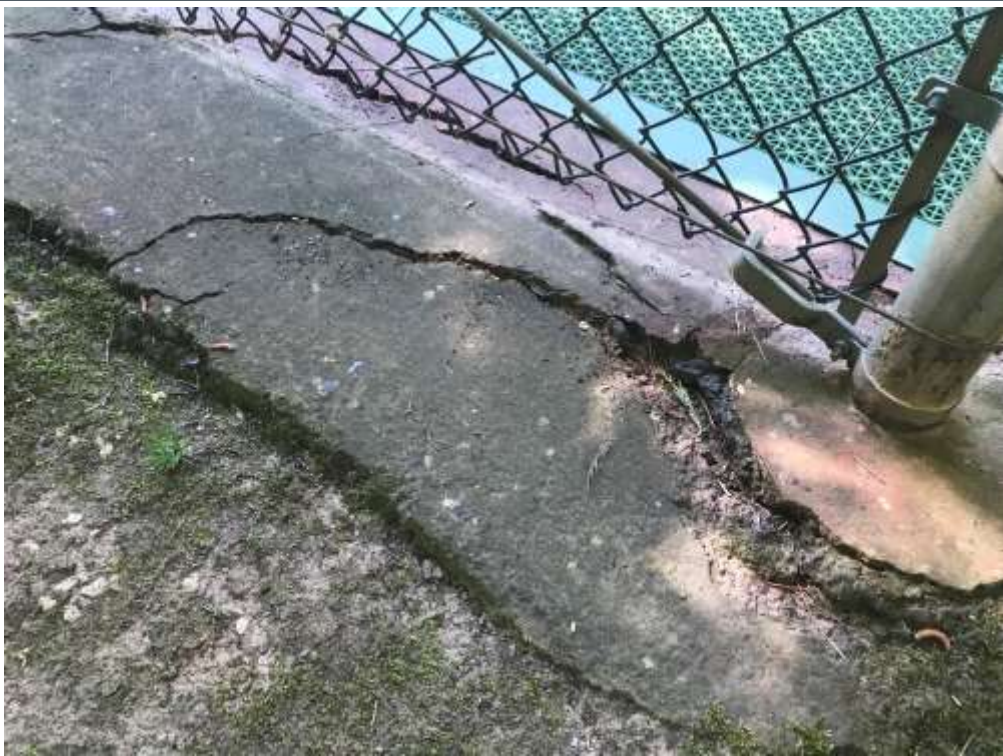
Photo No.
34

Pavement underlay at tennis court
