**WINDCREST COMMUNITY  
ASSOCIATION  
HOLLY SPRINGS, NC**

**DATE:  
OCTOBER 14, 2025**

**FULL RESERVE STUDY**

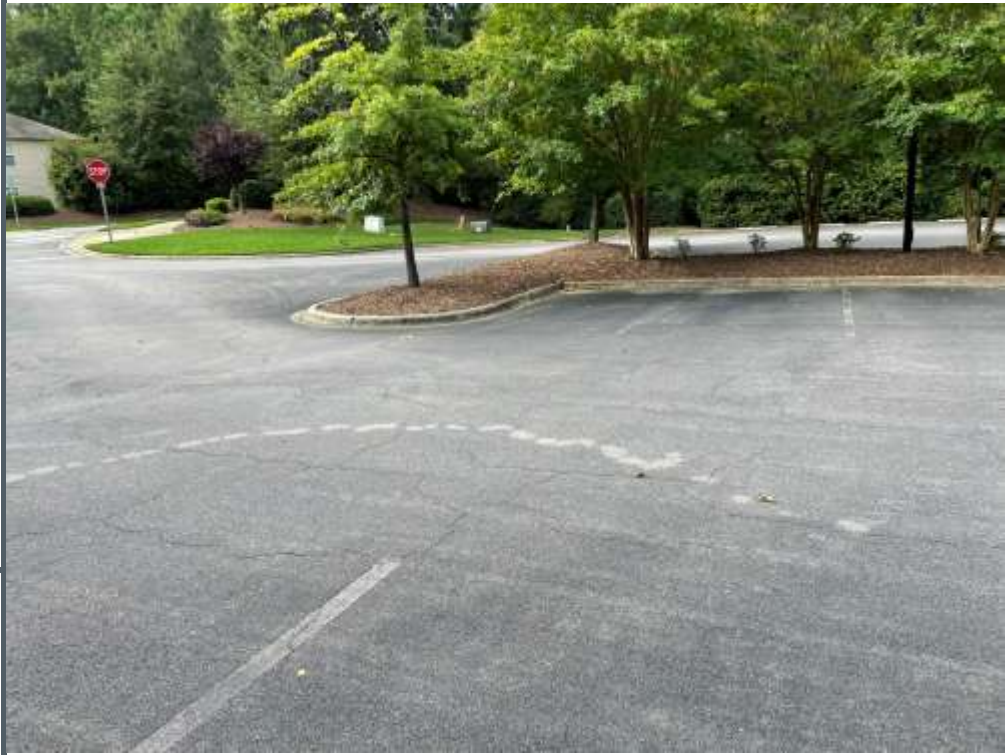
**Photo No.**  
**1**

Asphalt paved parking  
lot at amenity center.

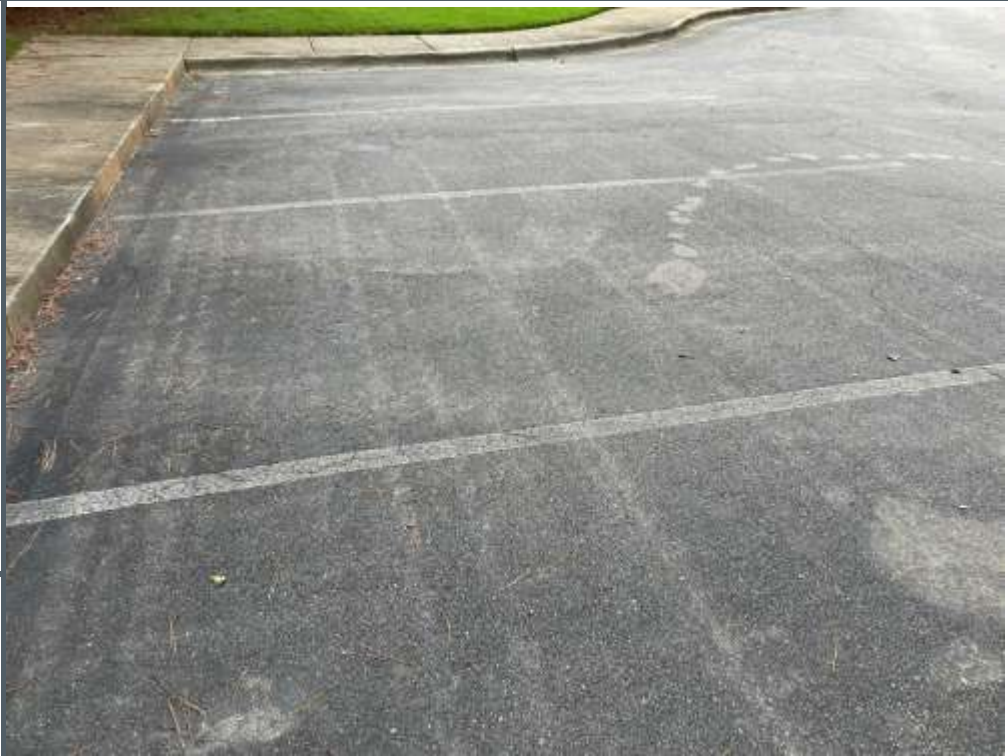
**Photo No.**  
**2**

Faded striping in parking  
lot.

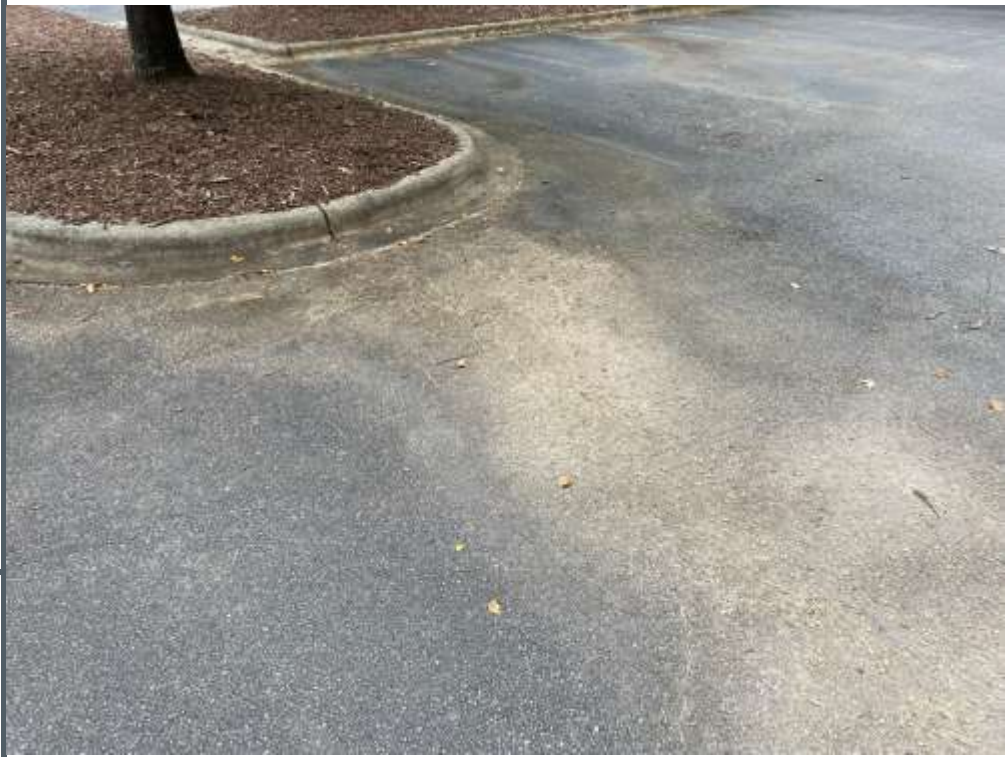
**Photo No.**  
**3**

Surface erosion in  
parking lot.

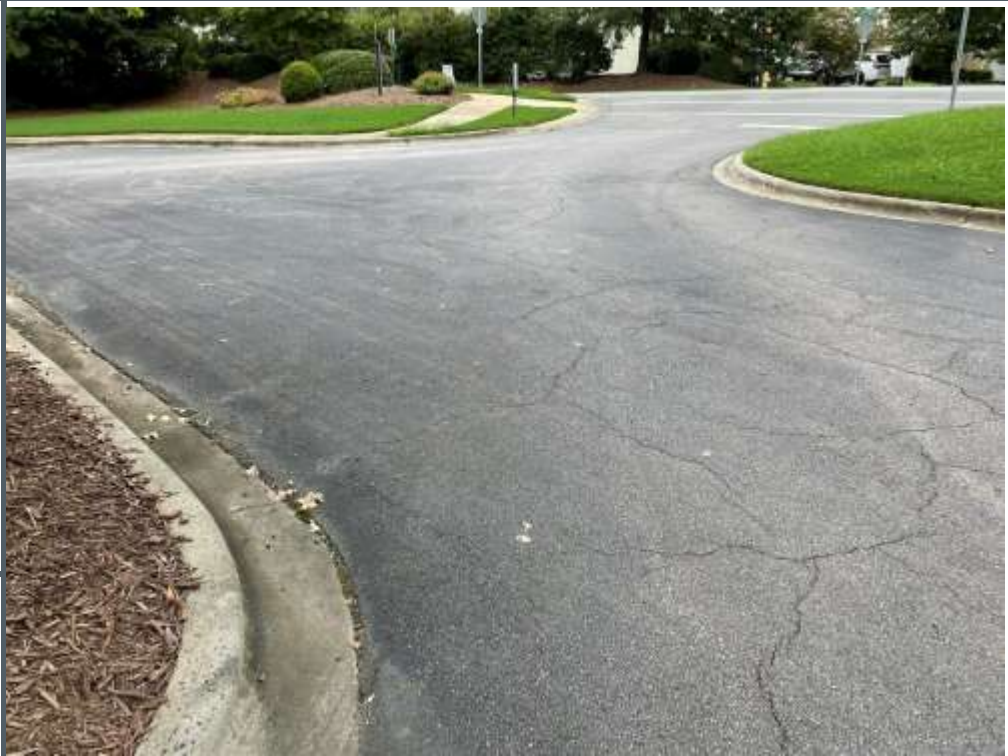
**Photo No.**  
**4**

Cracking in asphalt  
pavement.

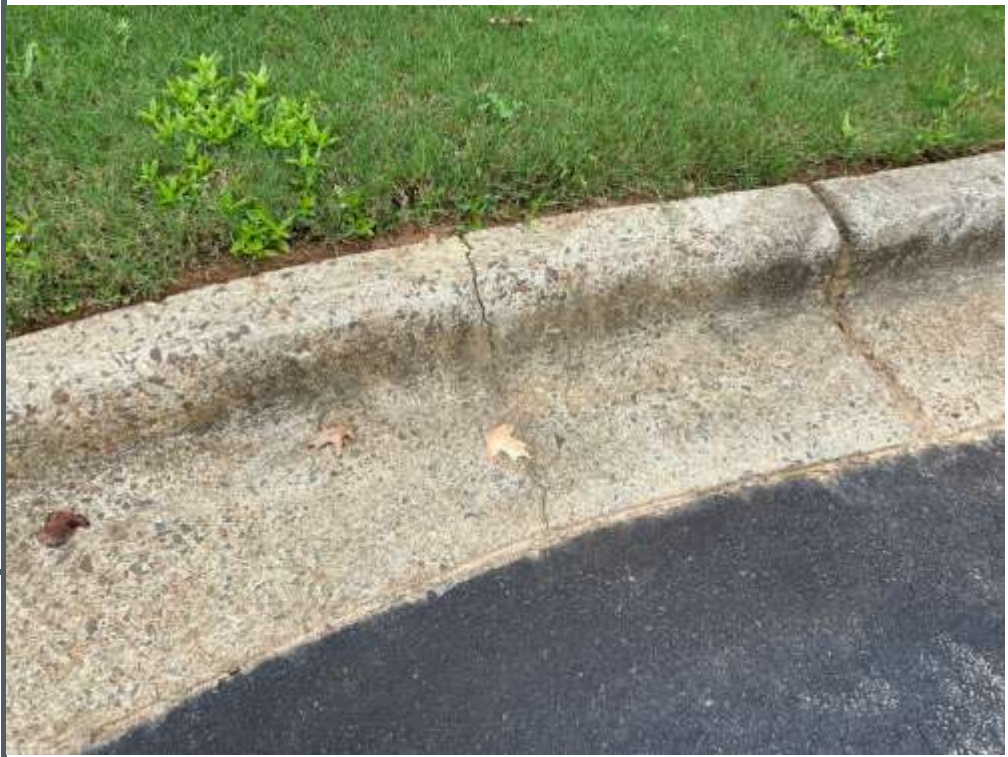
**Photo No.**  
**5**

The Association is responsible for maintaining the limited concrete curbing surrounding the parking lot at the amenity center. Additionally, the Association maintains the concrete flatwork which includes the concrete surfaces and sidewalks around the swimming pool area and on the amenity center grounds. We have assumed the curbing and sidewalks adjacent to public streets are maintained by the municipality. The concrete curbing and flatwork generally appeared to be in good condition with minor cracking noted. We have allocated funds for periodic repairs and/or replacement of concrete surfaces, as required, and have assumed that 5% of the concrete surfaces will require maintenance every 8 years beginning in 2031.

Cracking in concrete curbing.

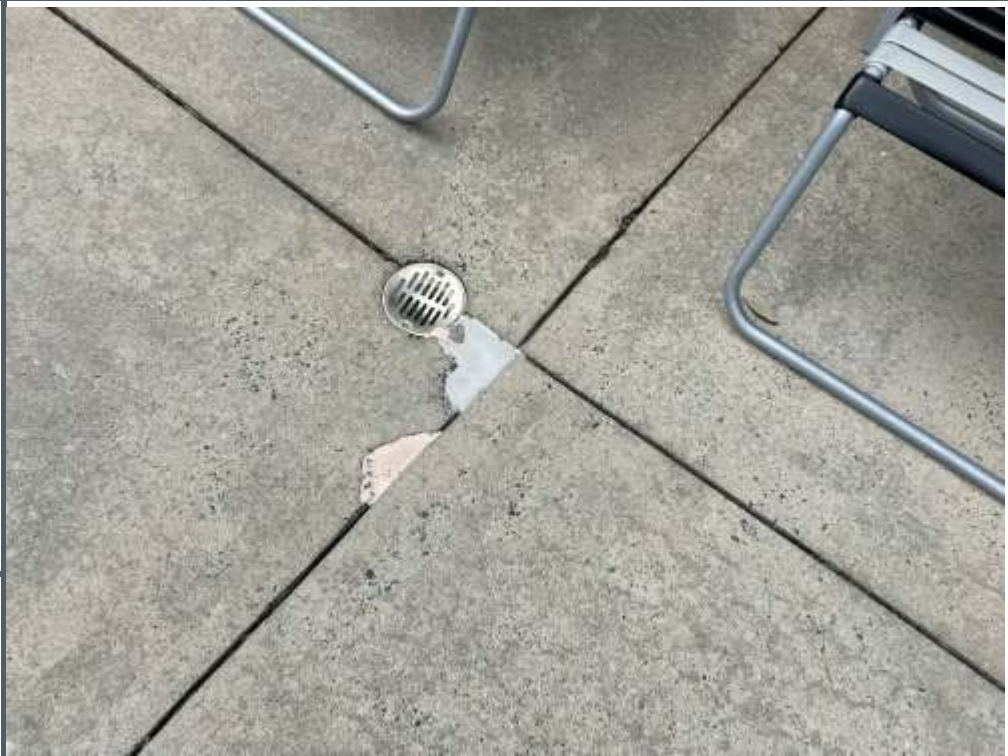
**Photo No.**  
**6**

Concrete deck repairs.

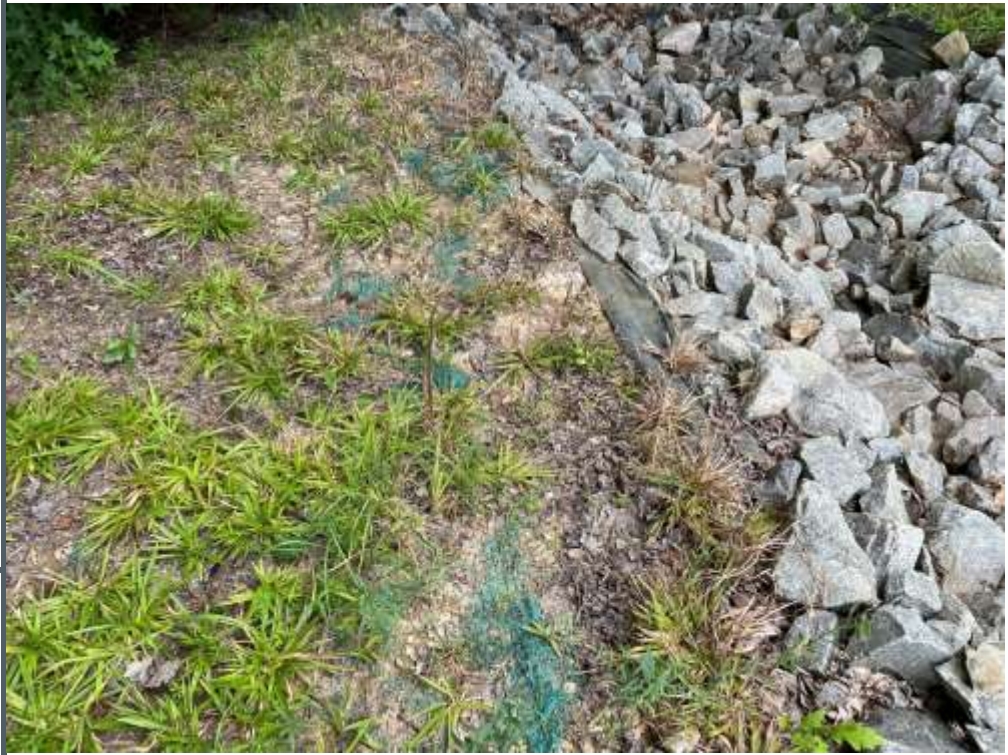
**Photo No.**  
**7**

Riprap armored swale with exposed landscape fabric.

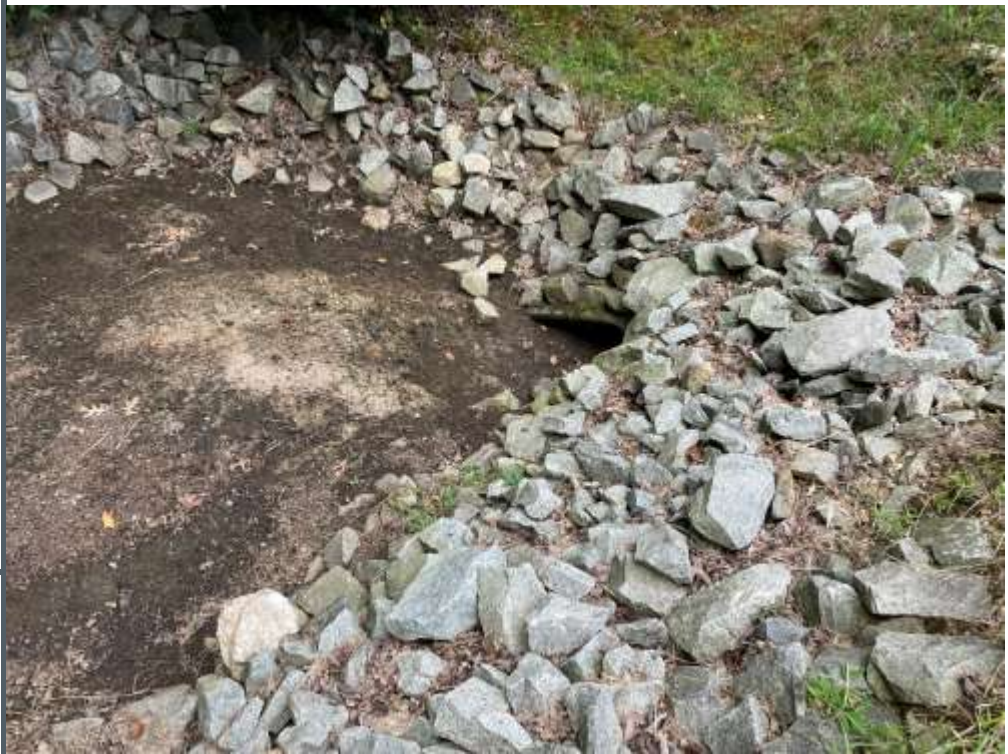
**Photo No.**  
**8**

Sediment buildup at outlet pipe.

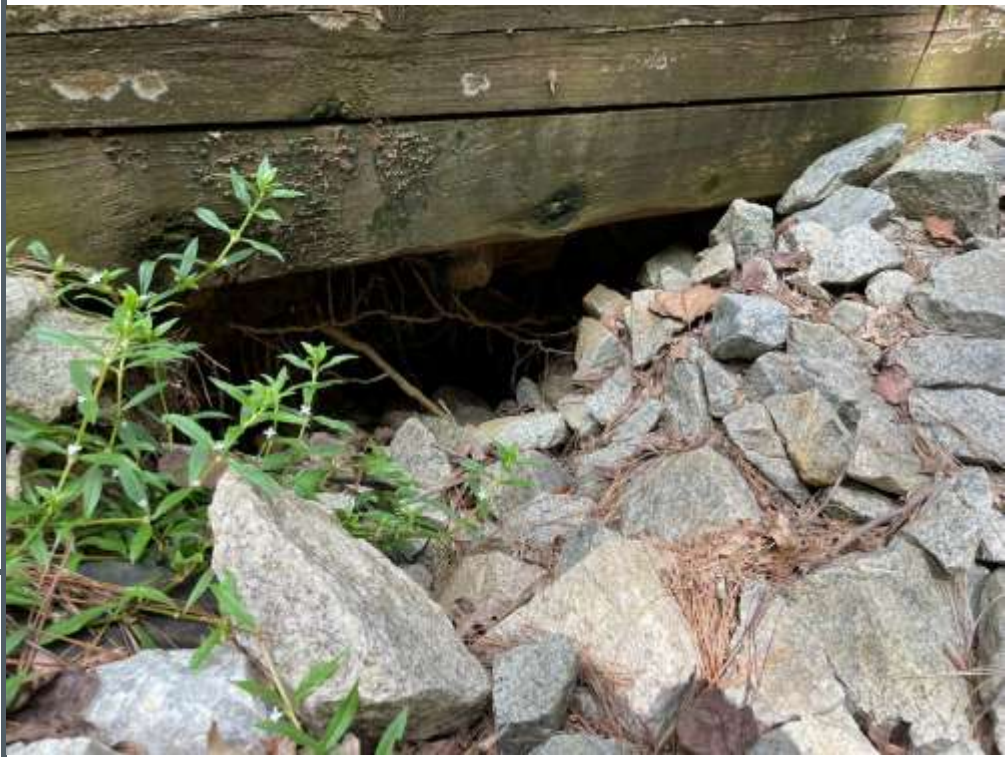
**Photo No.**  
**9**

Storm water on the site drains via surface flow or via landscaped swales toward catch basins in the paved and landscaped areas. Inlet grates in the roadway and the grassed areas collect stormwater that flows to the stormwater control measures (SCM) in the community via an underground piping system. The drainage systems were in generally good to fair condition at the time of the inspection with sediment build up noted in several outlet pipes and displaced riprap and exposed filter fabric within armored drainage swales. Additionally, we noted areas of erosion and undermined timbers in the drainage system behind 225-245 Apple Drupe Way.

Timber undermined  
behind 225 to 245 Apple  
Drupe Way.

We have allocated funds for drainage system repairs and improvements every 5 years beginning in 2026. Drainage improvements would likely include retrenching of swales to improve flow, inspection/maintenance of underground systems, installation and repair of riprap or turf reinforcement at inlets/outlets and on steep slopes, and installing French drains or other types of subsurface drainage systems. These types of repairs can be moderate (re-trenching swales, flushing pipes), to very expensive (new underground pipe systems). We have included a moderate budget to help cover these costs.

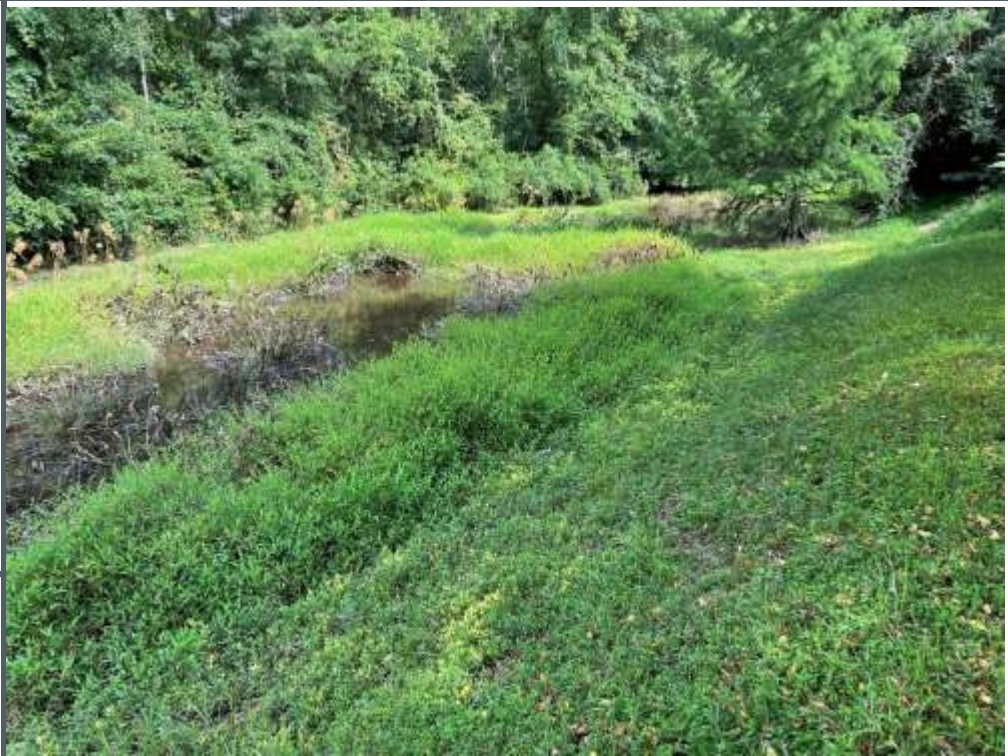
**Photo No.**  
**10**

The SCMs include what appears to be a constructed wetland device behind 100-120 Trayesan Drive. It appears the wetlands were constructed with a variable-depth pool and channel system with biodiverse vegetation plantings which are designed to filter sediment and naturally remove contaminants from collected stormwater while also regulating discharge rates through the outfalls. The wetlands will likely require partial reconstruction or major repairs/dredging to ensure proper functionality over the term. We have allocated funds for major repairs to the constructed wetland on a 20-year cycle beginning in 2026.

Constructed wetland  
device.

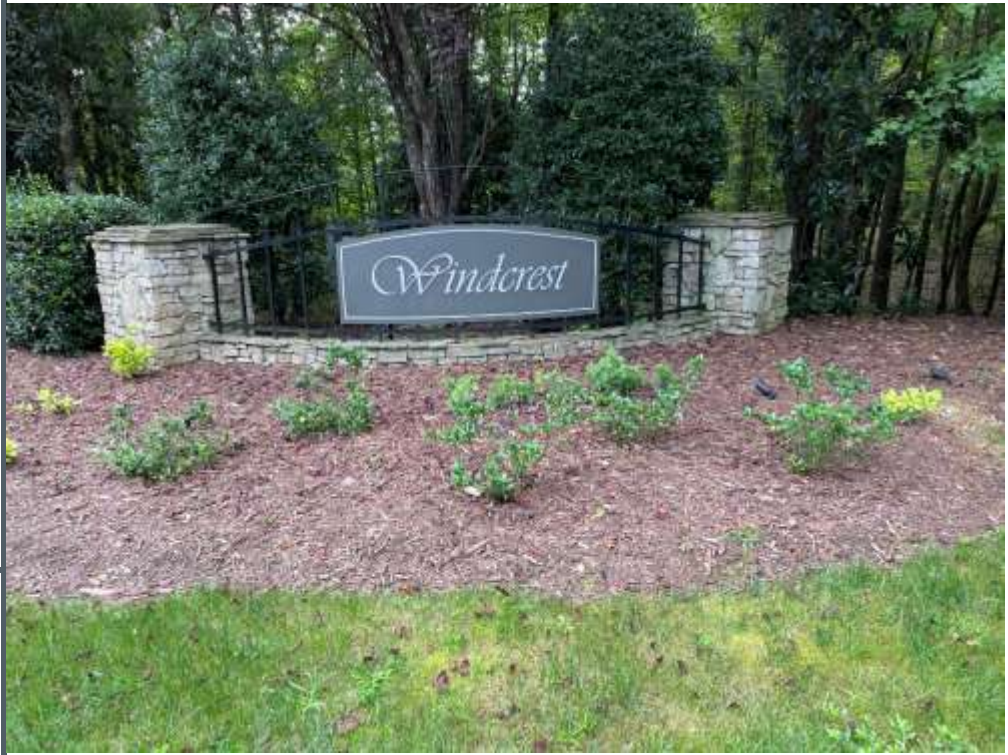
**Photo No.**  
**11**

Entrance monument.

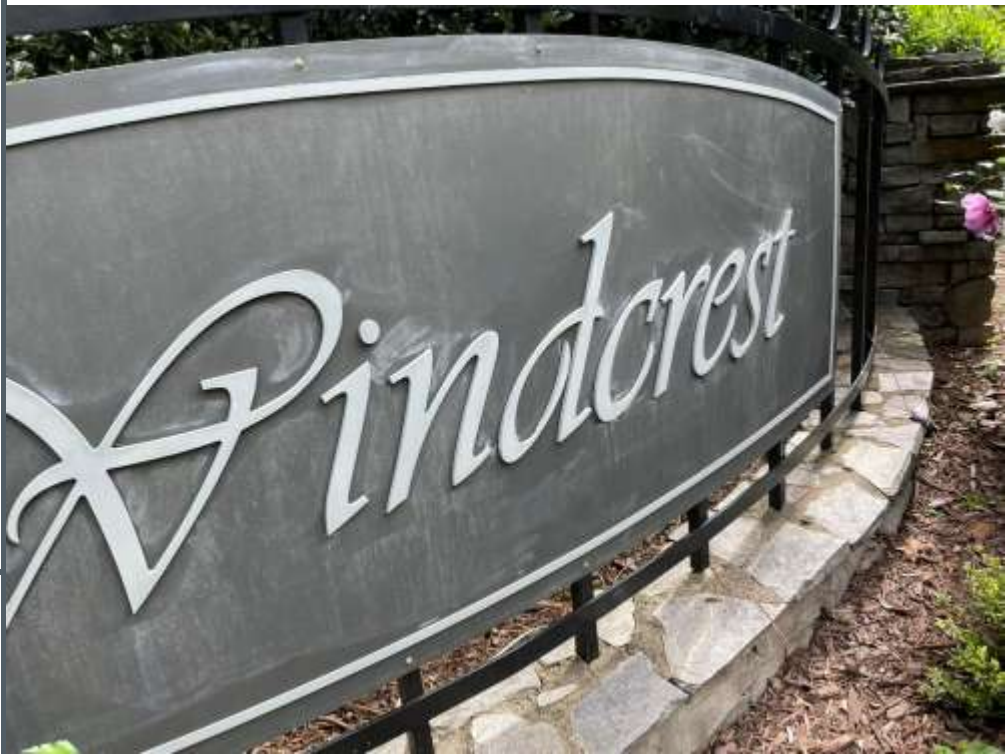
**Photo No.**  
**12**

Monument signage is located at the primary entrance to the community and generally consists of stone veneer masonry monument walls with metal fencing and signs bearing the community's name. The monuments are located in a landscaped bed with irrigation and uplighting. Stone veneer piers are located at the secondary entrance off N. Main Street at Crossway Lane. We noted fading on the metal signs and a missing sign inlay on the stone veneer piers at the Crossway Lane entrance. We do not anticipate a large-scale replacement project of the monuments; however, refurbishment may be periodically required. Refurbishment generally includes replacement/repairs of the signage, fence painting, and repairs to the stone veneer structures. We have included an allocation of funds for repairs to the monuments every 12 years beginning in 2027.

Faded metal entrance sign.

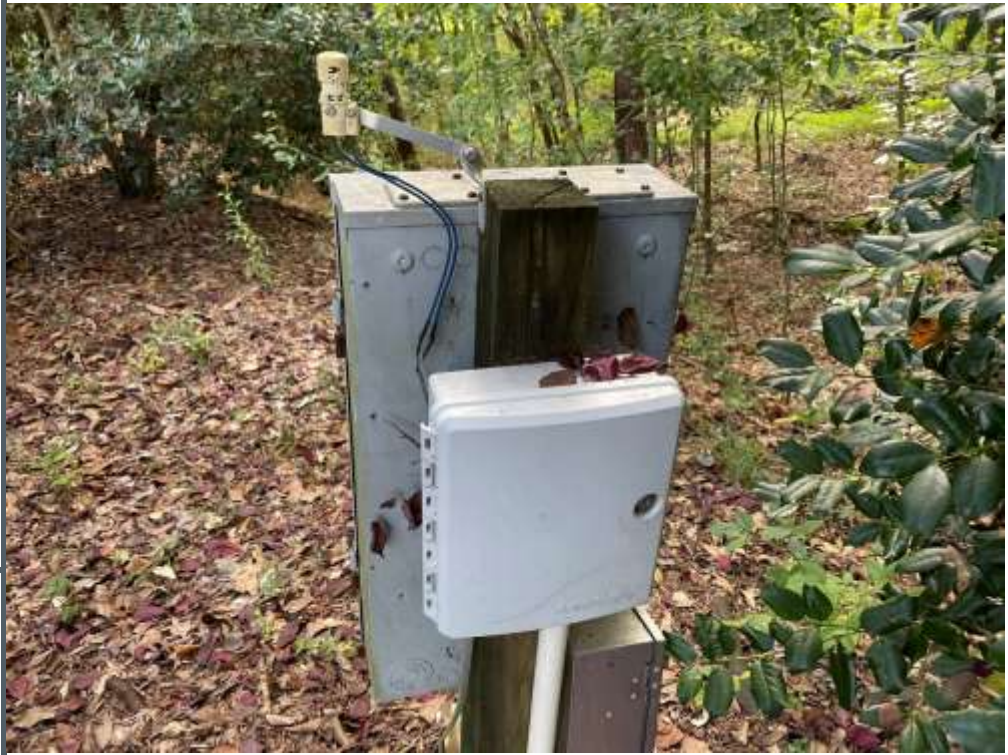
**Photo No.**  
**13**

Irrigation control box.

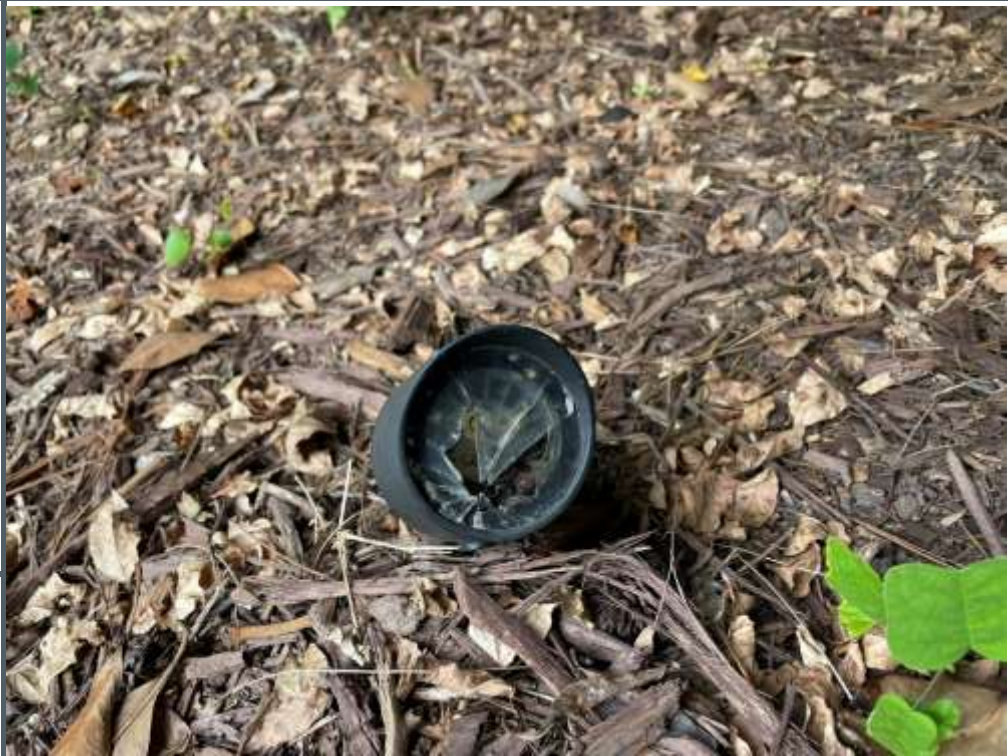
**Photo No.**  
**14**

Landscape irrigation and lighting systems are installed at the primary entrance to the community. The lighting and irrigation systems generally appeared to be in good to fair condition with aging irrigation components and damaged uplights noted. We have included funds to upgrade lighting components, replace the controllers, timers, pumps, and make valve repairs to the existing irrigation systems, as necessary, every 12 years beginning in 2027. We have assumed minor repairs (irrigation head replacement, pipe repairs, bulb replacement, etc.) would be funded from an annual maintenance budget.

Damaged landscape  
uplight.

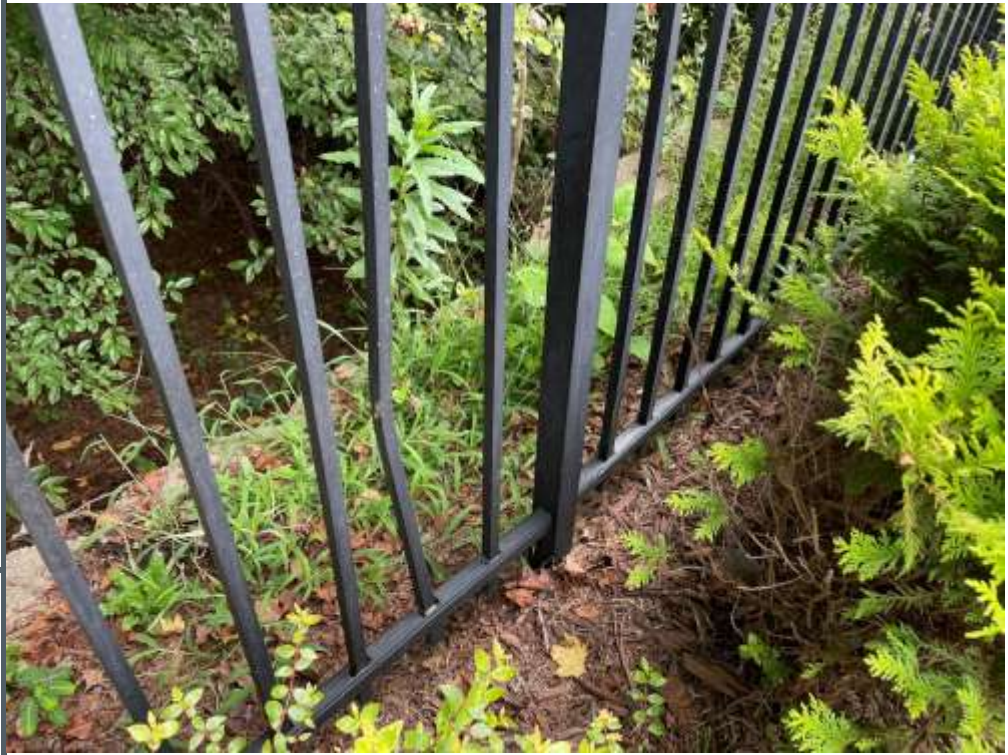
**Photo No.**  
**15**

Aluminum fencing was installed around the pool deck and above the retaining walls and generally appeared to be in good condition. At the time of the inspection, we observed limited areas of damage to the fencing which generally consisted of bent railings, missing post caps, and bent pickets. The aluminum fencing has an expected useful life of approximately 40 years and we have allocated funds for replacement in 2045. We have assumed painting and minor repairs to the aluminum site fencing will be funded from the operating budget.

Minor damage to  
aluminum fencing.

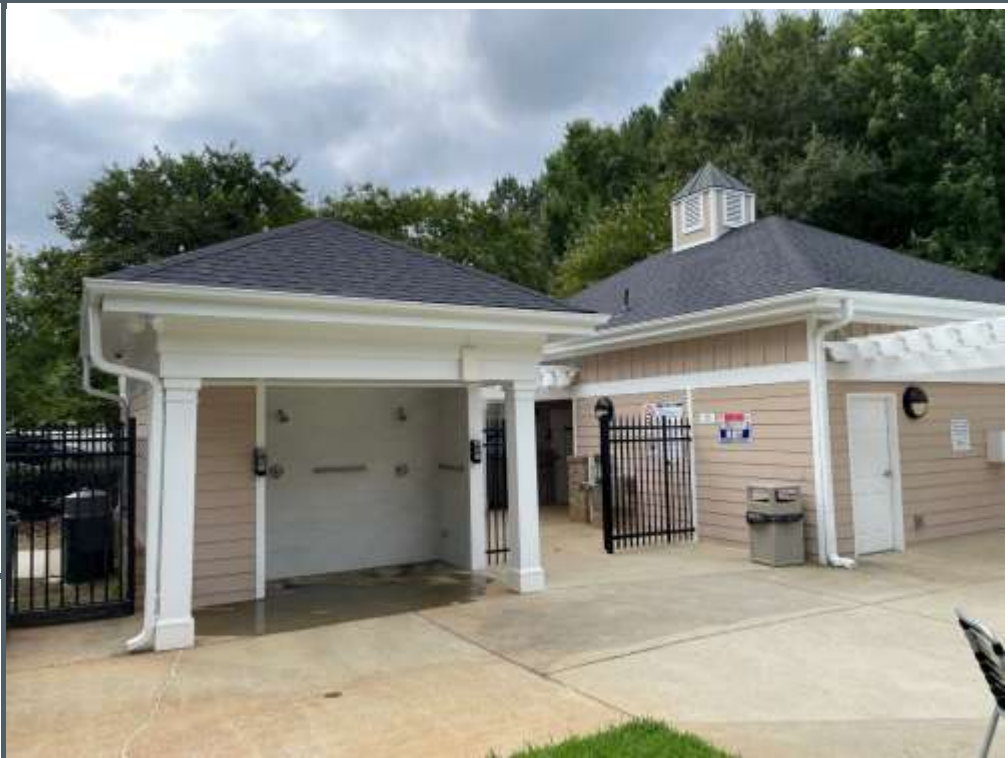
**Photo No.**  
**16**

The pitched roof surfaces of the amenity center buildings are covered in architectural grade asphaltic fiberglass shingles. Gutters and downspouts are installed and discharge stormwater to grade or to pipe extensions. Roof surfacing is applied over plywood roof sheathing and appears to be in good condition. Assuming minor repairs are performed in the interim, we estimate the shingled roofing surfaces to have an expected useful life of approximately 20 to 25 years. We have included funds to replace the building roofs in 2045.

Pool building roof.

We strongly recommend that any re-roofing project closely follow procedures outlined by the latest edition of the National Roofing Contractors Association's *Roofing and Waterproofing Manual*. A re-roofing sequence should include removal of the existing roofing material, replacement of any inadequate roof sheathing, replacement of any damaged flashing, and replacement of drip edge components. Periodic minor repairs to the vent boots, flashing and gutters will likely be required in the interim prior to full roof replacement. Minor repairs to correct roof leaks in the interim will also likely be required on an annual basis.

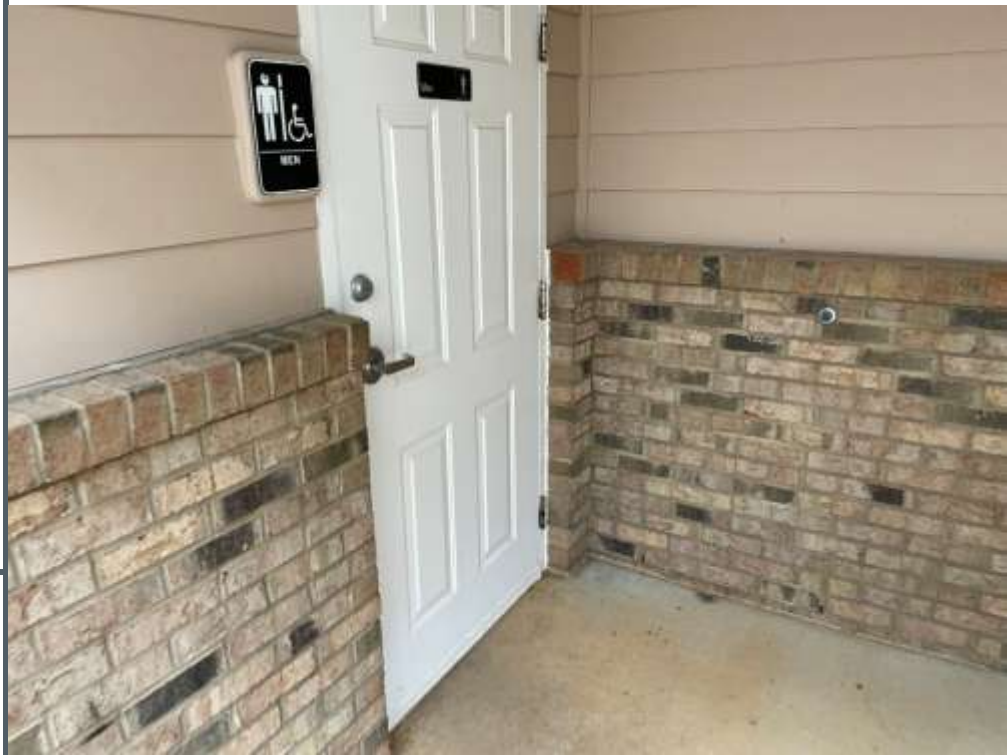
**Photo No.**  
**19**

Metal pool building  
door.

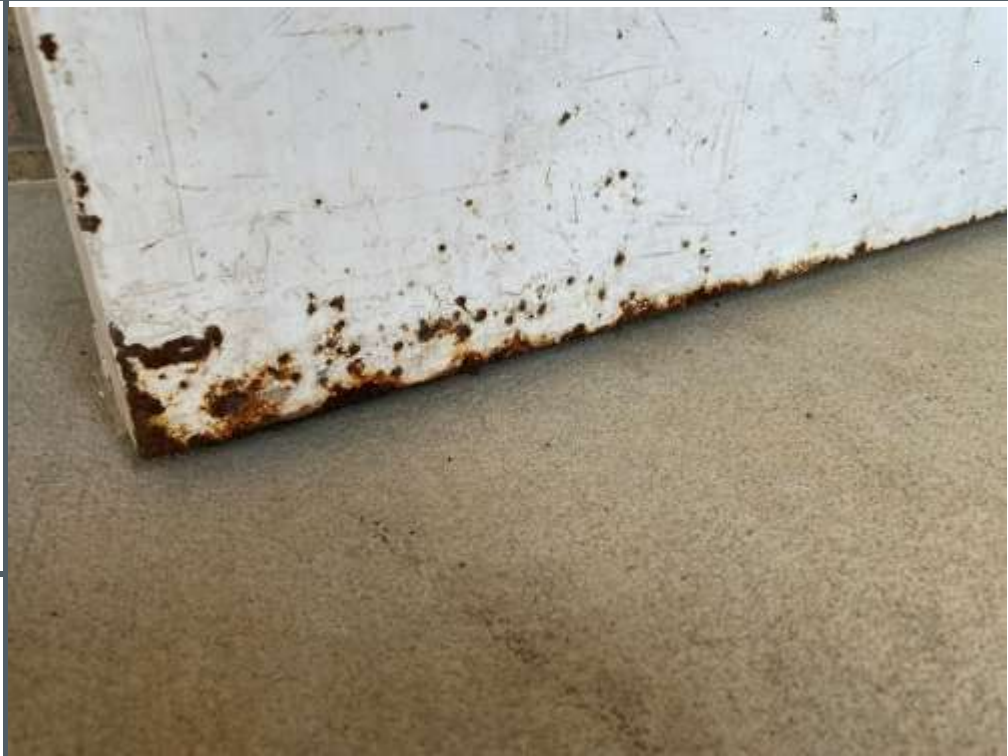
**Photo No.**  
**20**

Painted metal-skin doors are installed at the pool building and storage room. The doors generally appeared to be in fair condition with rust and deterioration noted near the bottom of the doors. Due to exposure and corrosion, the metal doors have an expected useful life of approximately 15 years and we have allocated funds for replacement in 2028.

Rust and corrosion at  
bottom of metal door.

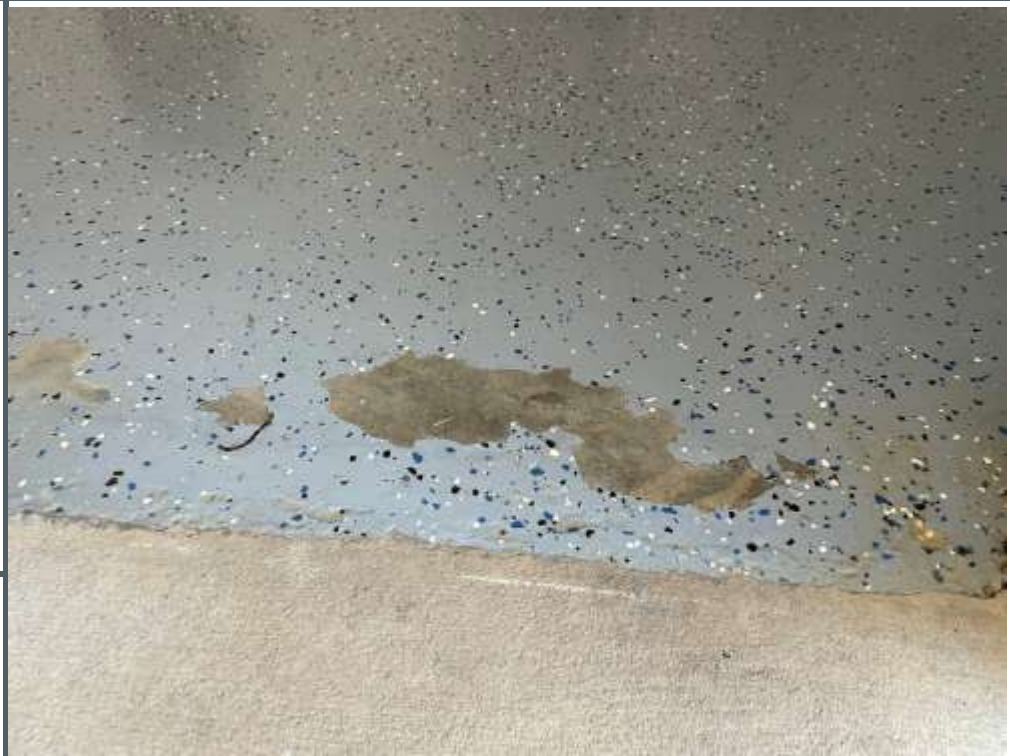
**Photo No.**  
**22**

Chipped epoxy flooring  
in restroom.

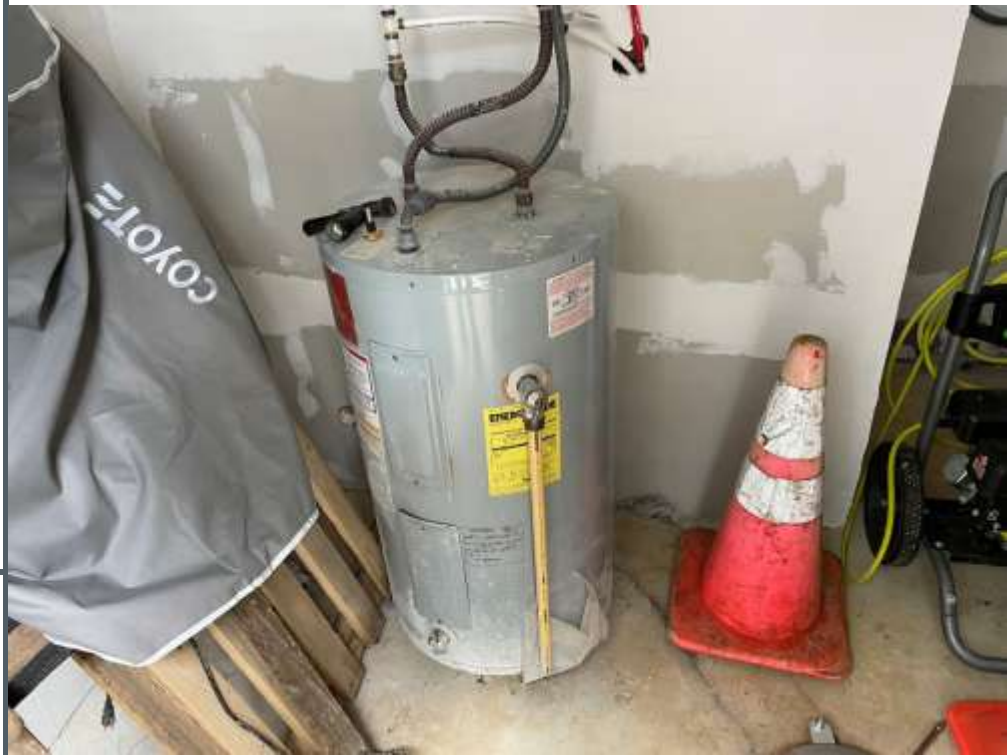
**Photo No.**  
**23**

Domestic hot water for the buildings is provided by commercial grade conventional storage tank electric water heaters. The water heaters were manufactured by State Industries in 2005. Commercial-grade water heaters typically have an expected usable life of approximately 12 to 15 years and we have allocated funds for replacement every 15 years beginning in 2026.

Water heater at pool building.
