JMTE WAYN 1489
TECHNICAL MEMORANDUM

July 24, 2024

**SUBJECT: LEGACY AT JORDAN LAKE TRAFFIC CALMING
STUDY (WAYN 1489)**

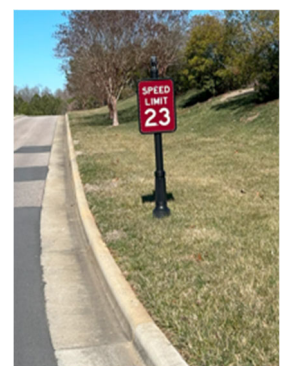
Figure 2 Posted Speed Limit

The Legacy at Jordan Lake is a gated residential community. The HOA owns and maintains all of the streets within the development. The streets are generally 20-foot wide paved, two-lane, and two-way. Legacy Falls Drive North, and Legacy Falls Drive South have a grassed median near the main entrance. Many of the roads in the development have a 5-foot concrete sidewalk on one side. There are no bike lanes or bike paths on the studied roads. The posted speed limit throughout the subdivision is 23 MPH:

The neighborhood needs more speed limit signs. The existing speed limit signs (Figure 2) are not MUTCD. The HOA should replace these signs with compliant R2-1 signs see Figure 12.

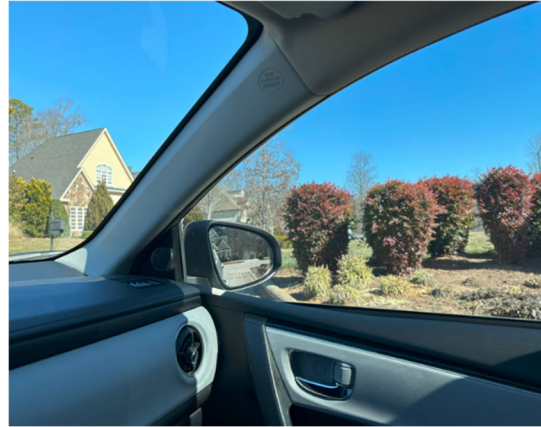
Figure 6: Obscured Sight Triangle Stoney Creek

As shown in Figure 6 overgrown ornamental plants obscure the sight distance on Stoney Creek Way at the loop. The HOA should remove these plants.

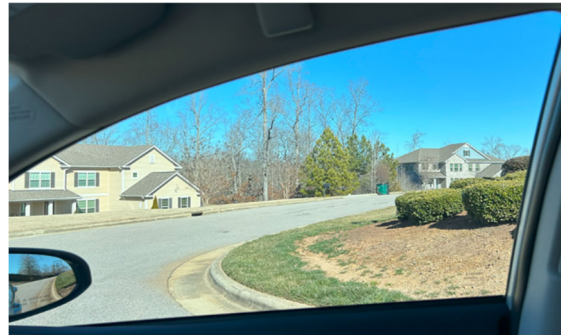
Figure 7: Obscured Sight Triangle Rolling Meadows Lane and Rolling Meadows

As shown in Figure 7 overgrown ornamental plants obscure the sight distance on Overgrown ornamental plantings obscure the sight distance at Rolling Meadows.

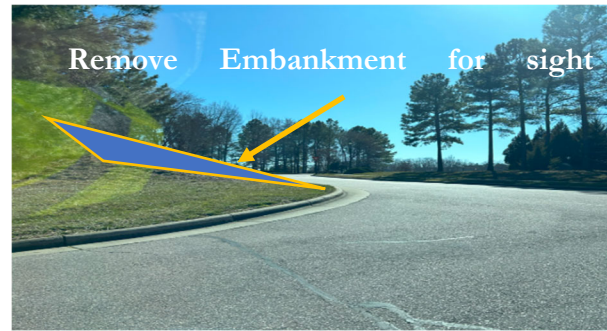
Figure 8: Obscured Sight Distance Rolling Meadows at Covered Bridge Trail

Site Distance is also a concern at Rolling Meadows Lane and Covered Bridge Trail (Figure 8) The Engineer recommends grading the embankment by removing the top 3-5 feet along a 3:1 slope.

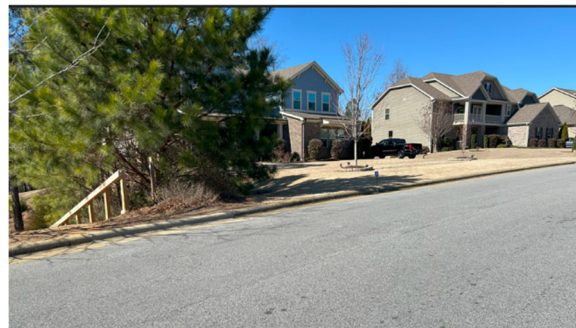
Figure 9: Stony Creek Way Trailhead

The Engineer noted several unmarked trailheads and trail crossings. Figure 9 is an example location. The Engineer recommends that the HOA install American with Disabilities Act (ADA) compliant curb ramps, high visibility crosswalks, and advanced warning (MUTCD RS-068) signs on both approaches to trailheads.

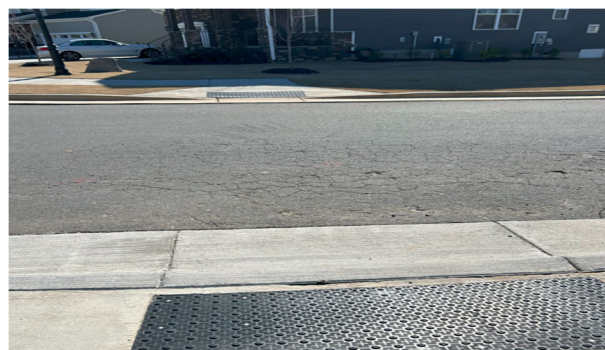
Figure 10: Unmarked Crosswalk

North Crest Drive has two unmarked crosswalks (Figure 10) The first is near the North Crest Drive loop and the second is near the High Woods Ridge intersection with North Crest Drive. The cost in Table 4 is for signs only and does not include pavement repair.

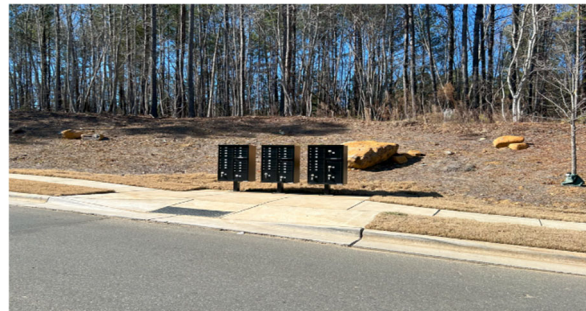
Figure 11: High Woods Ridge Mailbox Cluster

The community should consider the installation of a driver pull-off and crosswalk at the mailbox cluster on High Woods Ridge. The area would need to be widened with curb and gutter removed and reinstalled including additional pavement for parking up to 2 to 4 cars and a crosswalk. See Figure 11.

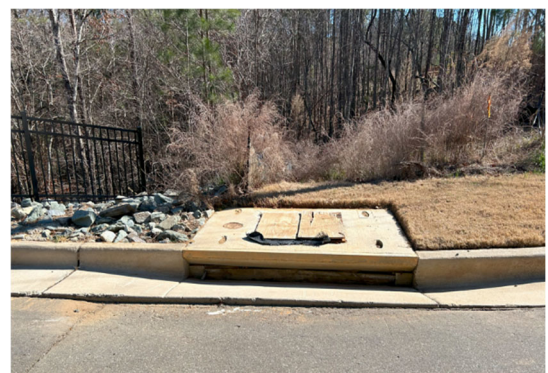
Figure 13: High Woods Ridge Road Curb Inlets

During the site visit the Engineer noted drainage and pavement issues that the HOA should have addressed. The curb inlets at the bridge on High Woods Ridge Road are blocked. This is done as an erosion control measure during construction. The Engineer believes that High Woods Ridge Road is still under construction because the final layer of asphalt has not been placed. However, water could pool here during major storms and create a hazard. The curb inlets should be opened as soon as practical, or when the final layer of pavement is placed. The HOA should monitor this location and close the road in the event of standing water.

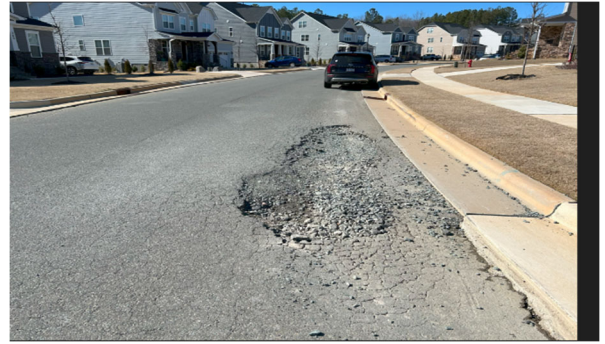
Figure 14: High Woods Ridge Asphalt

Pavement and subgrade failures are evident near 55 Permit Court, 143 Permit Court, and 163 Permit Court. The HOA should petition the developer to correct this condition and the similar condition on Legacy Falls does not have the final course of asphalt. There are sections with pavement distress caused by utility trenching and pavement failures as a result of subgrade failures.

High Woods Ridge Road is 20 feet wide with a curb and gutter. The final layer of asphalt has not been placed, and there is substantial evidence of weathering and alligator cracking. There is a severe pothole at 355 High Woods Ridge Road, see Figure.
