**LEGACY AT JORDAN LAKE
PROPERTY OWNER'S
ASSOCIATION, INC.
CHAPEL HILL, NC**

MAY 30, 2024

**TRANSITION
STUDY**

GILES & FLYTHE
ENGINEERS

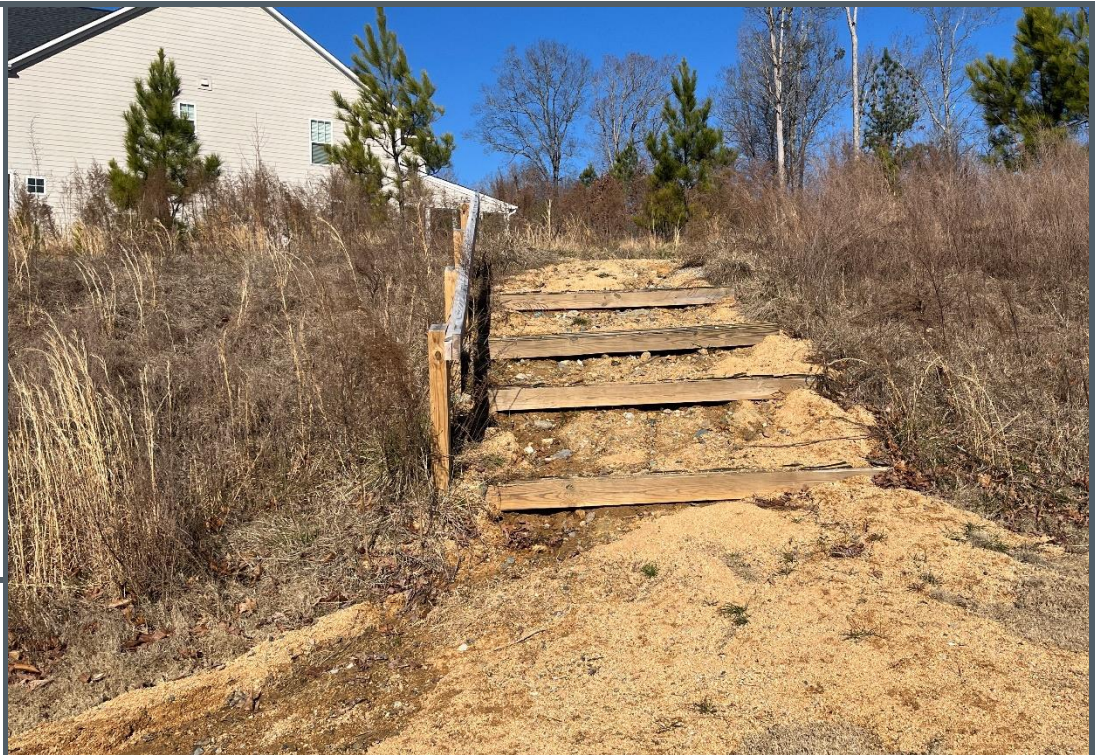
Photo No.
4

Additionally, there are several walking trails located throughout the community with various ground cover installed including grass, Chapel Hill grit, crushed stone, and mulch. The most significant area of surface erosion noted on the walking trails was at the sloped embankment near the intersection of Legacy Falls Drive and Winding Creek Loop. Wooden landscape timbers were noted to be installed on the path to help prevent surface erosion caused by stormwater runoff and the timbers were noted to be undermined at the time of the site visit.

A view of surface
erosion at the walking
trails

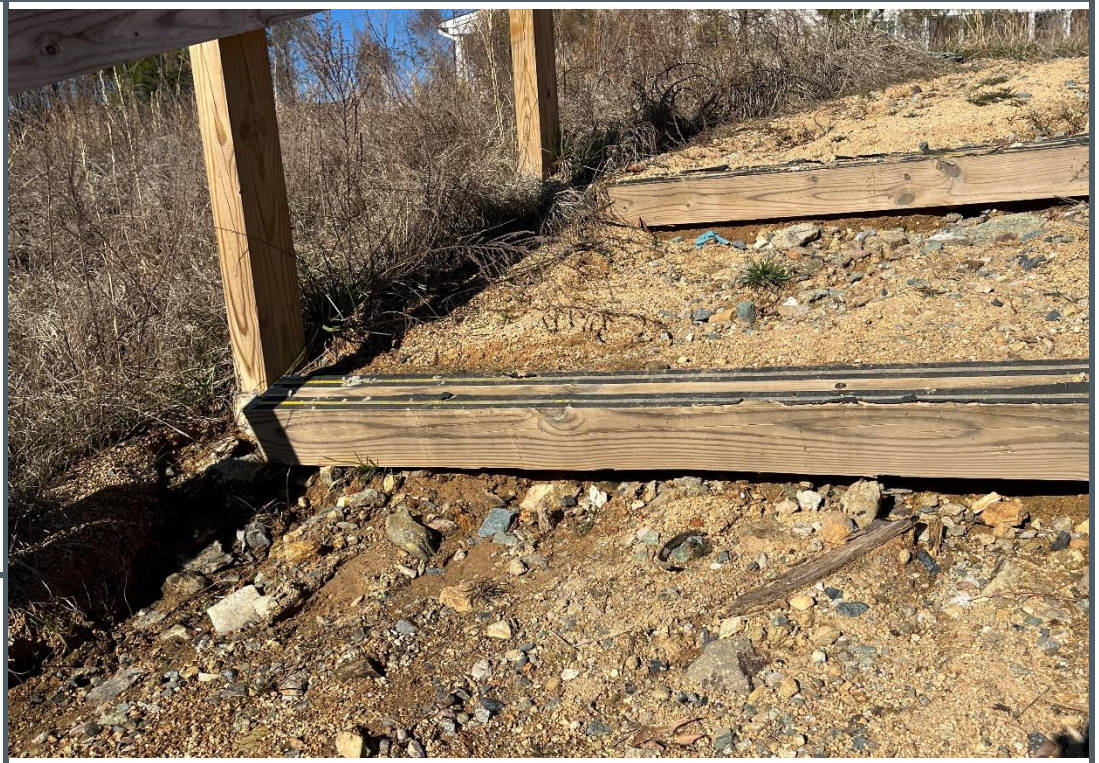
Photo No.
5

A view of surface erosion at the walking trail

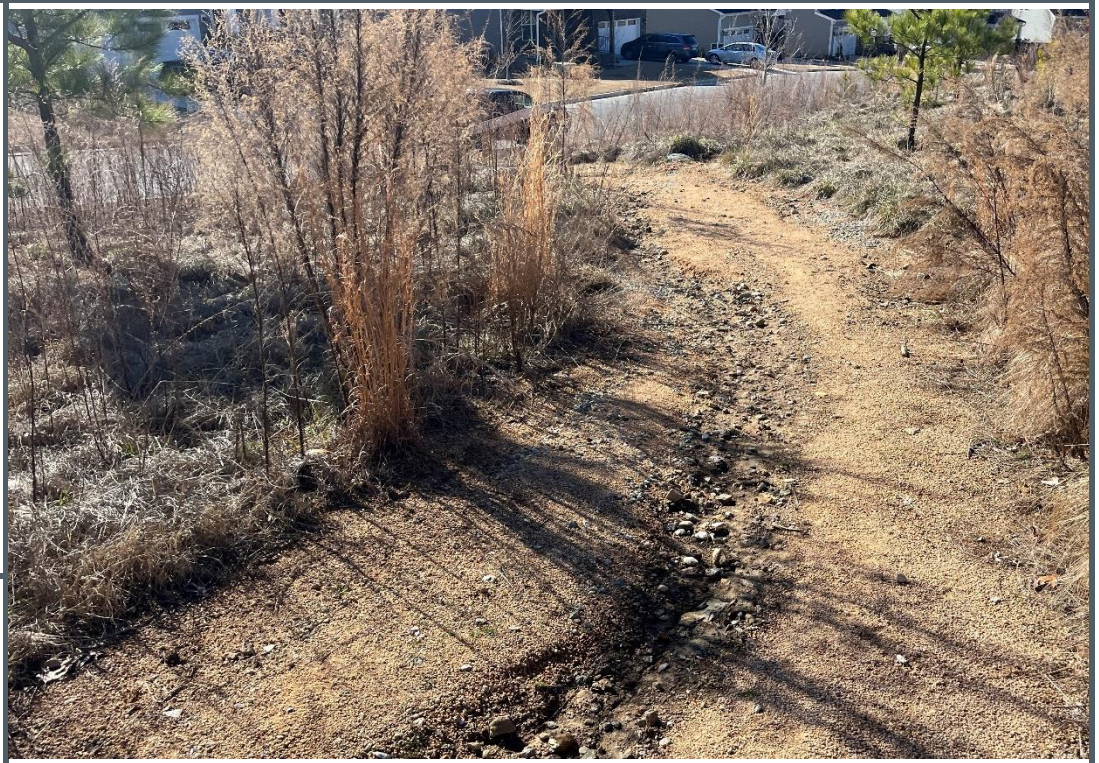
Photo No.
6

A view of surface erosion at the walking trail

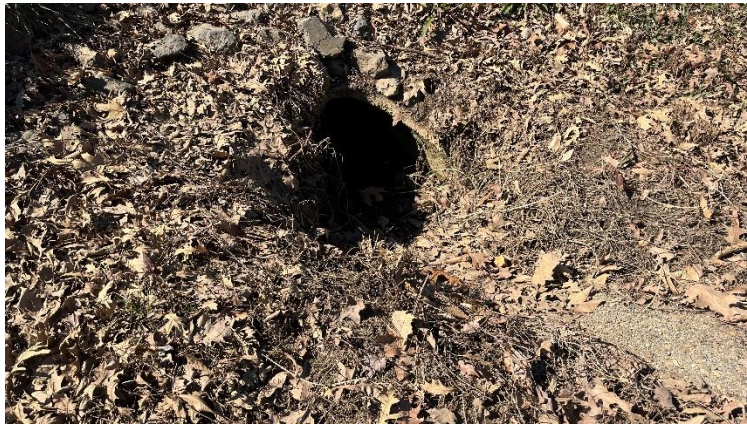
Photo No.
8

- The inlet pipe was noted to be undermined and moderate surface erosion was noted at the wet pond behind 103 Two Creeks Loop.
- A partially obstructed inlet pipe was noted at the wet pond located near 134 Stoney Creek Way. The inlet pipe was partially obstructed with soil and organic debris. A negative slope was noted at the inlet pipe due to a buildup of soil near this area.

A view of an obstructed stormwater pond inlet

2	Earthwork repairs are needed at the inlet pipes to multiple stormwater ponds to ensure proper stormwater flow into the SCMs.
3	The perimeter of the SCMs should likely include a vegetative shelf extending into the waterline. Obtain the original design drawings for the SCMs to ensure the ponds meet the original design criteria.

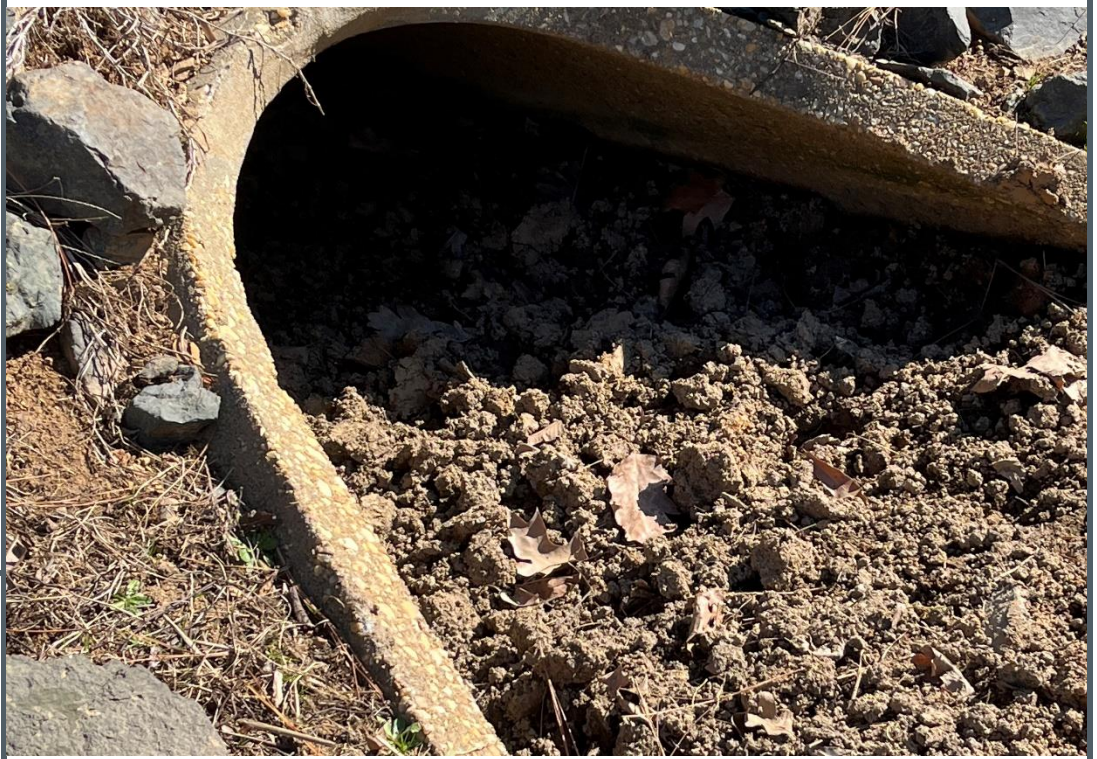
Photo No.
9

A view of an obstructed stormwater pond inlet

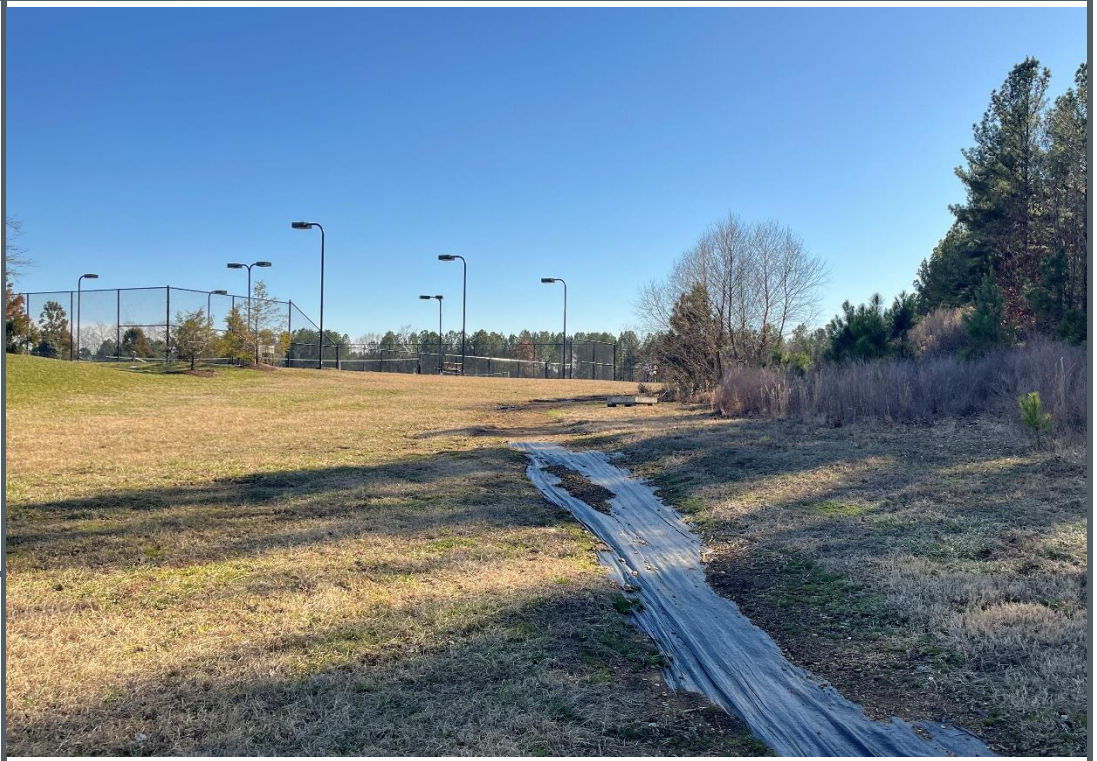
Photo No.
12

A view of erosion at the
walking trails near the
clubhouse

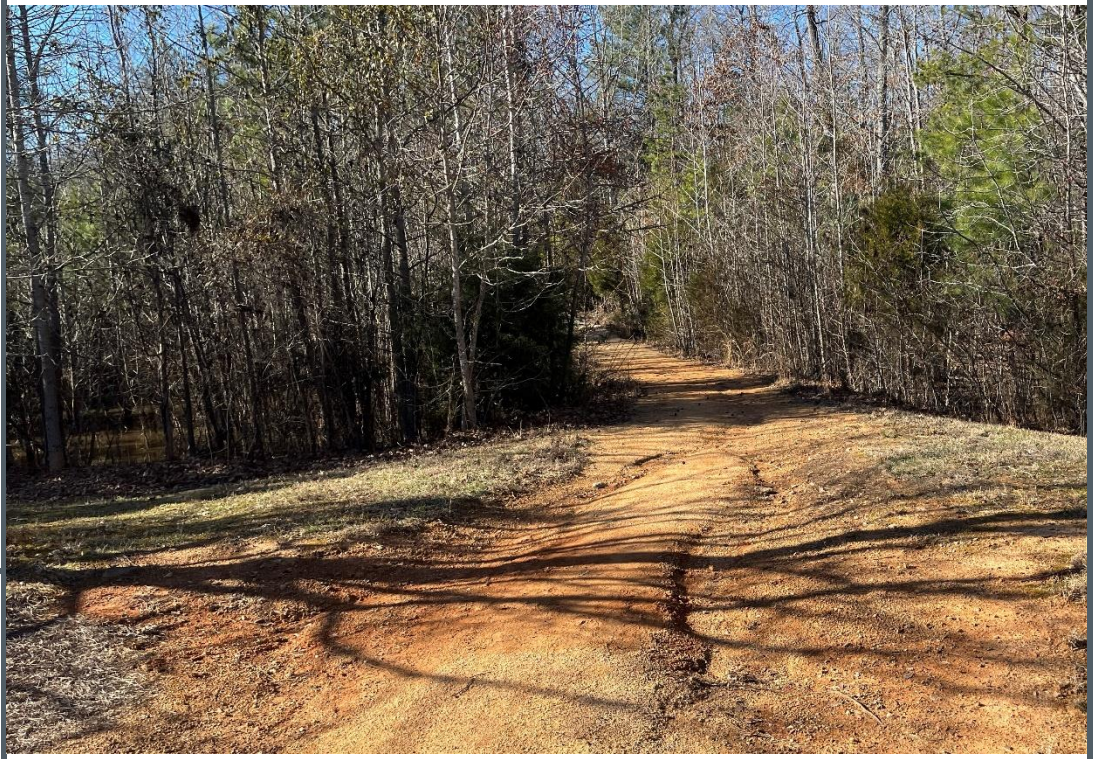
Photo No.
13

A view of surface erosion on the walking trails

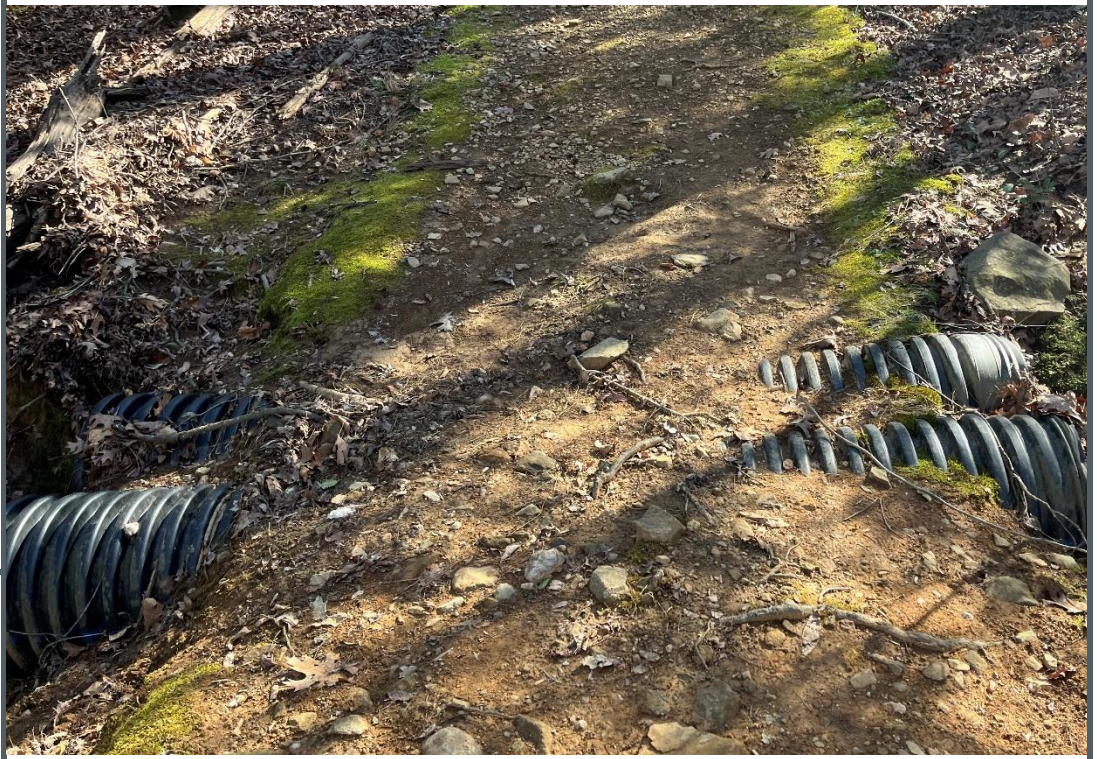
Photo No.
14

A view of surface erosion on the walking trails

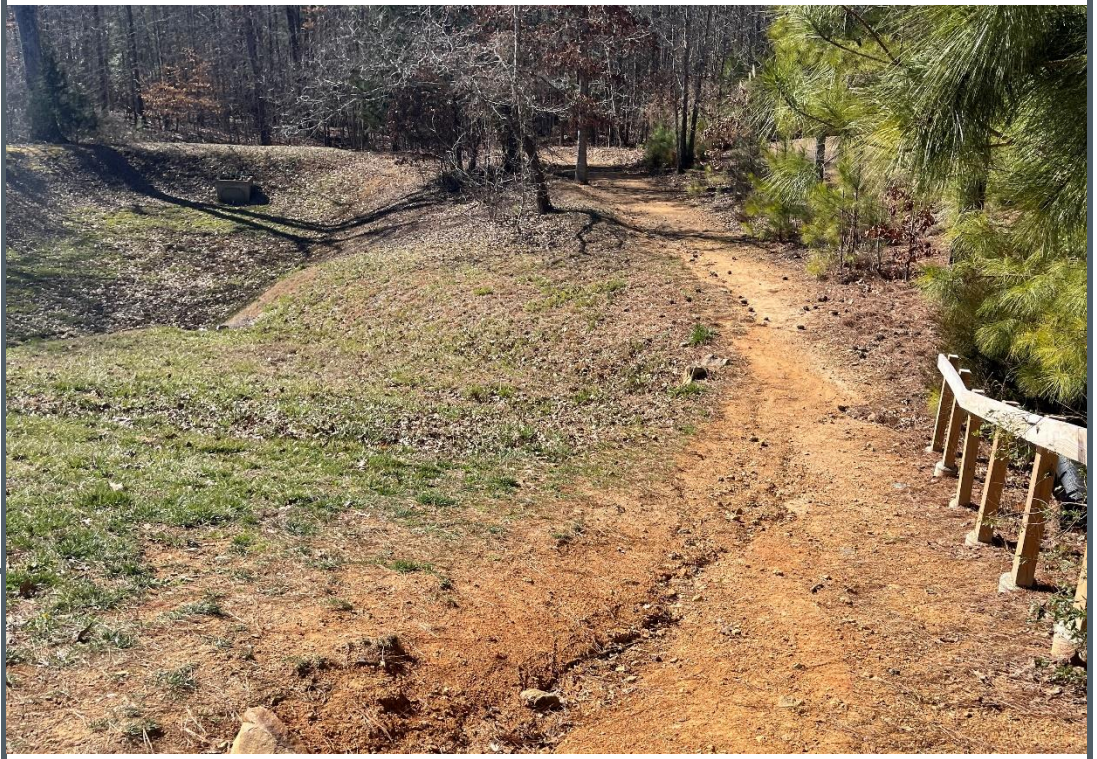
Photo No.
15

A view of surface erosion on the walking trails

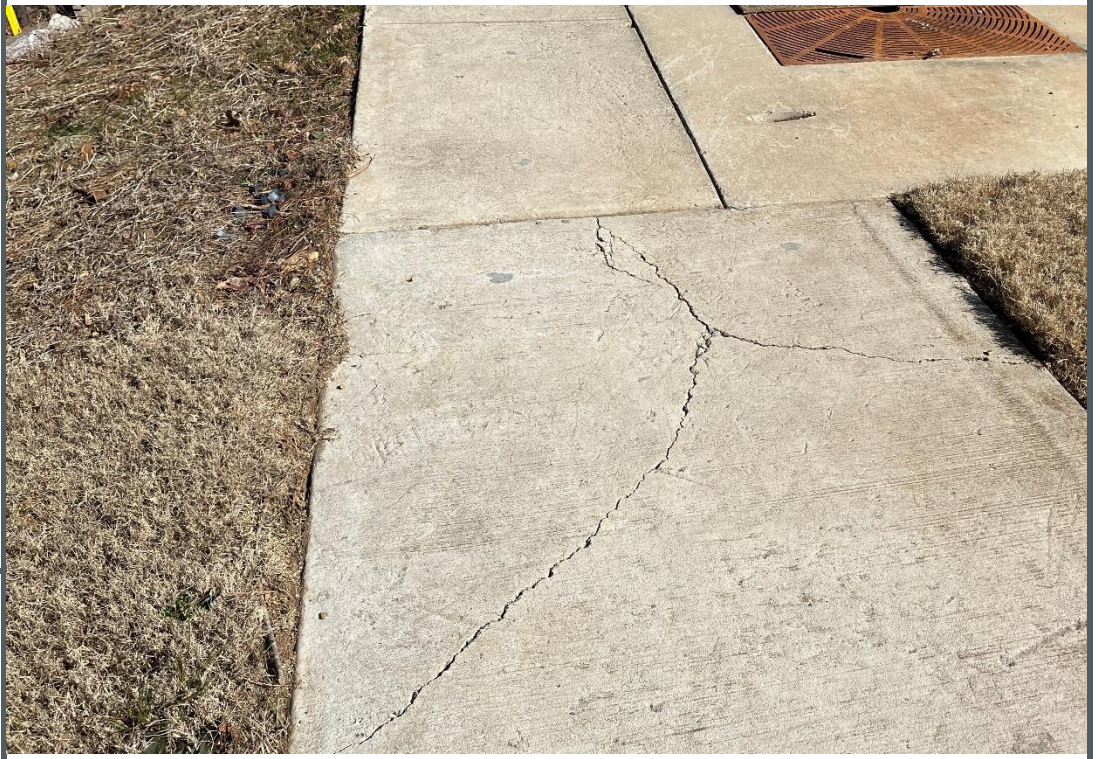
Photo No.
19

Concrete sidewalks were noted to be installed throughout the community, near the clubhouse, and along at least one side of each road. Minor cracks, upheaval, and settlement were observed in individual sections of the concrete sidewalk. We consider the minor settlement and cracking in the concrete sidewalks to be a maintenance item and not a deficiency in the installation of the site elements based on the age of the components. We recommend that the community establish reserve funds to repair/replace damaged sections of concrete sidewalks on a regular cycle.

A typical view of cracks
in the concrete sidewalk

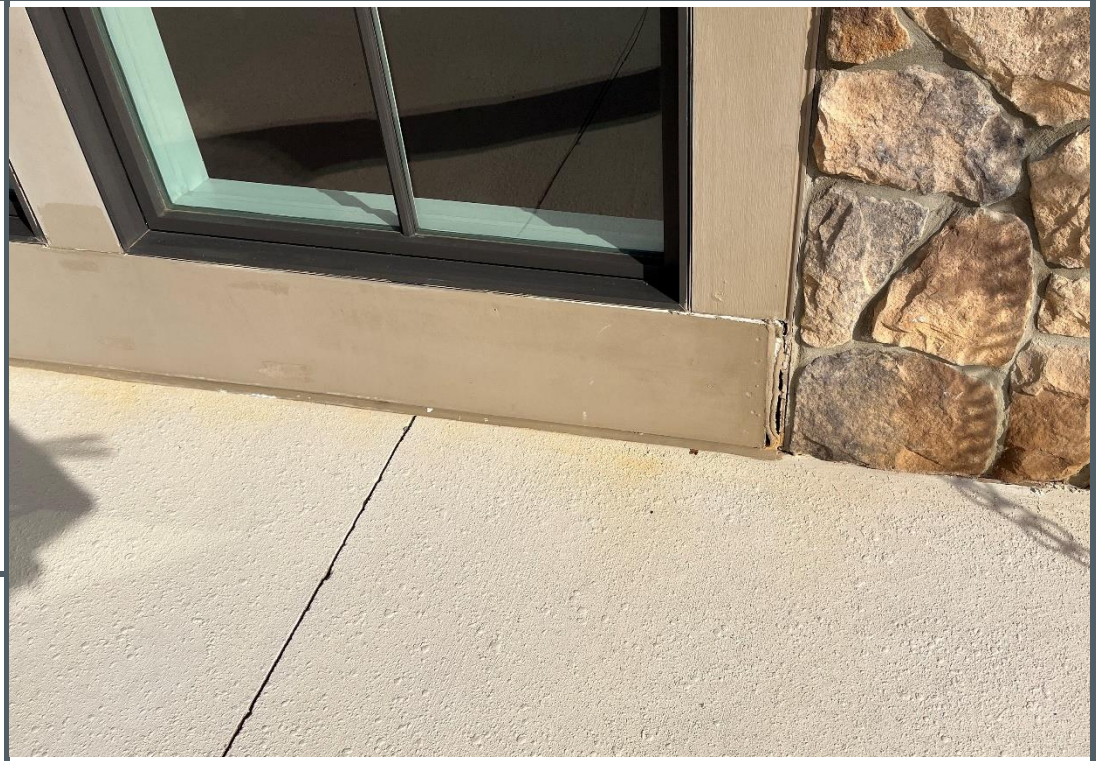
Photo No.
22

A view of the trim board pulling away from the windows. Failed joint sealant at the side of the trim

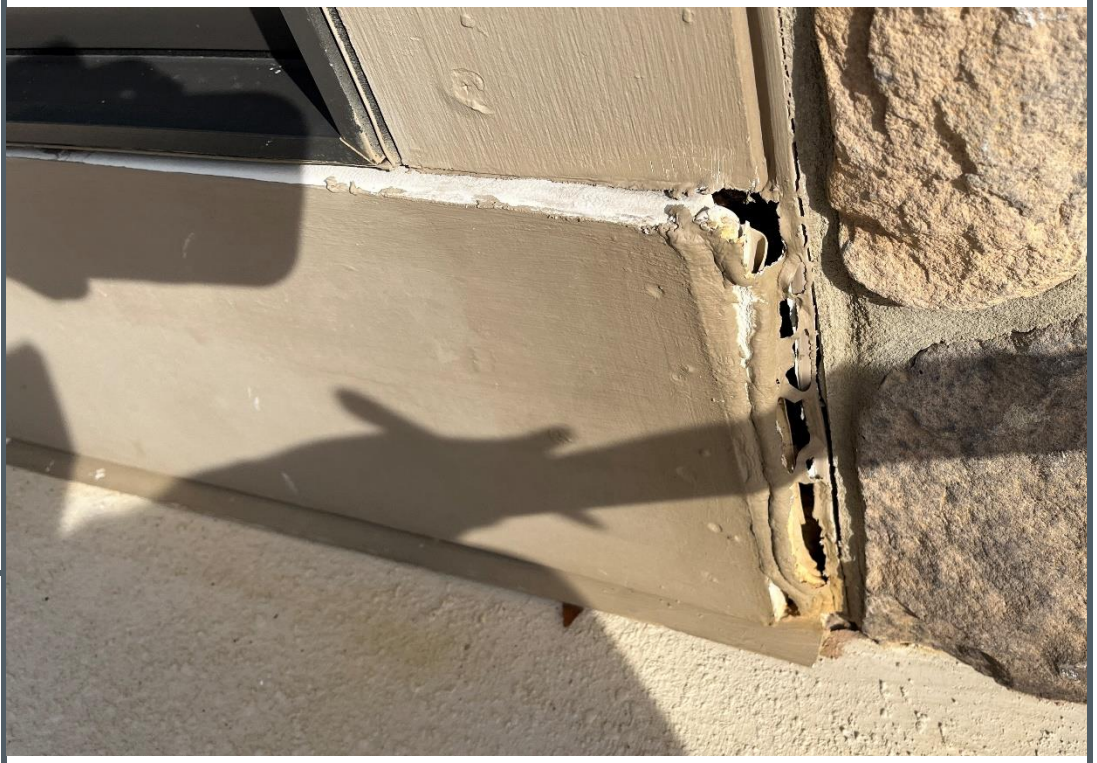
Photo No.
23

A view of the trim board pulling away from the windows. Failed joint sealant at the side of the trim

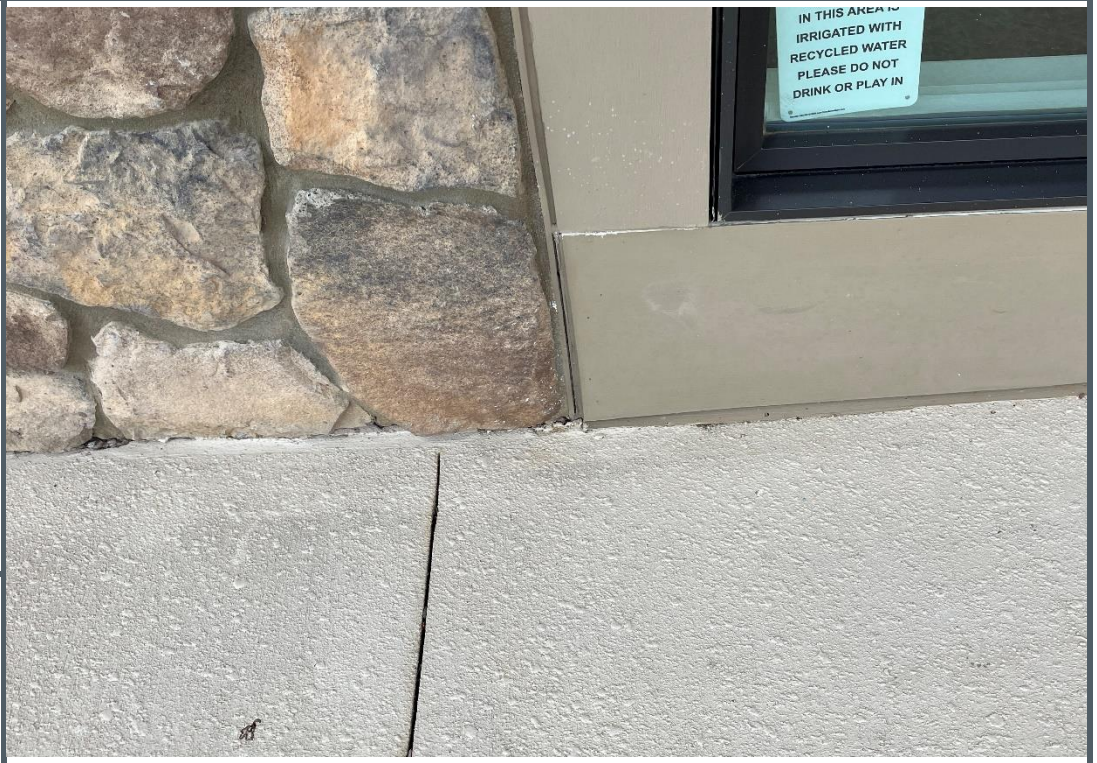
Photo No.
24

A view of the trim board pulling away from the windows. Failed joint sealant at the side of the trim

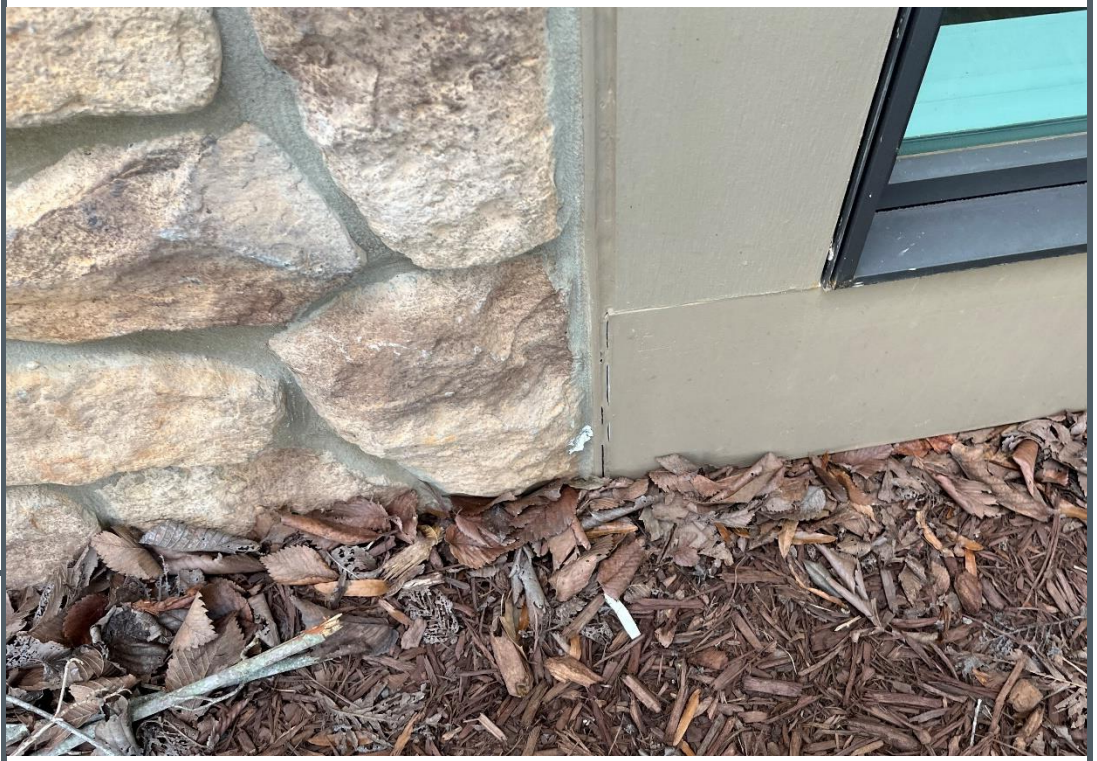
Photo No.
25

A view of trim board pulling away from the windows. Failed joint sealant at the side of the trim

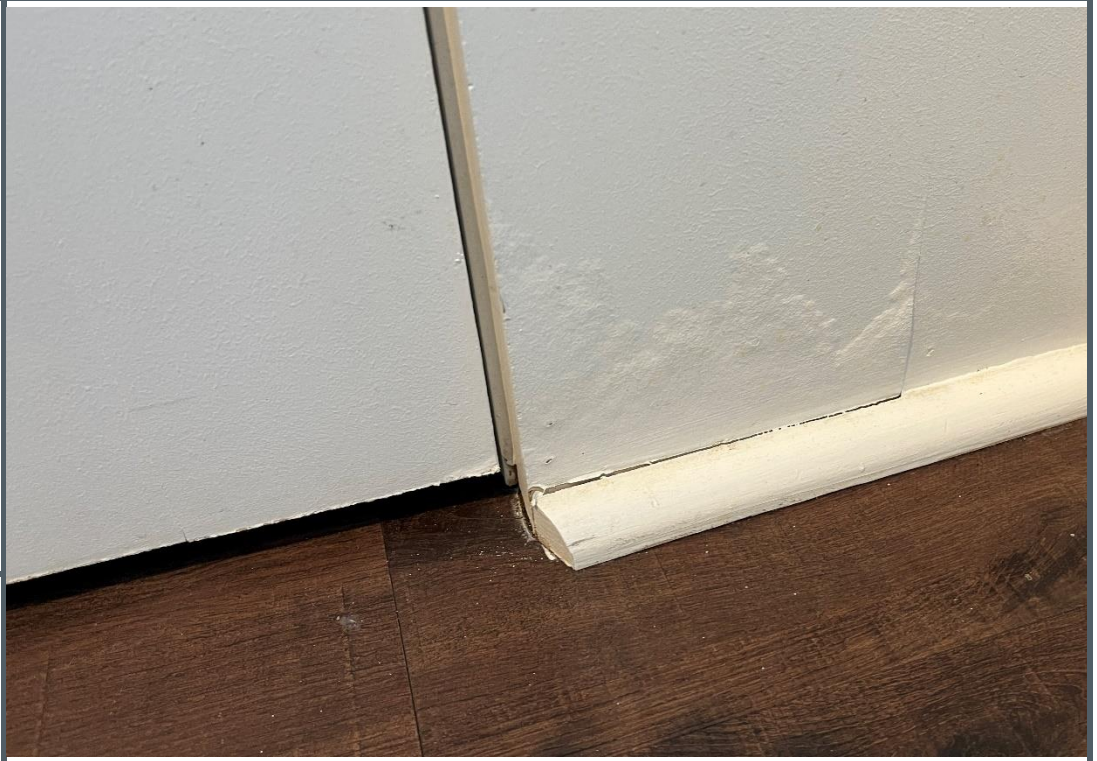
Photo No.
26

A view of moisture staining noted at the interior of the clubhouse

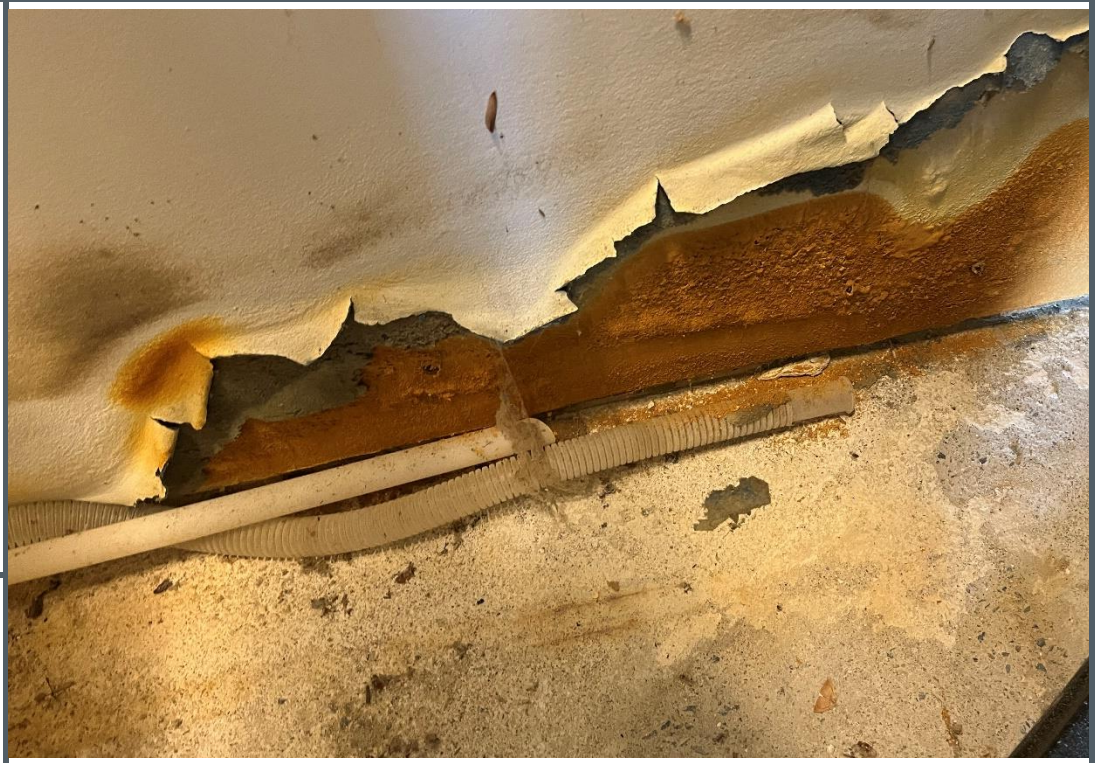
Photo No.
27

A view of drywall damage noted at the chemical room

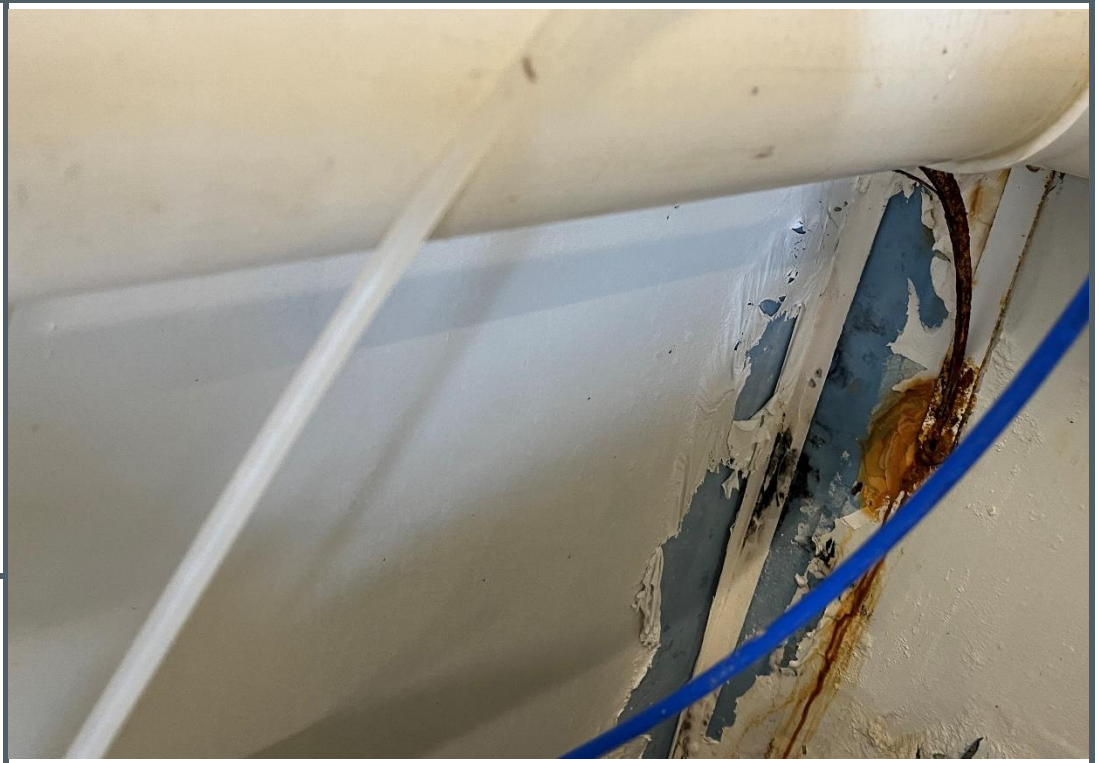
Photo No.
28

A view of drywall damage noted at the chemical room

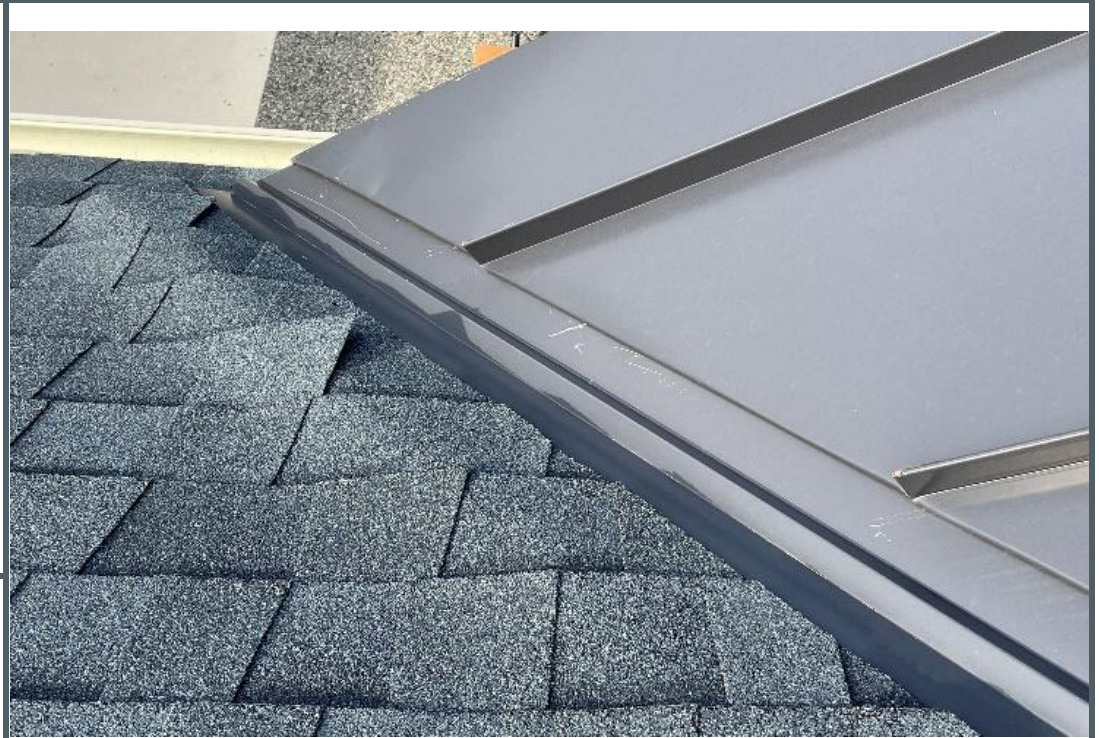
Photo No.
30

A view of the lifted shingles near the metal roofing

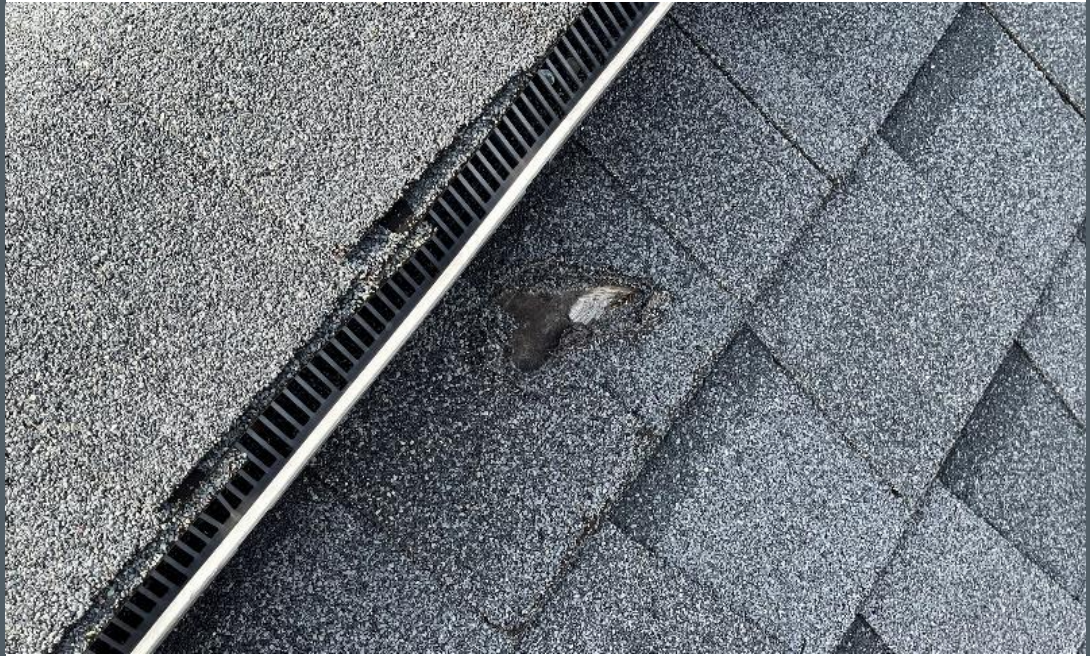
<p>Photo No. 32</p>

<p>Description</p> <p>A typical view of shingle damage noted on the clubhouse</p>

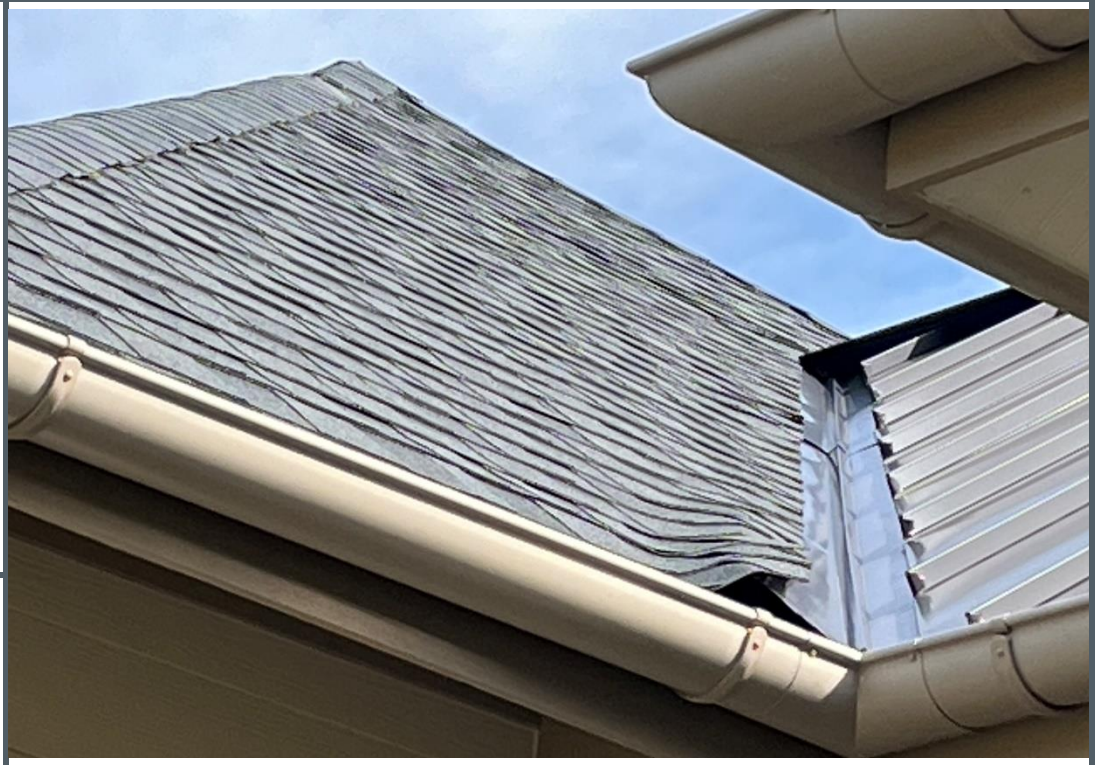
Photo No.
33

A view of the lifted shingles near the metal roofing

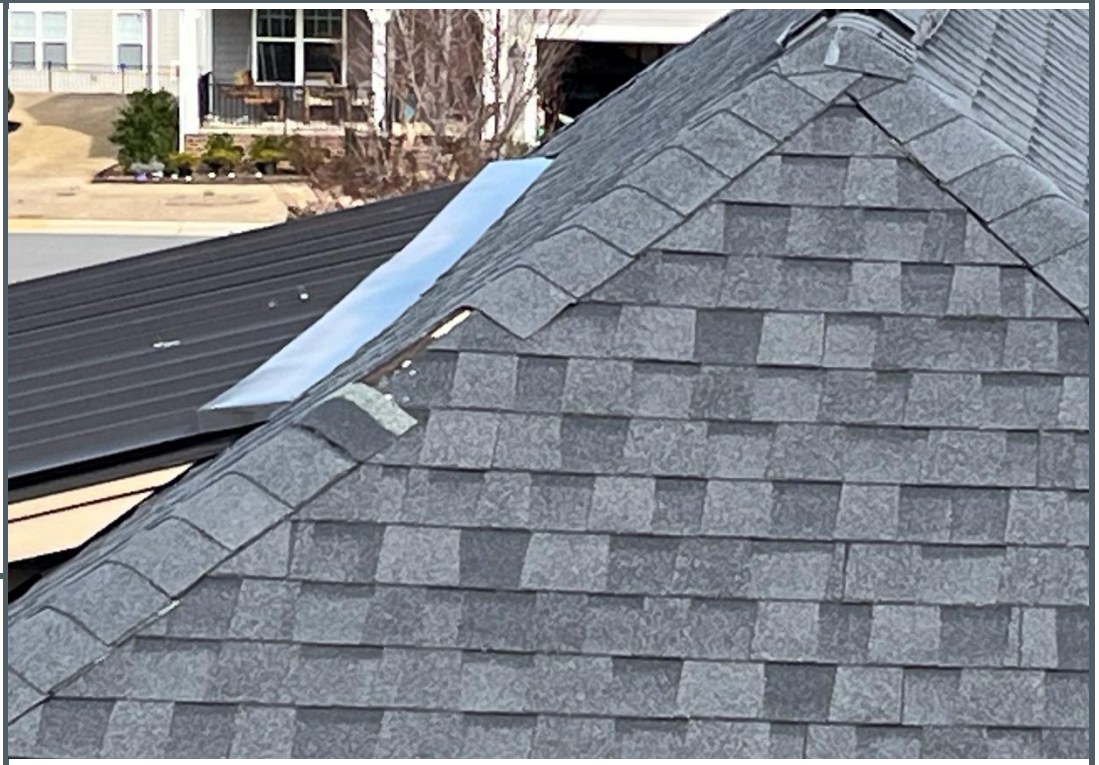
Photo No.
34

A view of missing shingles above the fitness center

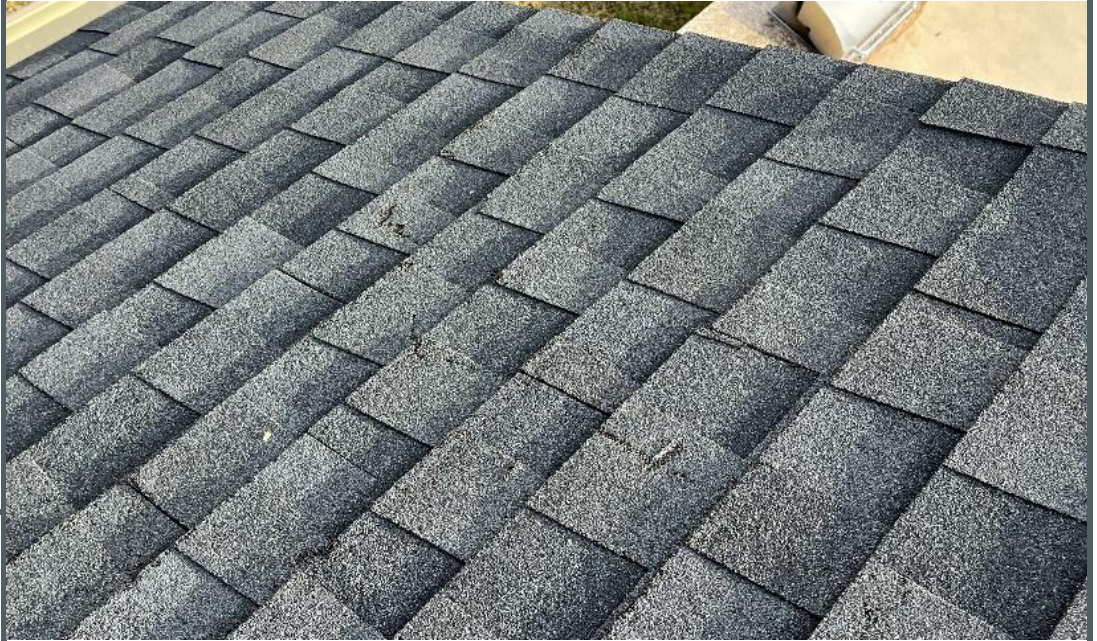
Photo No.
35

A view of shingle damage on the clubhouse roof

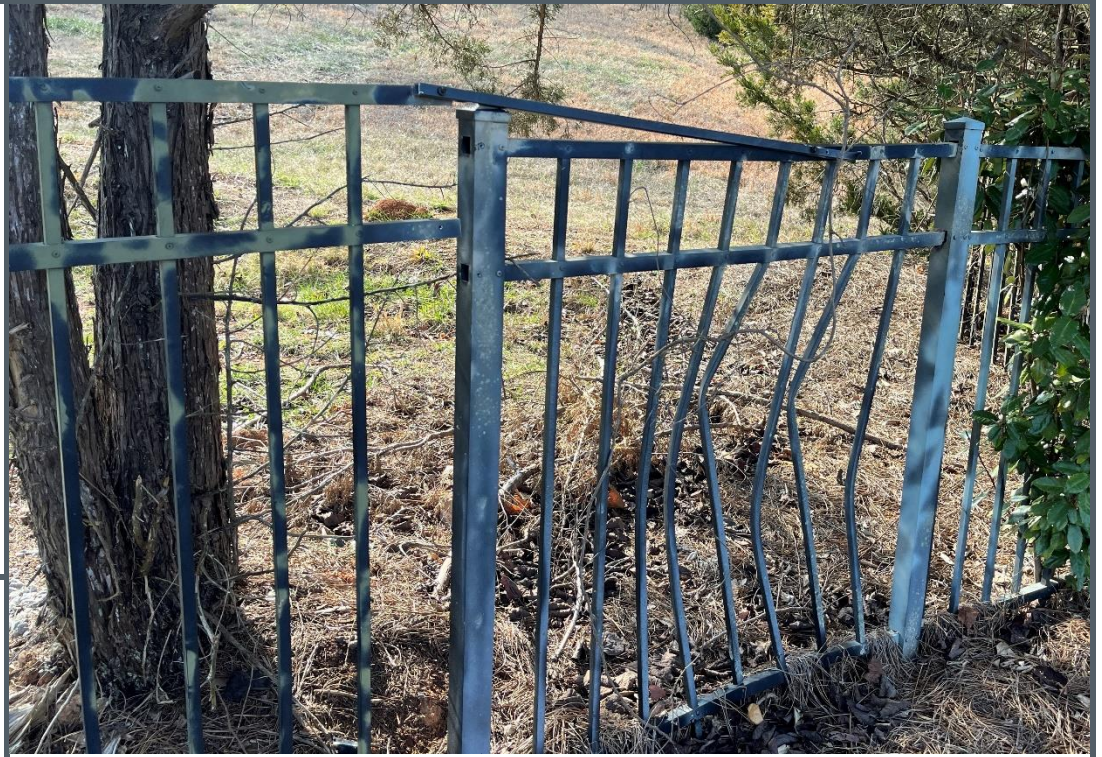
Photo No.
45

A view of the damaged
fencing at the waterfall
feature
