The HOA team reached out to us stating there was some perceived incongruities and deficiencies with the entrance water feature. We coordinated a site visit for today. I arrived at 11:15am. The water feature was operating. Met with Mr. St. Pierre. Walked the site, inspected the pump room, the site and the following is a brief report of what was found.

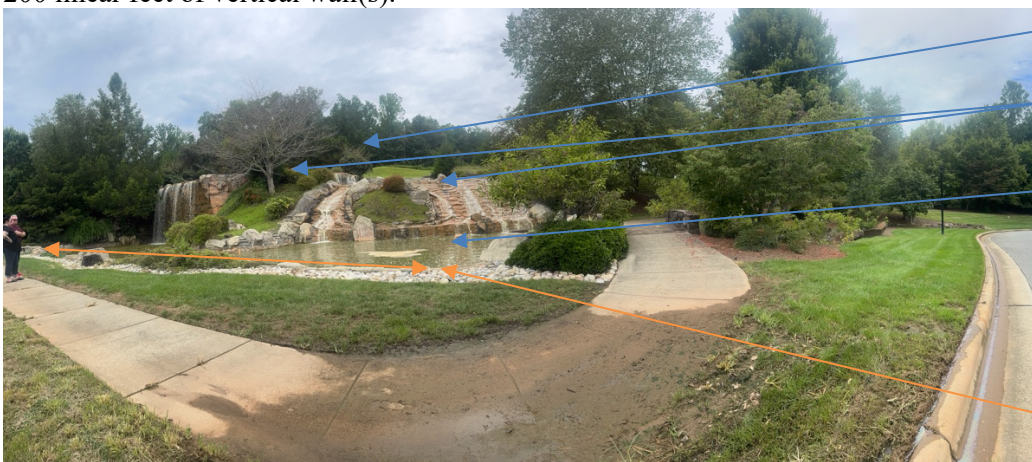
Every wall has fluorescence runs on their face. This is calcium from the concrete behind the face, being drawn through by water from behind the water feature face. Hydrostatic pressure from behind the wall/faces are pushing the concrete and cracking the faces and moving the walls. These will all need to be secured with wall anchors with a depth not less than the height of the wall itself. Paired with geotextile material for drainage, a J-drain for routing the water and 57 stone for gravity drain. Along nearly 200 linear feet of vertical wall(s).

- Needs: Drainage along rear of feature (trees removed, fence fixed)
- Sealed Pools and Falls areas
- Lower pool cleaned out
- Lower pool sealed
- Entire area to be sealed and stained to match itself
- Potential littoral shelf or guardrail along this area for safety and liability lessening.

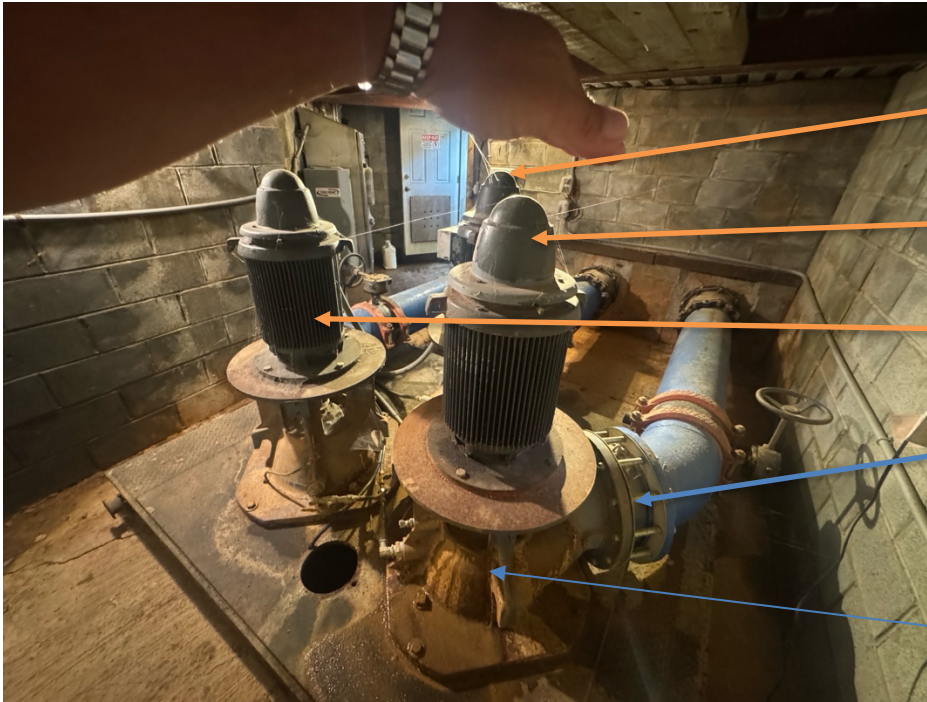
Motor – reads nearly out of spec  
Pump is fine

Motor – reads within spec  
Pump is fine

Motor – out of spec and pump unable to test.

These 12” check valves are all broken. Three of them they SLAM shut and will eventually fail and damage the equipment more.

All of this sediment is from years of no seal servicing.

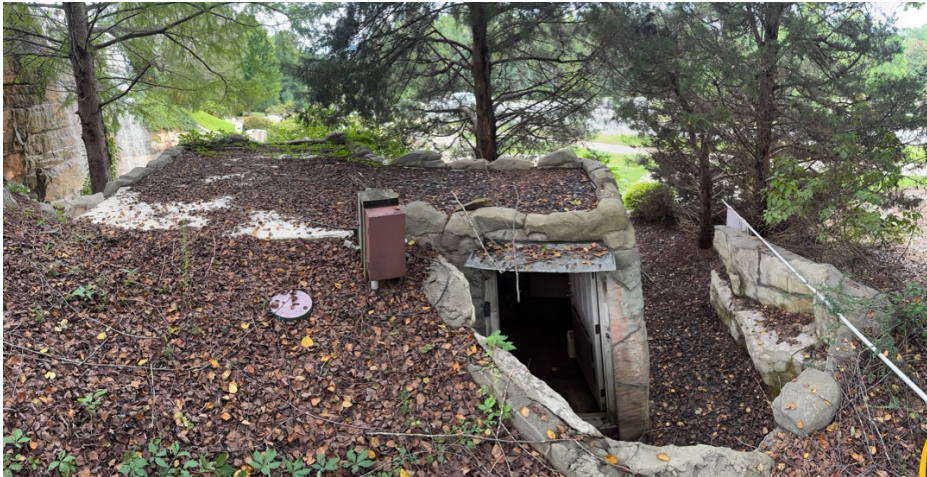
This roof WAS designed to be removable – someone thought it'd be a good idea to cover it in concrete. This will have to be jackhammered out to service the pumps.

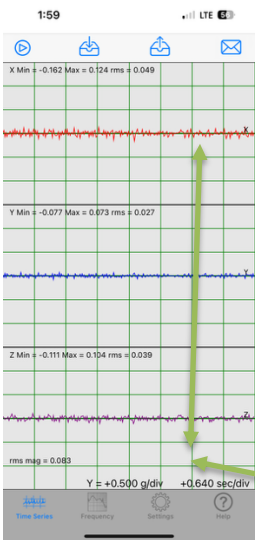
left: Pump 1: there is less than 0.25mm of vibration per second at 57hz. Shown here at 0.162mm per second. this is well within spec for the pump and motor.

right: Pump 2: there is less than 0.25.. of vibration per second at 57hz. Shown here at 0.154mm per second. Also well within spec.

GOOD

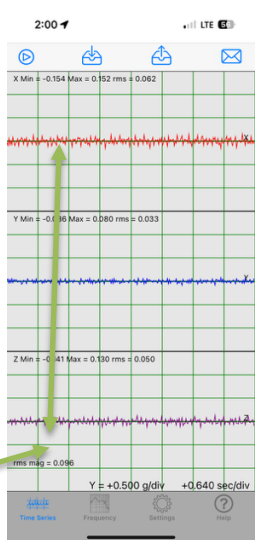
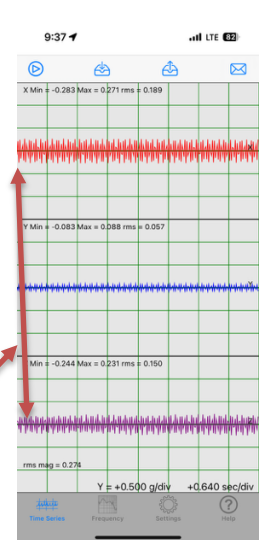
For reference... here on the right is a motor/pump that is well out of spec and shakes the entire building. The 2 Legacy at Jordan Lake Pumps I was able to test are in good working order. (ex: Barbuda Ocean Club)

BAD

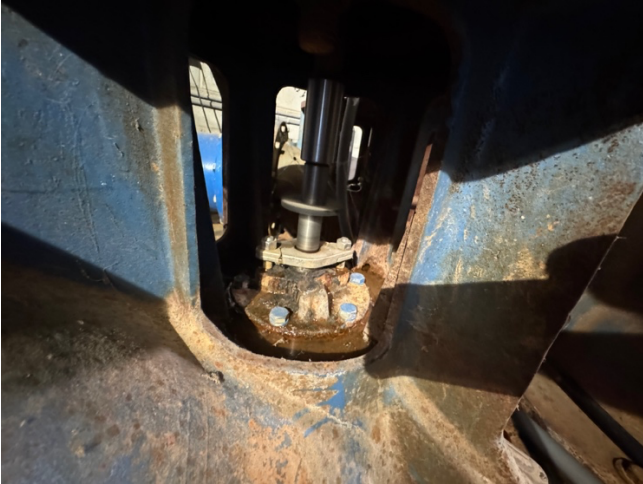
P1 and P2 have stuffing boxes with graphite seals. P2 hasn't been serviced in years.

The only reason this one looks good is because it's been off for over a year.

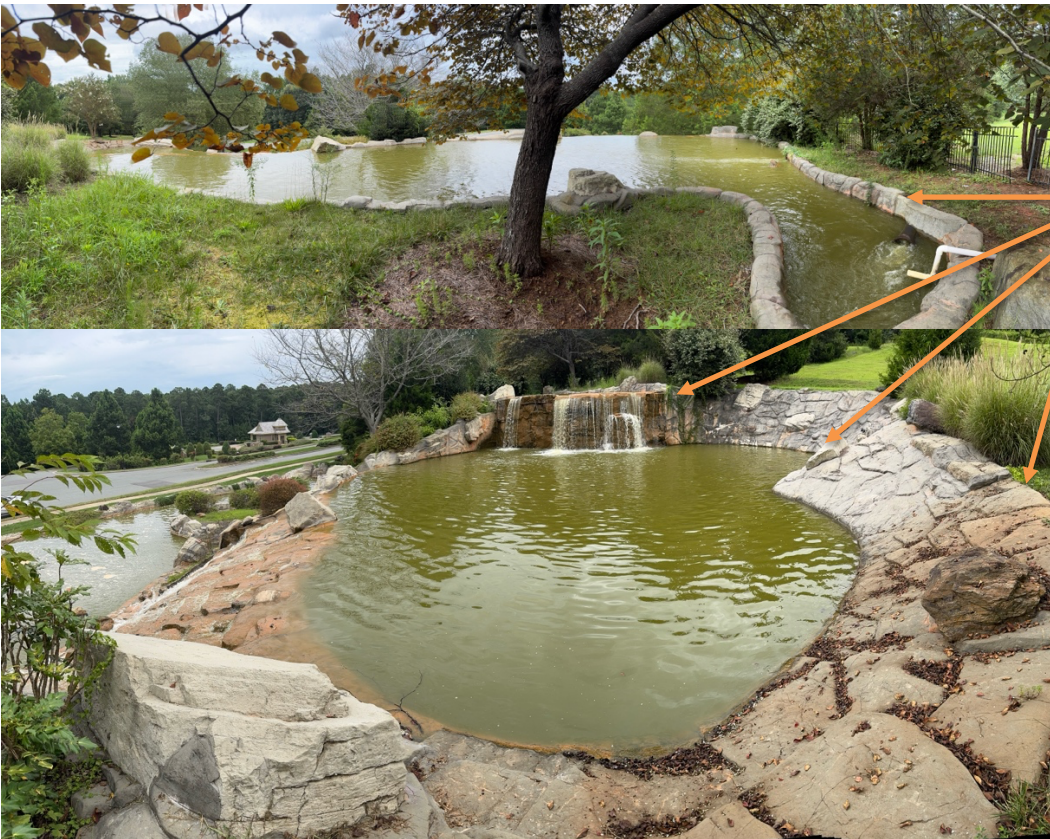
Every rear vertical coping edge on the high side of the water feature has been compromised and is eroding along the back of it. There are calcium deposit all over the face of the back walls.

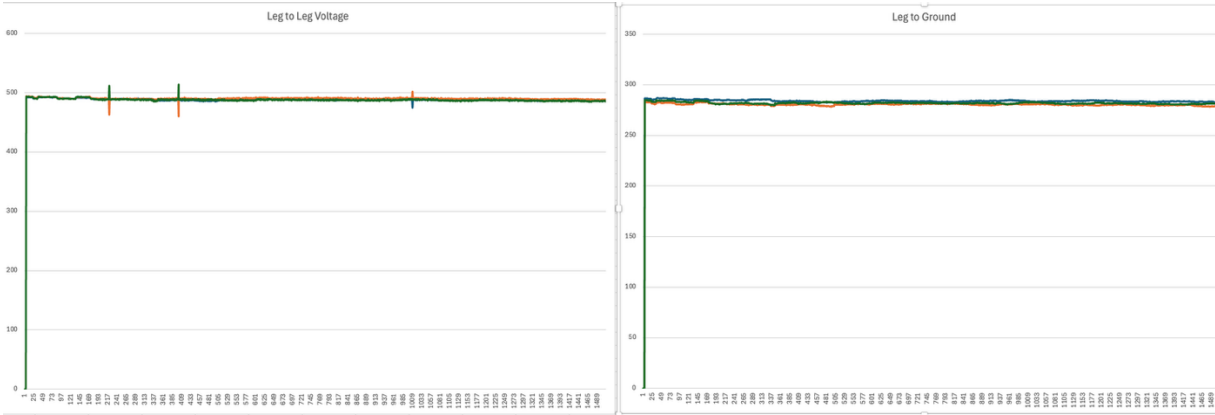
There are a few voltage spikes. If we left this device on for a few days we could probably capture an actual input phase loss. There are several on the alarm screen.

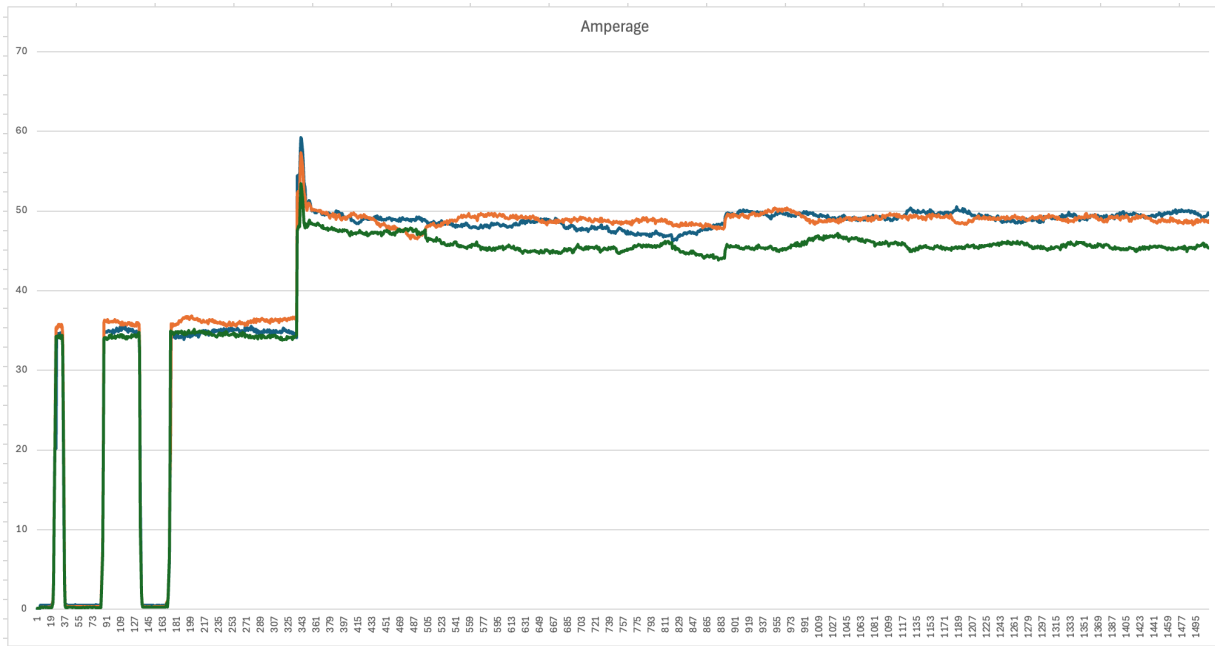
There is an amperage variance on P2. The P1 unit is well within the tolerance, the P2 motor is 15-18% out on phase C/3. This paired with not knowing how to wire the ABB VFD may be why the #2 unit was never put back in service. I just programmed it to run to 25% out of phase. Its within the VFD capabilities. But will accelerate the motor failure.

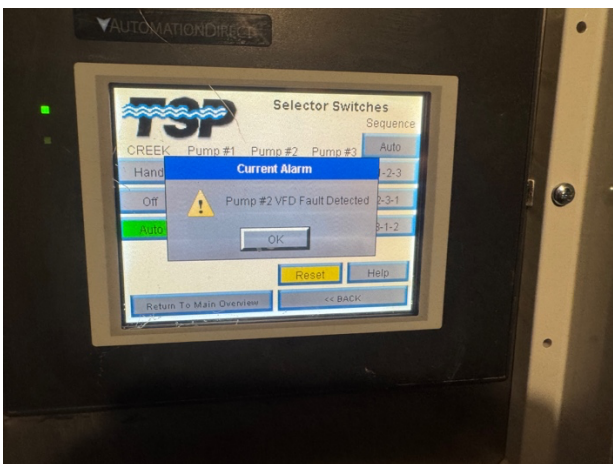
The control panel claims there is a VFD 2 fault. This only tells part of the story. The alarm isn't wired to the vfd. It is wired to itself. The VFD was not wired properly. It will only run in -HAND- this means you must open the panel, press -hand- button then the up arrow to get to a useable motor speed. When the power goes out it'll retire and may not start back up unless the exercise is repeated.

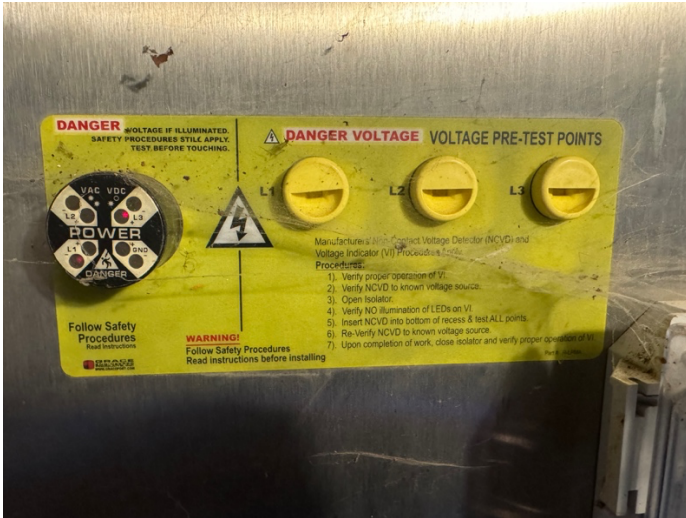
This is an external/visual reference to know that the incoming power is -ok-. There are 2 damaged legs on this unit. That is evidence of lightning damage.

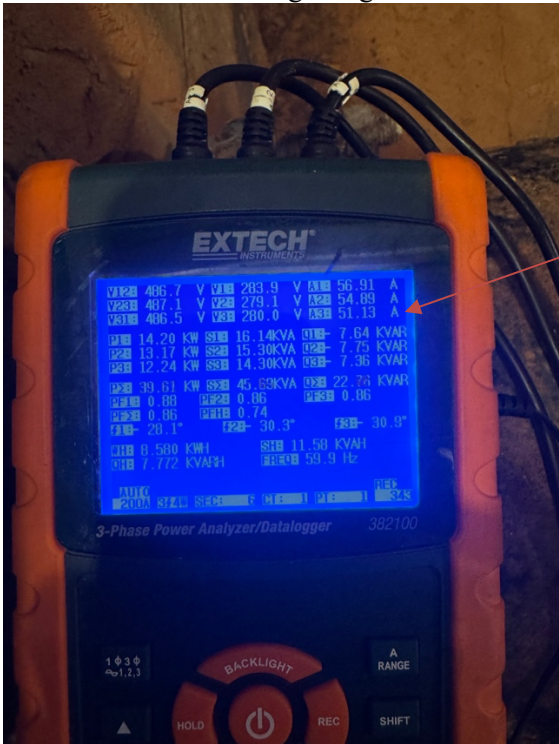
A3

Going back to the graphs above... this is a photo of the power analyzing data logger. This unit samples ever 6 seconds and stores the power data for later review. We can see the amperage differential on that is shown in the graph on motor 2.

Is 15-18% off when running at full load. Shown here it is about 9% off. The safeties are set to 3-5%. We overrode all safeties during this testing exercise.

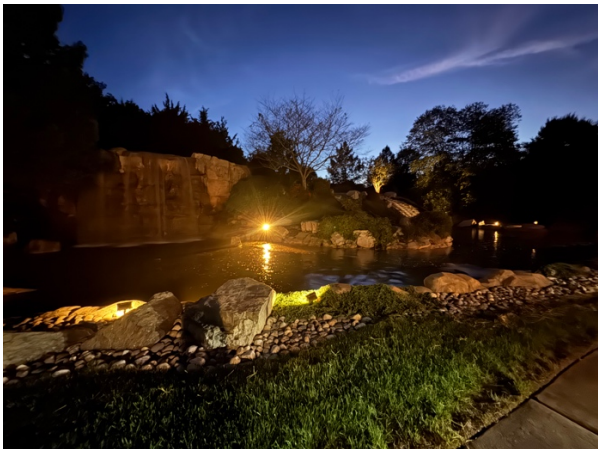
There are a few lights that do not shine onto the water feature but are pointed at the traffic lanes. These need to be replaced with LED units and pointed at the area to be illuminated and not at drivers eyes...

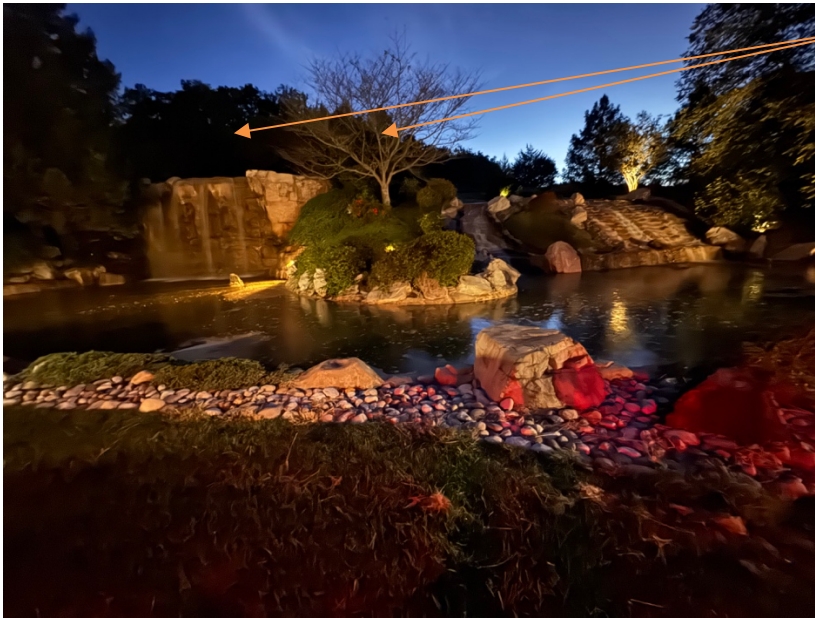
This tree and the tree above/behind upper pool 1 will need to be removed. Other flowering media can be placed here but no more trees.. roots break concrete and cause problems...
