RESERVE STUDY

Windcrest Community Association

Holly Springs, North Carolina
April 2, 2019

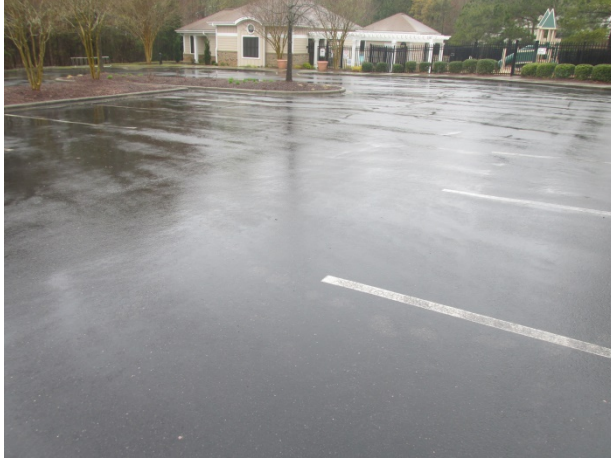
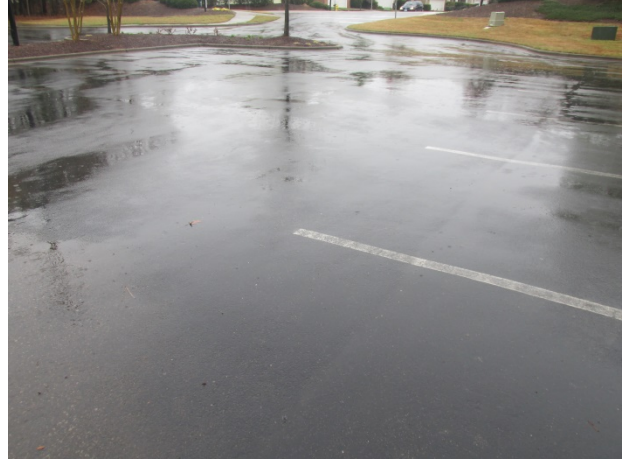
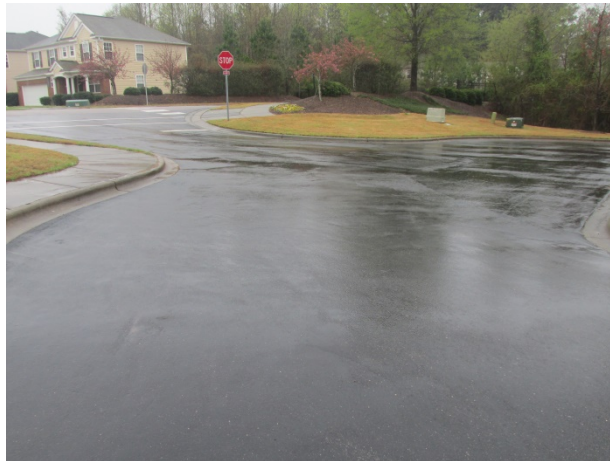
Condition: Good to fair overall with surface cracks evident

Parking lot overview

The manner of repaving is either a mill and overlay or total replacement. A mill and overlay is a method of repaving where cracked, worn and failed pavement is mechanically removed or milled until sound pavement is found. A new layer of asphalt is overlaid atop the remaining base course of pavement. Total replacement includes the removal of all existing asphalt down to the base course of aggregate and native soil followed by the application of two or more new lifts of asphalt. We recommend mill and overlayment on asphalt pavement that exhibits normal deterioration and wear. We recommend total replacement of asphalt pavement that exhibits severe deterioration, inadequate drainage, pavement that has been overlaid multiple times in the past or where the configuration makes overlayment not possible. Based on the apparent visual condition and configuration of the asphalt pavement, we recommend the mill and overlay method for initial repaving followed by the total replacement method for subsequent repaving at Windcrest.

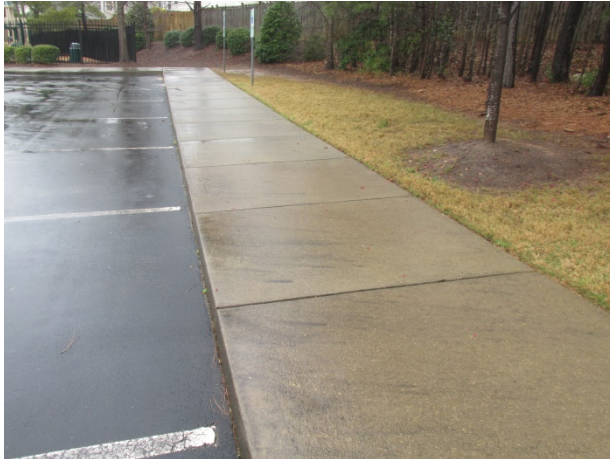
Condition: Good to fair overall with cracks evident

Concrete sidewalk at the pool parking lot

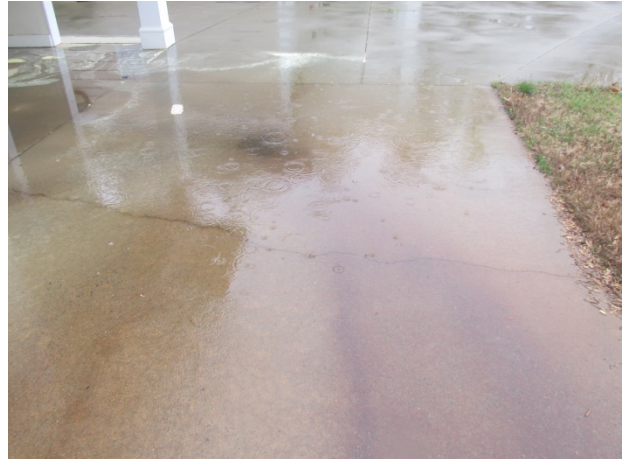
Cracks evident

Expenditure Detail Notes: Expenditure timing and costs are depicted in the **Reserve Expenditures** table in Section 3. We estimate that up to 570 square feet of concrete sidewalks, or thirty percent (30%) of the total, will require replacement during the next 30 years.

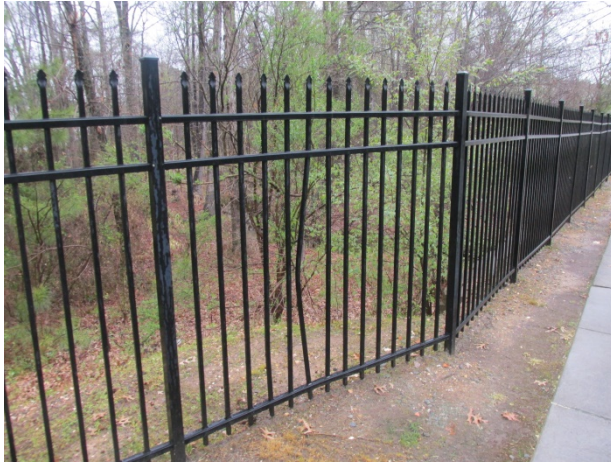
Condition: Good to fair overall with bent pickets evident

Bent pickets evident

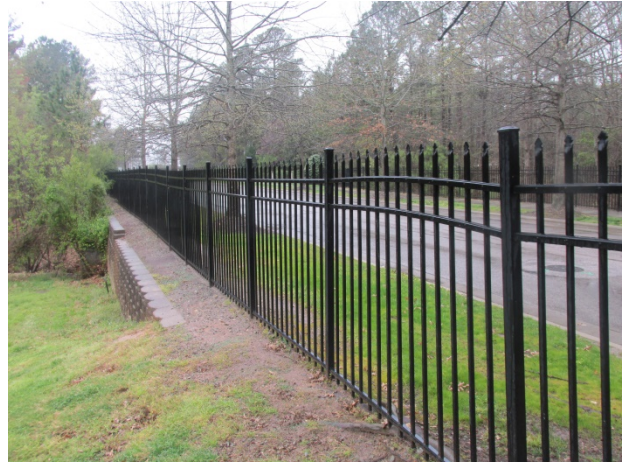
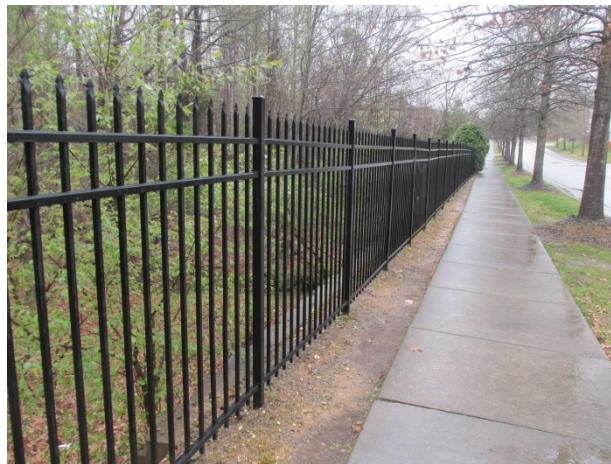
Aluminum fence at masonry retaining wall

Aluminum fence

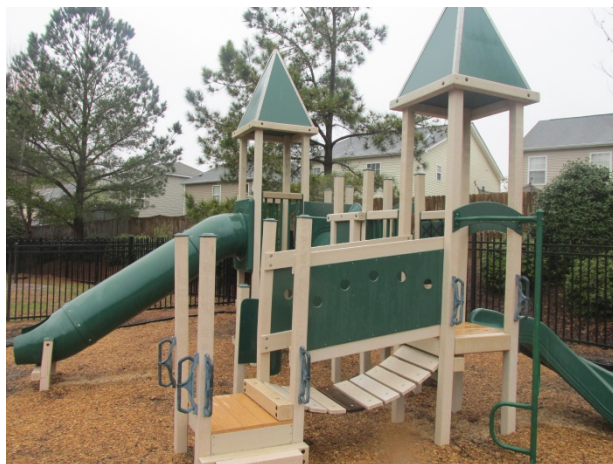
Condition: Fair overall with cracks in the structure evident

Playground equipment

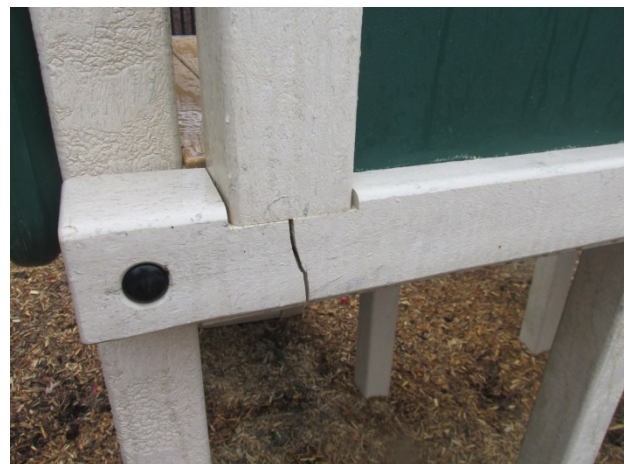
Cracks evident

Component Detail Notes: Safety is the major purpose for maintaining playground equipment. We recommend an annual inspection of the playground equipment to identify and repair as normal maintenance loose connections and fasteners or damaged elements. We suggest the Association learn more about the specific requirements of playground equipment at PlaygroundSafety.org. We recommend the use of a specialist for the design or replacement of the playground equipment environment.

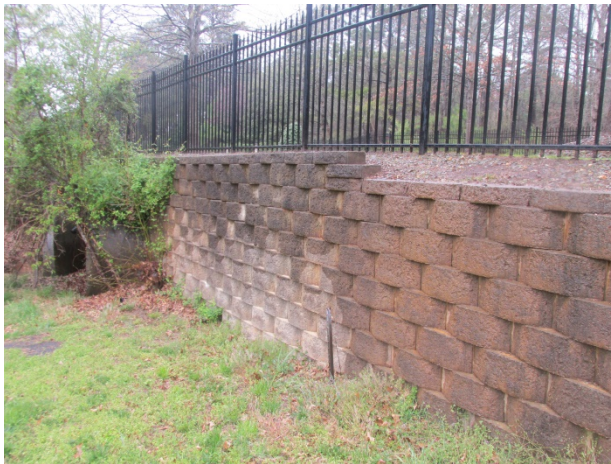
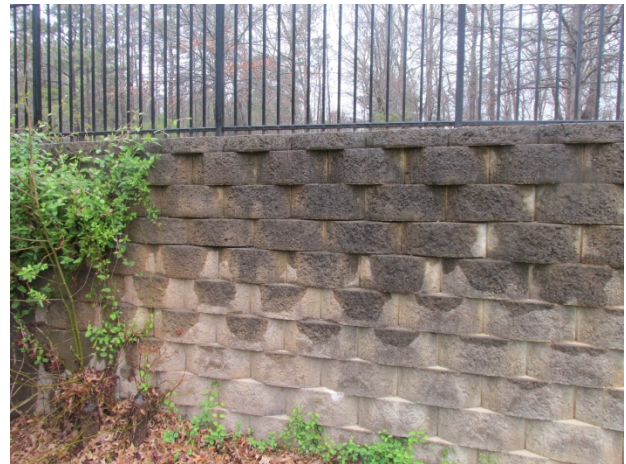
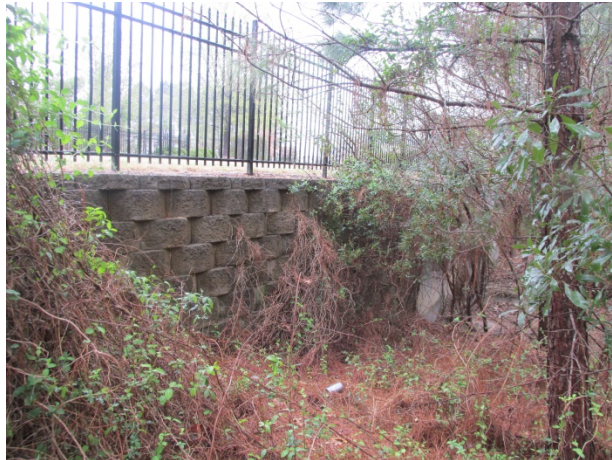
Condition: Good to fair overall

Masonry retaining wall

Useful Life: Masonry retaining walls have indeterminate useful lives. However, we recommend the Association plan for inspections and capital repairs every 10- to 15- years to forestall deterioration.

Expenditure Detail Notes: Expenditure timing and costs are depicted in the **Reserve Expenditures** table in Section 3. Our cost includes an allowance for an inspection, partial resetting and replacement of up to ten percent (10%).

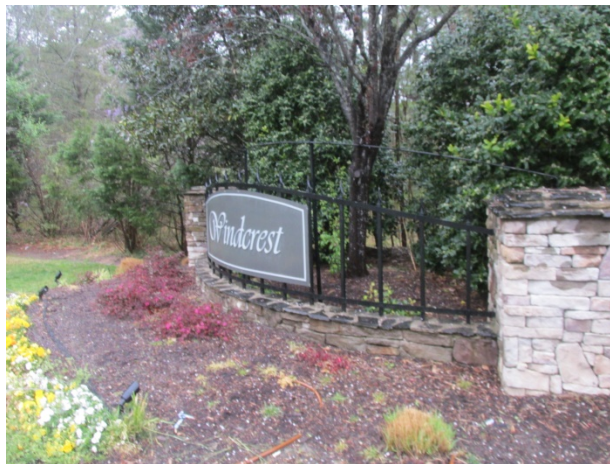
Condition: Good to fair overall

Property identification monument

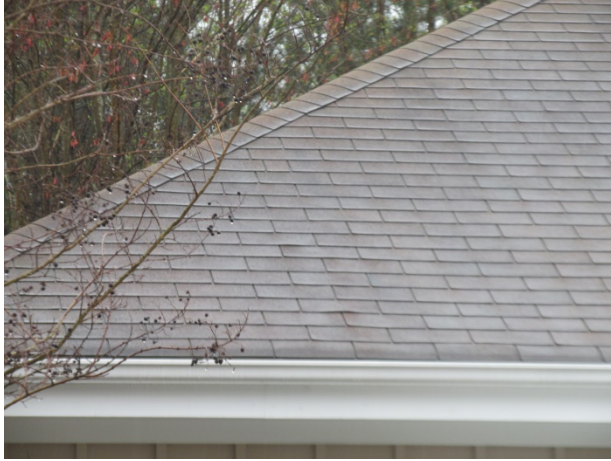
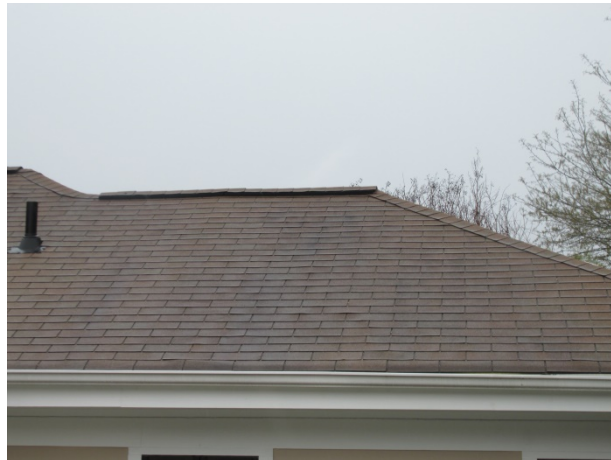
Condition: Good to fair overall with shingle lift evident from our visual inspection from the ground.

Shingle lift evident

Certain characteristics of condition govern the times of replacement. Replacement of an asphalt shingle roof becomes necessary when there are multiple or recurring leaks and when the shingles begin to cup, curl and lift. These conditions are indications that the asphalt shingle roof is near the end of its useful life. Even if the shingles are largely watertight, the infiltration of water in one area can lead to permanent damage to the underlying roof sheathing. This type of deterioration requires replacement of saturated sections of sheathing and greatly increases the cost of roof replacement. Roof leaks may occur from interrelated roof system components, i.e., flashings. Therefore, the warranty period, if any, on the asphalt shingles, may exceed the useful life of the roof system.

Contractors use one of two methods for replacement of sloped roofs, either an overlayment or a tear-off. Overlayment is the application of new shingles over an existing roof. However, there are many disadvantages to overlayment including hidden defects of the underlying roof system, absorption of more heat resulting in accelerated deterioration of the new and old shingles, and an uneven visual appearance. Therefore, we recommend only the tear-off method of replacement. The tear-off method of replacement includes removal of the existing shingles, flashings if required and underlayments.

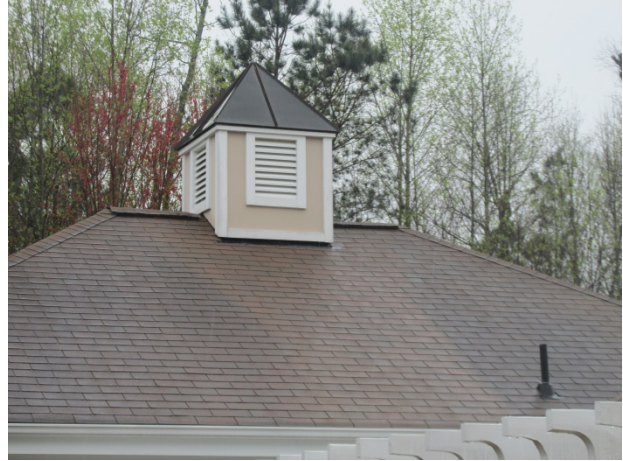
Asphalt shingle roof overview and metal cupola

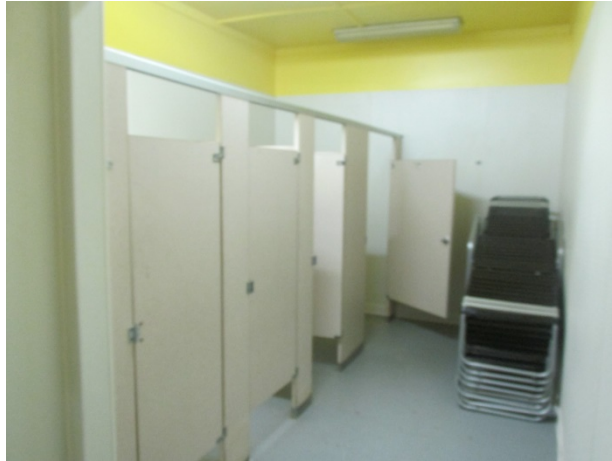
Rest room finishes and fixtures

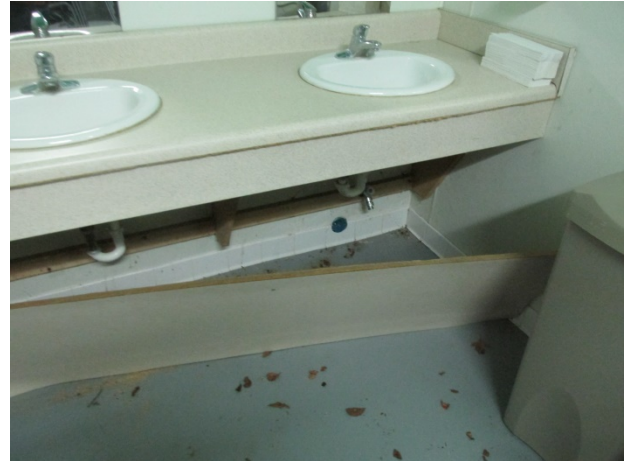
Condition: Good to fair overall. We note isolated damage to the countertop and recommend funding repairs through the operating budget.

Damaged countertop

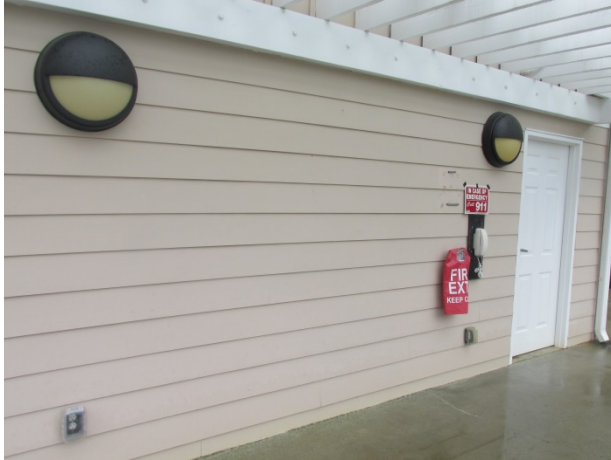
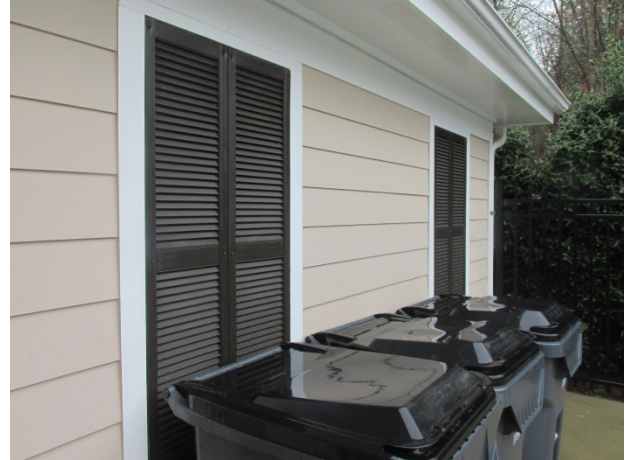
Condition: Good to fair overall

Fiber cement siding

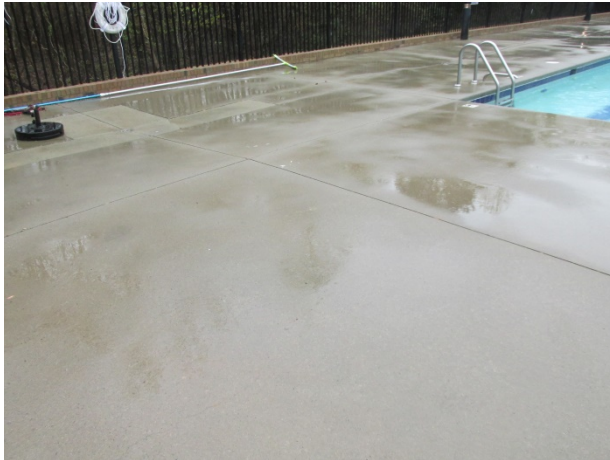
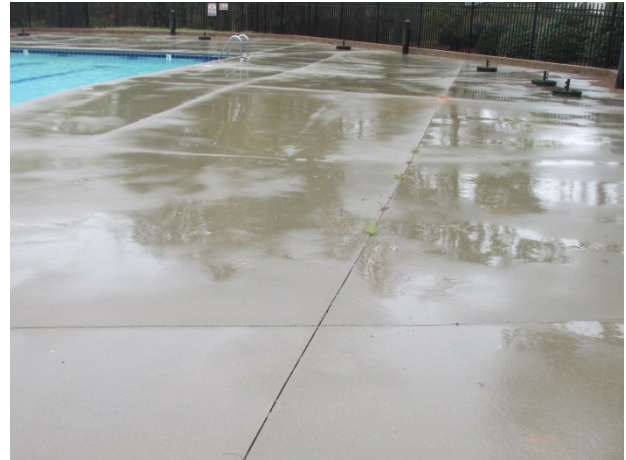
Concrete pool deck

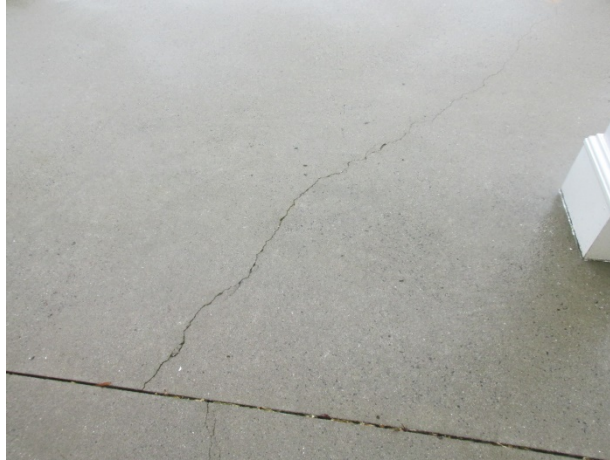
Condition: Good to fair overall with cracks evident

Cracks evident

Useful Life: The useful life of a concrete pool deck is up to 60 years or more with timely repairs. We recommend the Association conduct inspections, partial replacements and repairs to the deck every 8- to 12-years.

- Selective cut out and replacements of up to ten percent (10%) of concrete
- Crack repairs as needed
- Mortar joint repairs
- Caulk replacement

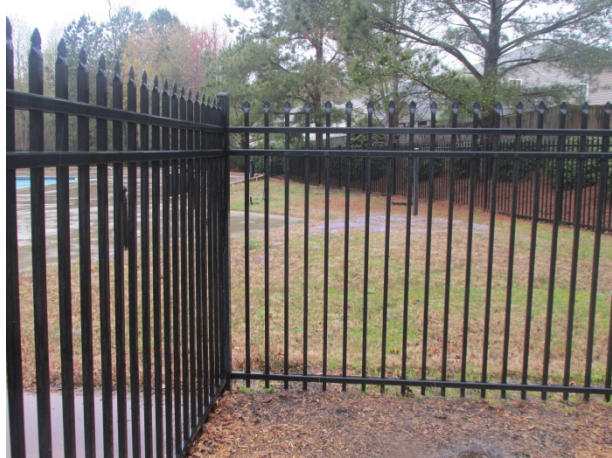
Fence at pool perimeter

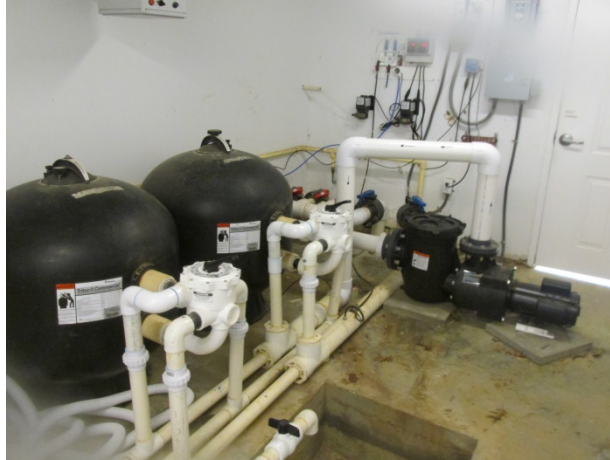
Condition: Reported in satisfactory operational condition

Pool pumps and filters

Expenditure Detail Notes: Expenditure timing and costs are depicted in the **Reserve Expenditures** table in Section 3. Failure of the pool mechanical equipment as a single event is unlikely. Therefore, we include replacement of up to fifty percent (50%) of the equipment per event. We consider interim replacement of motors and minor repairs as normal maintenance.

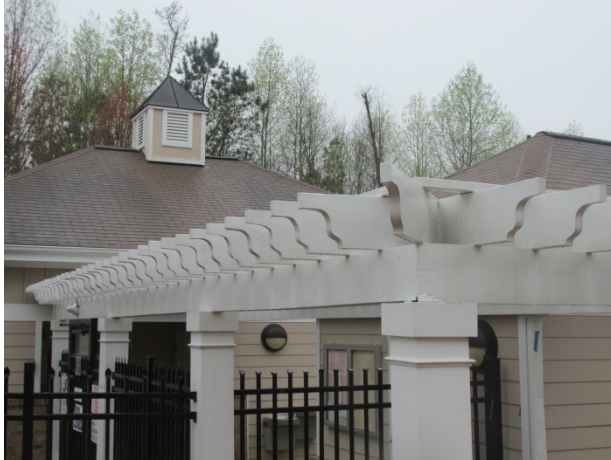
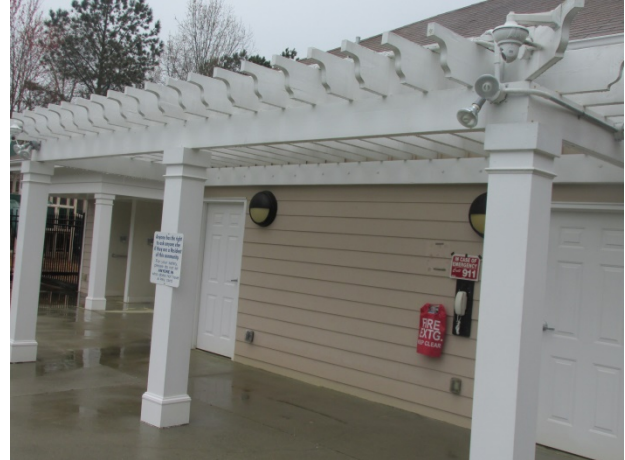
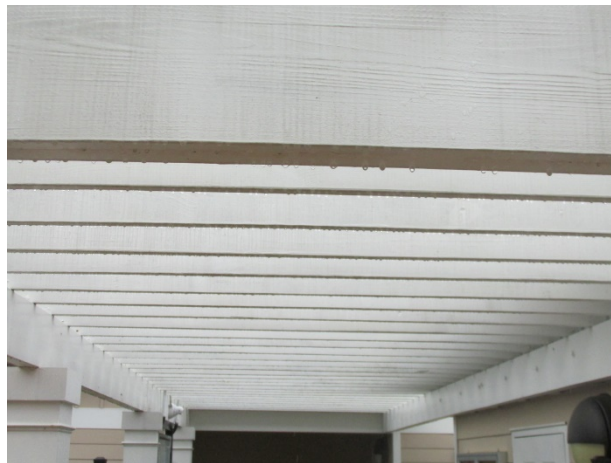
Wood pergola

Pergola structure

Expenditure Detail Notes: Expenditure timing and costs are depicted in the **Reserve Expenditures** table in Section 3. We recommend the Association budget for paint applications and repairs through the operating budget.

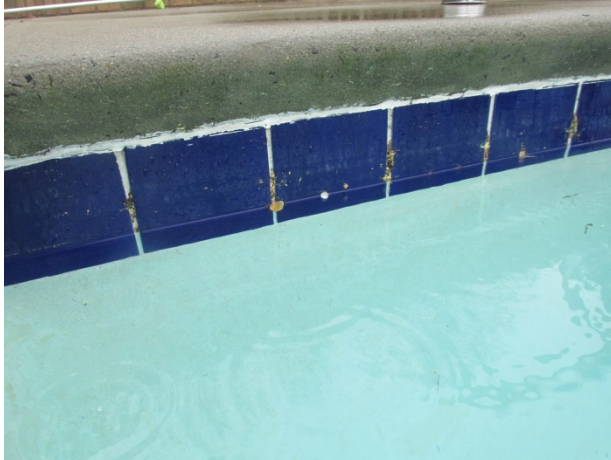
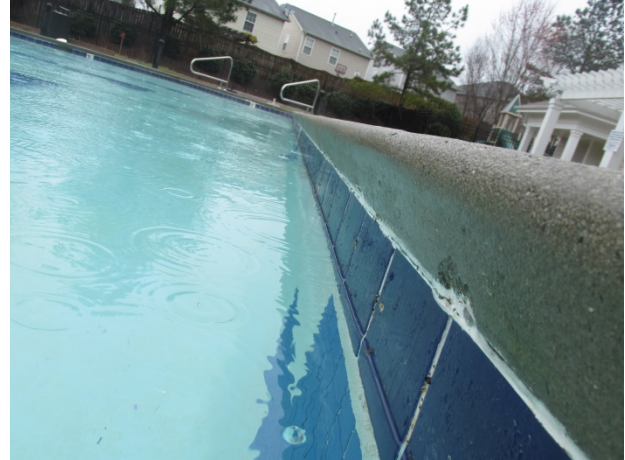
Condition: Fair overall

Plaster and tile at the pool perimeter
