JMTE WAYN 1489
TECHNICAL MEMORANDUM

July 24, 2024

**SUBJECT: LEGACY AT JORDAN LAKE TRAFFIC CALMING
STUDY (WAYN 1489)**

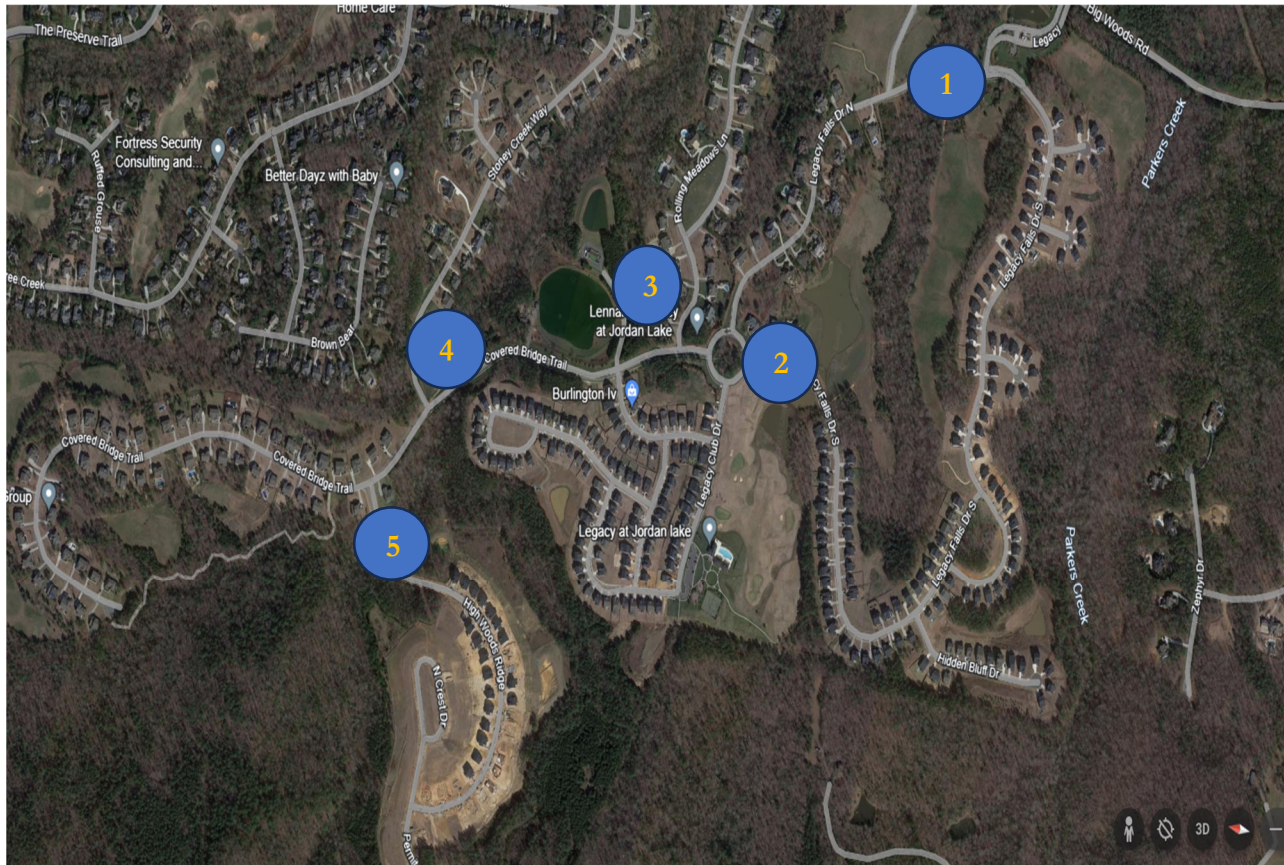
Figure 1: Legacy at Jordan Lake Count Locations & Numbers Shown in Blue (Source: Google Earth)

The Engineer installed pneumatic tube vehicle speed and classification systems (count tubes) at five locations:

- Legacy Falls Dr. North, near the entrance of Legacy,
- Legacy Fall Dr. South of Westlake Circle,
- Covered Bridge Trail north of Rolling Meadows Lane,
- Covered Bridge Trail south of Stoney Creek Way, and
- High Woods Ridge, as shown in Figure 1.

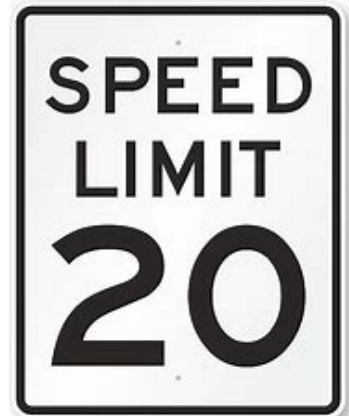
Figure 12: MUTCD R2-1 (Speed Limit)

The neighborhood needs more speed limit signs. The existing speed limit signs (Figure 2) are not MUTCD. The HOA should replace these signs with compliant R2-1 signs see Figure 12.

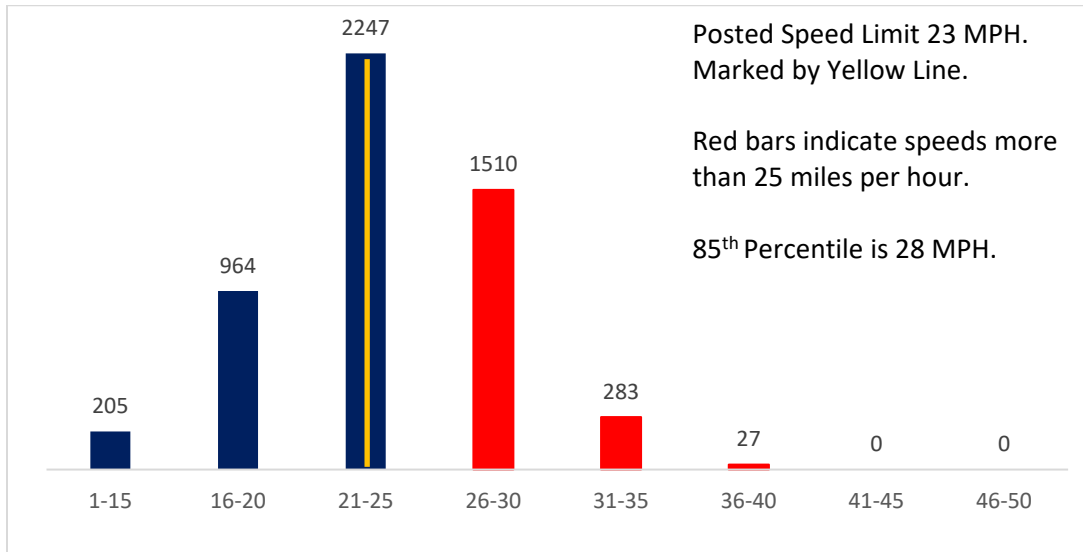
Figure 23: Legacy Falls Drive North – Count Station 1

Based on the posted speed limit in Legacy at Jordan Lake of 23 miles per hour, the 85th percentile speeds are more than 5 miles per hour over the posted speed limit. The speeds for the count locations are shown in Figures 23 – 27 and Table 4 shows the mean and 85th percentile speeds. The 85th percentile speeds are indicative of a speeding problem in Legacy at Jordan Lake. The higher 85th percentile speeds indicate that the current speed limit could be too low, and the residents are comfortable driving at a higher than posted speed. Legacy at Jordan Lake could increase the posted speed limit within the development or install the traffic calming solutions provided.

Counter	Street Name	NB & SB Mean Speed	NB & SB 85th Percentile Speed
1	Legacy Falls Drive N. of Legacy	23	28
2	Legacy Falls Dr. S. of Westlake Circle	27	33
3	Covered Bridge Trail N. of Rolling Meadows Ln.	26	31
4	Covered Bridge Trail S. of Stoney Creek Way	25	29
5	129 High Woods Ridge	23	28
