Revised RESERVE STUDY

Harrison Place Owners Association

Cary, North Carolina Inspected - July 17, 2019 Revised - September 17, 2019

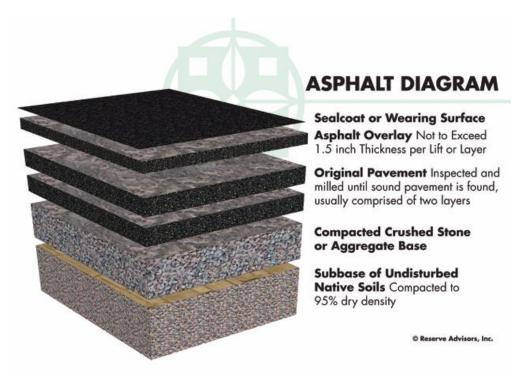
Component Detail Notes: The initial installation of asphalt uses at least two lifts, or two separate applications of asphalt, over the base course. The first lift is the binder course. The second lift is the wearing course. The wearing course comprises a finer aggregate for a smoother more watertight finish. The following diagram depicts the typical components although it may not reflect the actual configuration at Harrison Place:

The manner of repaving is either a mill and overlay or total replacement. A mill and overlay is a method of repaving where cracked, worn and failed pavement is mechanically removed or milled until sound pavement is found. A new layer of asphalt is overlaid atop the remaining base course of pavement. Total replacement includes the removal of all existing asphalt down to the base course of aggregate and native soil followed by the application of two or more new lifts of asphalt. We recommend mill and overlayment on asphalt pavement that exhibits normal deterioration and wear. We recommend total replacement of asphalt pavement that exhibits severe deterioration, inadequate drainage, pavement that has been overlaid multiple times in the past or where the configuration makes overlayment not possible. Based on the apparent visual condition and configuration of the asphalt pavement, we recommend the mill and overlay method followed by total replacement at Harrison Place.
