**ASHBOURNE OWNERS
ASSOCIATION, INC.
CARY, NC**

**FULL RESERVE
STUDY**

GILES & FLYTHE
ENGINEERS

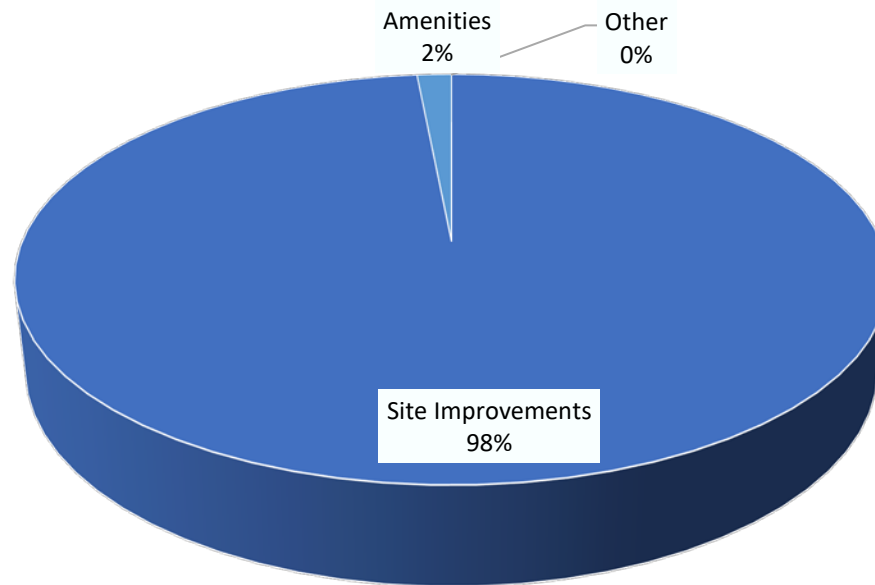
Breakdown of Total Costs by Type

Total over term capital expenditure (un-inflated)	\$361,820
Total over term capital expenditure with inflation:	\$557,048
Average estimated annual capital expenditure with inflation:	\$27,852
Current Reserve Account Balance	\$50,818
Full Funding Balance	\$96,458
Percent Funded	52.68%

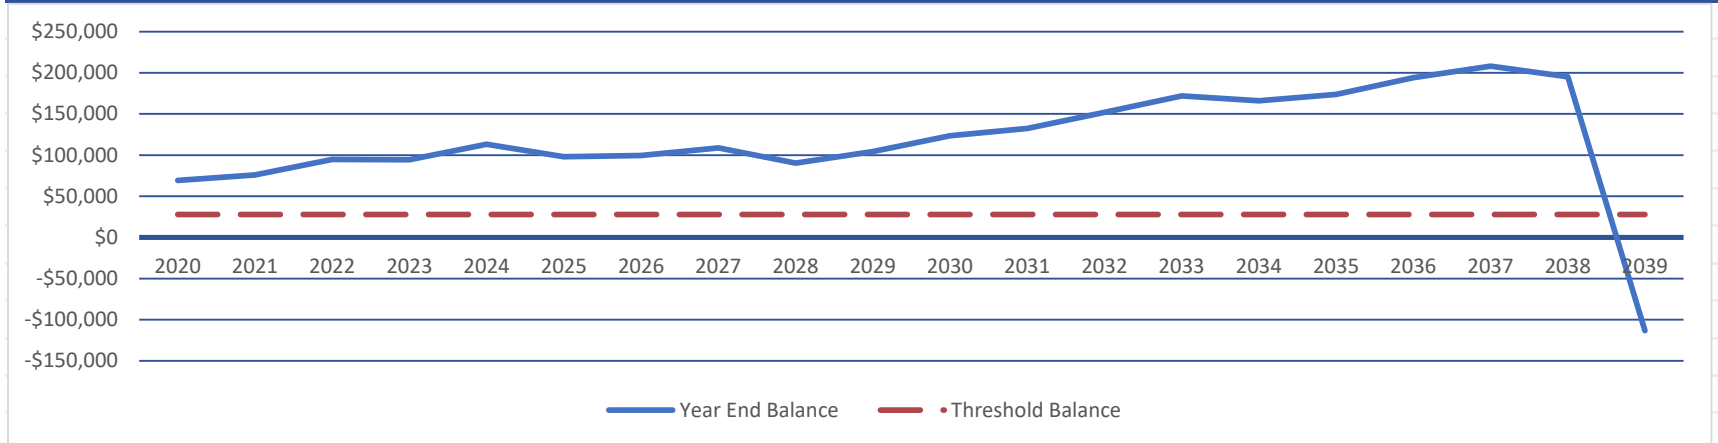
Current Funding Analysis

Year	Starting Balance	Reserve Account Contribution	Average Per Unit/Month	Return on Investments	Repair Expenses	Special Assessments	Year End Balance
2020	\$50,818	\$17,760	\$16.44	\$762	\$0	\$0	\$69,341
2021	\$69,341	\$17,760	\$16.44	\$1,040	\$12,360	\$0	\$75,781
2022	\$75,781	\$17,760	\$16.44	\$1,137	\$0	\$0	\$94,677
2023	\$94,677	\$17,760	\$16.44	\$1,420	\$19,669	\$0	\$94,189
2024	\$94,189	\$17,760	\$16.44	\$1,413	\$0	\$0	\$113,361
2025	\$113,361	\$17,760	\$16.44	\$1,700	\$34,778	\$0	\$98,044
2026	\$98,044	\$17,760	\$16.44	\$1,471	\$17,911	\$0	\$99,363
2027	\$99,363	\$17,760	\$16.44	\$1,490	\$9,839	\$0	\$108,775
2028	\$108,775	\$17,760	\$16.44	\$1,632	\$37,686	\$0	\$90,480
2029	\$90,480	\$17,760	\$16.44	\$1,357	\$5,219	\$0	\$104,378
2030	\$104,378	\$17,760	\$16.44	\$1,566	\$0	\$0	\$123,704
2031	\$123,704	\$17,760	\$16.44	\$1,856	\$11,074	\$0	\$132,246
2032	\$132,246	\$17,760	\$16.44	\$1,984	\$0	\$0	\$151,989

2033	\$151,989	\$17,760	\$16.44	\$2,280	\$0	\$0	\$172,029
2034	\$172,029	\$17,760	\$16.44	\$2,580	\$26,470	\$0	\$165,899
2035	\$165,899	\$17,760	\$16.44	\$2,488	\$12,464	\$0	\$173,684
2036	\$173,684	\$17,760	\$16.44	\$2,605	\$0	\$0	\$194,049
2037	\$194,049	\$17,760	\$16.44	\$2,911	\$6,611	\$0	\$208,109
2038	\$208,109	\$17,760	\$16.44	\$3,122	\$33,623	\$0	\$195,367
2039	\$195,367	\$17,760	\$16.44	\$2,931	\$329,344	\$0	-\$113,286

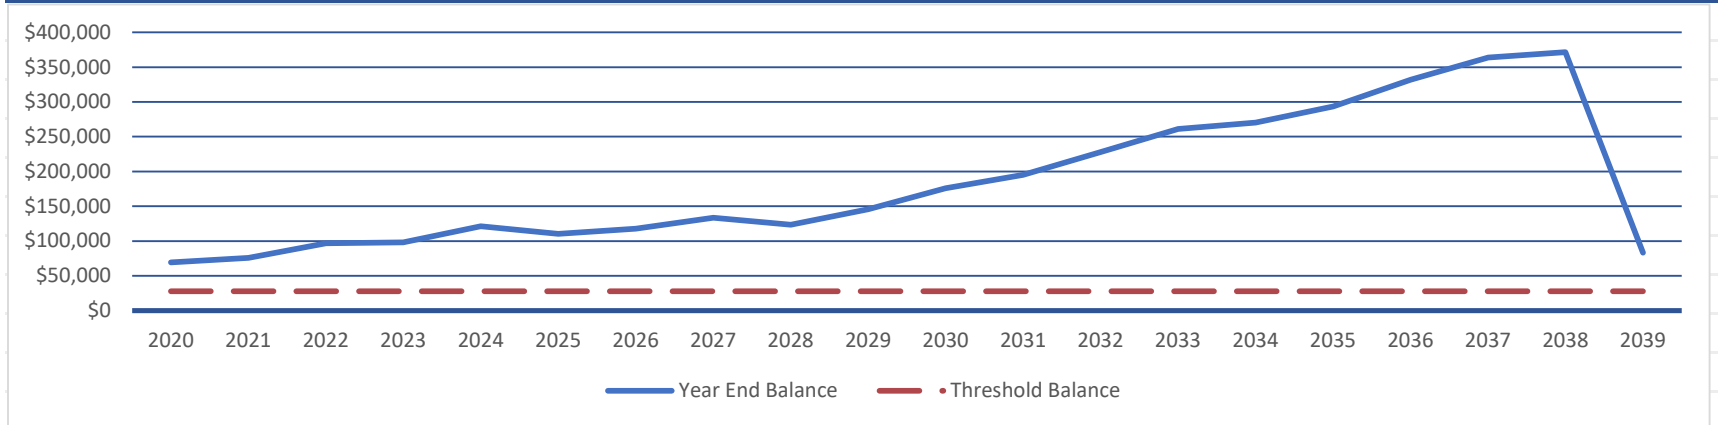
Funding Alternative 1 - Step Funding Increases Every Other Year

Year	Starting Balance	Reserve Account Contribution	Average Per Unit/Month	Return on Investments	Repair Expenses	Special Assessments	Year End Balance
2020	\$50,818	\$17,760	\$16.44	\$762	\$0	\$0	\$69,341
2021	\$69,341	\$17,760	\$16.44	\$1,040	\$12,360	\$0	\$75,781
2022	\$75,781	\$19,760	\$18.30	\$1,137	\$0	\$0	\$96,677
2023	\$96,677	\$19,760	\$18.30	\$1,450	\$19,669	\$0	\$98,219
2024	\$98,219	\$21,760	\$20.15	\$1,473	\$0	\$0	\$121,452
2025	\$121,452	\$21,760	\$20.15	\$1,822	\$34,778	\$0	\$110,255
2026	\$110,255	\$23,760	\$22.00	\$1,654	\$17,911	\$0	\$117,758
2027	\$117,758	\$23,760	\$22.00	\$1,766	\$9,839	\$0	\$133,446
2028	\$133,446	\$25,760	\$23.85	\$2,002	\$37,686	\$0	\$123,521
2029	\$123,521	\$25,760	\$23.85	\$1,853	\$5,219	\$0	\$145,915
2030	\$145,915	\$27,760	\$25.70	\$2,189	\$0	\$0	\$175,863
2031	\$175,863	\$27,760	\$25.70	\$2,638	\$11,074	\$0	\$195,188
2032	\$195,188	\$29,760	\$27.56	\$2,928	\$0	\$0	\$227,875

2033	\$227,875	\$29,760	\$27.56	\$3,418	\$0	\$0	\$261,054
2034	\$261,054	\$31,760	\$29.41	\$3,916	\$26,470	\$0	\$270,259
2035	\$270,259	\$31,760	\$29.41	\$4,054	\$12,464	\$0	\$293,609
2036	\$293,609	\$33,760	\$31.26	\$4,404	\$0	\$0	\$331,773
2037	\$331,773	\$33,760	\$31.26	\$4,977	\$6,611	\$0	\$363,898
2038	\$363,898	\$35,760	\$33.11	\$5,458	\$33,623	\$0	\$371,494
2039	\$371,494	\$35,760	\$33.11	\$5,572	\$329,344	\$0	\$83,483

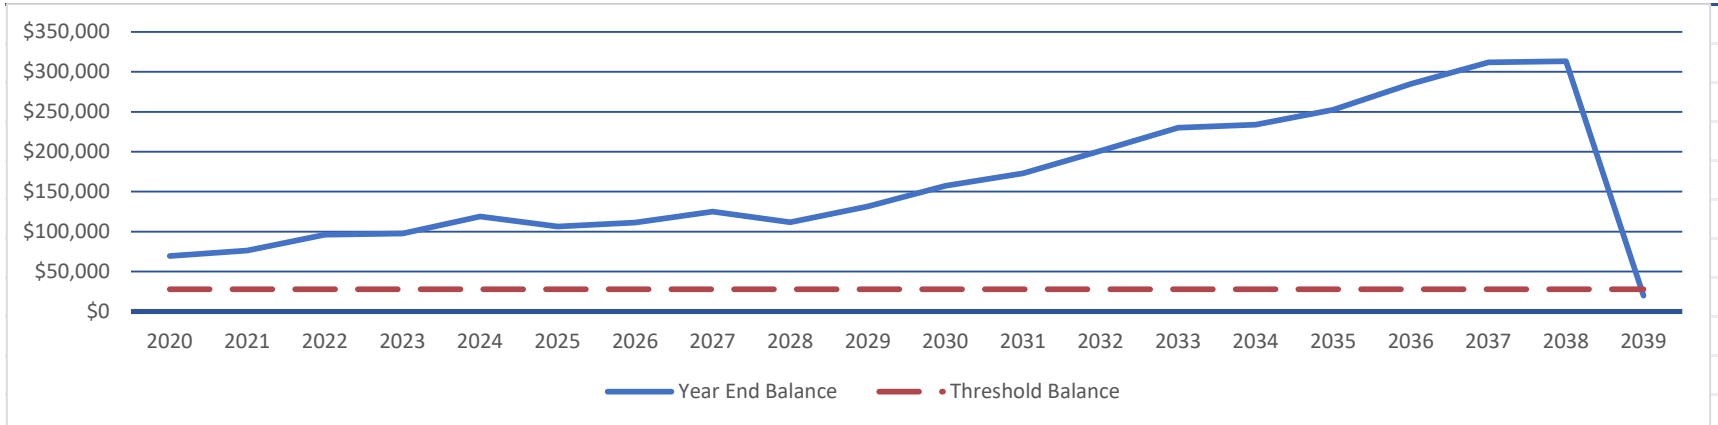
Funding Alternative 2 - Escalating Funding at 3.0% Annually

Year	Starting Balance	Reserve Account Contribution	Average Per Unit/Month	Return on Investments	Repair Expenses	Special Assessments	Year End Balance
2020	\$50,818	\$17,760	\$16.44	\$762	\$0	\$0	\$69,341
2021	\$69,341	\$18,293	\$16.94	\$1,040	\$12,360	\$0	\$76,314
2022	\$76,314	\$18,842	\$17.45	\$1,145	\$0	\$0	\$96,300
2023	\$96,300	\$19,407	\$17.97	\$1,444	\$19,669	\$0	\$97,482
2024	\$97,482	\$19,989	\$18.51	\$1,462	\$0	\$0	\$118,933
2025	\$118,933	\$20,589	\$19.06	\$1,784	\$34,778	\$0	\$106,528
2026	\$106,528	\$21,206	\$19.64	\$1,598	\$17,911	\$0	\$111,421
2027	\$111,421	\$21,843	\$20.22	\$1,671	\$9,839	\$0	\$125,096
2028	\$125,096	\$22,498	\$20.83	\$1,876	\$37,686	\$0	\$111,784
2029	\$111,784	\$23,173	\$21.46	\$1,677	\$5,219	\$0	\$131,415
2030	\$131,415	\$23,868	\$22.10	\$1,971	\$0	\$0	\$157,254
2031	\$157,254	\$24,584	\$22.76	\$2,359	\$11,074	\$0	\$173,123
2032	\$173,123	\$25,322	\$23.45	\$2,597	\$0	\$0	\$201,041

2033	\$201,041	\$26,081	\$24.15	\$3,016	\$0	\$0	\$230,138
2034	\$230,138	\$26,864	\$24.87	\$3,452	\$26,470	\$0	\$233,983
2035	\$233,983	\$27,670	\$25.62	\$3,510	\$12,464	\$0	\$252,699
2036	\$252,699	\$28,500	\$26.39	\$3,790	\$0	\$0	\$284,989
2037	\$284,989	\$29,355	\$27.18	\$4,275	\$6,611	\$0	\$312,007
2038	\$312,007	\$30,235	\$28.00	\$4,680	\$33,623	\$0	\$313,299
2039	\$313,299	\$31,142	\$28.84	\$4,699	\$329,344	\$0	\$19,797
