Hare Snipe Watershed Study

The Hare Snipe Watershed Study will help us make informed and strategic decisions about stormwater projects planned over the next several decades. Projects identified from the watershed study include stormwater conveyance improvements, stream restoration, flood hazard mitigation, water quality improvements, and stormwater infrastructure rehabilitation.

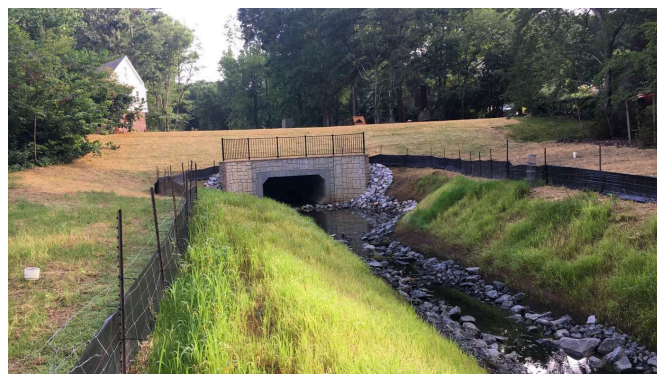
Example of a Stormwater Conveyance Improvement

A hydraulic model was developed to look at the severity and frequency of flooding in the watershed. Conveyance improvements are made when existing pipes and culverts are too small to convey stormwater during rainfall events. Replacing undersized infrastructure can help reduce flooding and prevent roadway overtopping. Priority projects were identified to address roadway overtopping in the watershed.

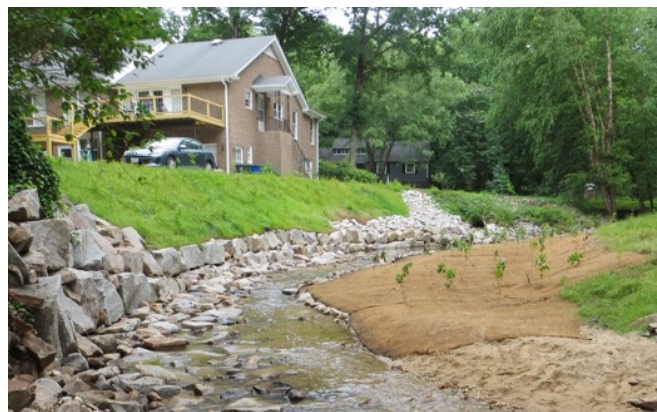
Repaired streambank in Hare Snipe watershed

The goal of the stream assessments was to collect information that will help inform the City's strategic planning, develop future stream enhancement opportunities, and further partnerships with the community. Twenty-two miles of stream were inventoried in the watershed and 70% have been impacted to the point where some level of stream restoration or stabilization would be beneficial. A number of stream enhancement opportunities were identified and prioritized. Because stream restoration projects often involve re-establishing a stream's floodplain, one consideration for these projects is the availability of land for the City to perform an effective project. Homeowners who wish to repair streambanks may contact our Drainage Assistance Program.

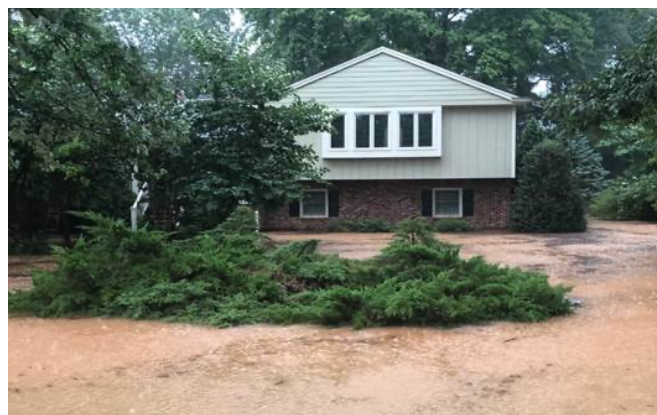
Flood mitigation in Hare Snipe Watershed

The floodplain is an area next to a river or creek that floods during a storm. The floodplain gives water a place to go when streams cannot handle any more water. The floodplain also helps to reduce pollution. We cannot prevent flooding in the floodplain, but we can take steps to offset the impacts to streets and structures. These steps could include constructing stormwater control measures such as wet or dry ponds to help manage stormwater runoff. However, there is limited space for effective stormwater detention/retention in the Hare Snipe watershed.

This means there is limited opportunity to significantly reduce the volume of stormwater that flows during rainfall events. In addition, even if the capacities of all stormwater culverts in the watershed were increased, hydraulic modeling shows that low-lying areas would still be impacted by flooding.

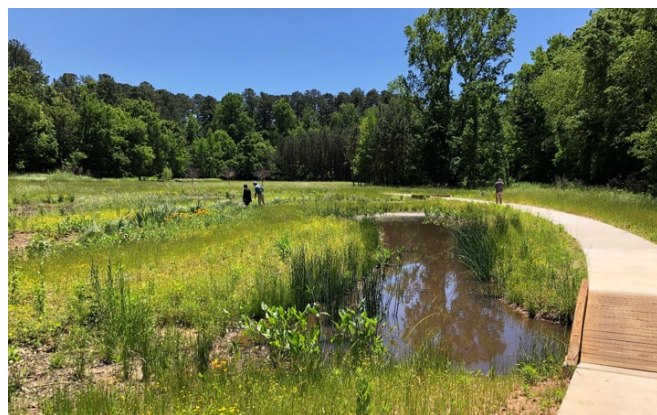
A central goal of the Stormwater program is to protect water resources and support environmental sustainability. The City is leading by example with investment in Green Stormwater Infrastructure (GSI) and capital projects to improve water quality, enhance wildlife habitat, and create public amenities. An example of this is Wooten Meadow Park in Hare Snipe watershed which was completed in 2022. A water quality model was constructed for the Hare Snipe Creek Watershed to assess the potential benefits of future capital projects could be assessed. Approximately 20 water quality improvement opportunities were identified as part of this study. These include retrofitting existing stormwater control measures to provide greater water quantity and quality benefits as well as identifying opportunities for GSI.
